# OSAGE BEACH VISION ZERO ACTION PLAN

Existing Conditions Report

January 2026

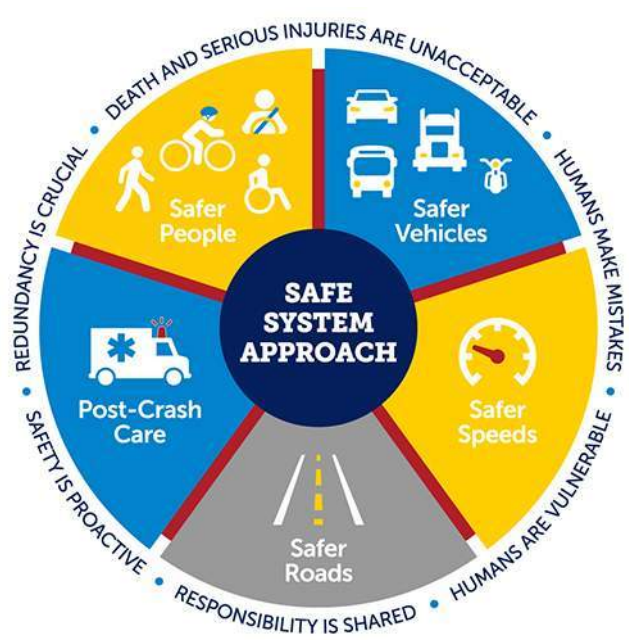
Figure 1 - Safe System Approach

The Safe System Approach focuses on both human mistakes and human vulnerability and designs a system with many redundancies in place to protect everyone. In support of this approach, safety programs are focused on infrastructure, human behavior, responsible oversight of the vehicle and transportation industry, and emergency response.

- Death and serious injuries are unacceptable
- Humans make mistakes
- Humans are vulnerable
- Responsibility is shared
- Safety is proactive
- Redundancy is crucial

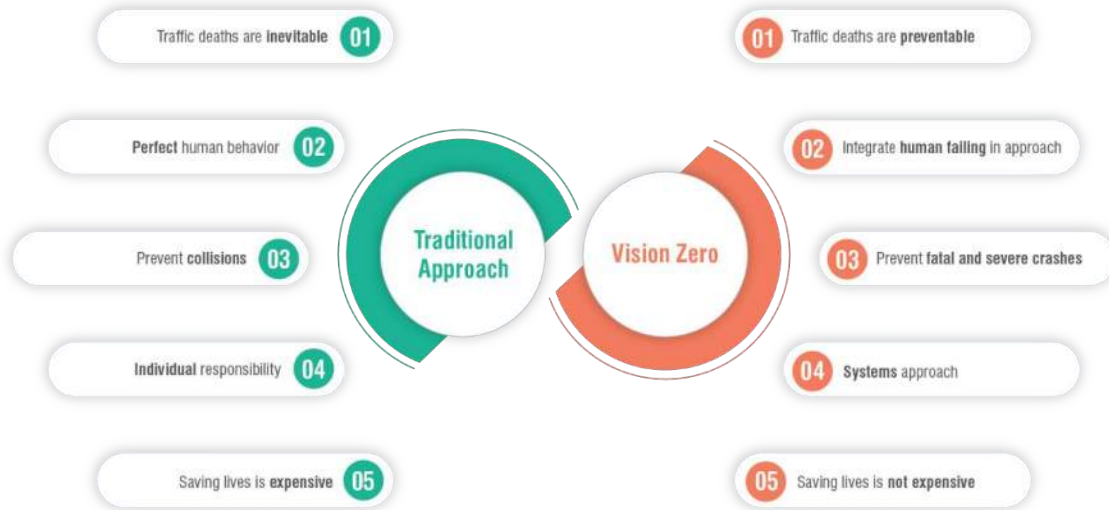
Figure 2 - Vision Zero vs Traditional Approach

Vision Zero is a multi-disciplinary approach aimed at eliminating all traffic fatalities and serious injuries on transportation networks while increasing safety, health, and equitable mobility for all. This approach is utilized throughout this analysis by focusing on crash types that result in fatal and serious injuries and addressing the most vulnerable roadway users. Through this approach, there may be low cost infrastructure improvements that save lives.

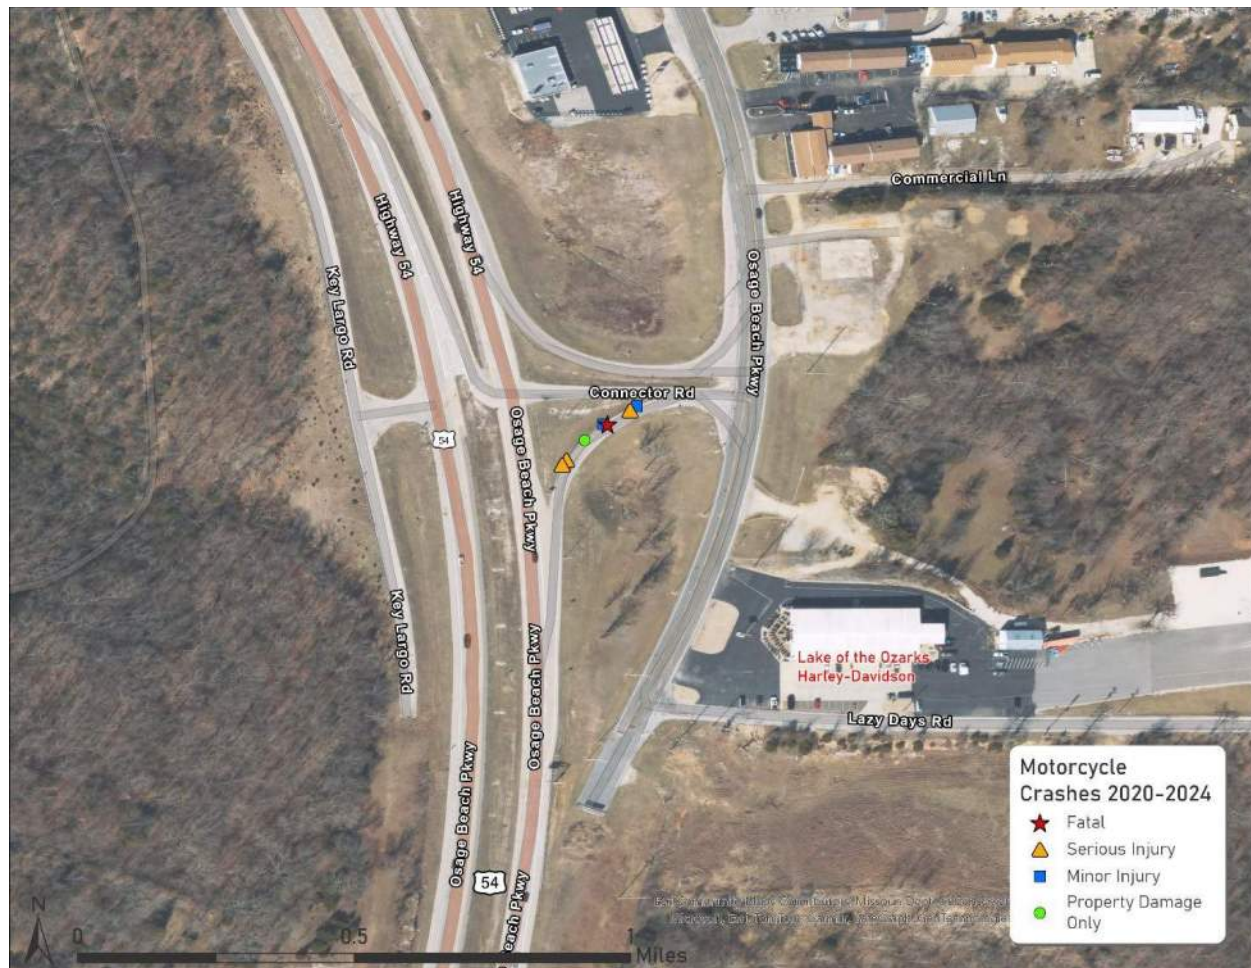
Figure 12 - Motorcycle Crashes Zoomed in to Key Largo Rd 2020-2024

Motorcyclists are exposed road users with limited physical protection and are more susceptible to fatal and severe injury in crashes. Motorcycle crashes make up 3% of all crashes in Osage Beach Missouri from 2020-2024, but make up **34%** of Fatal and Serious injury crashes.

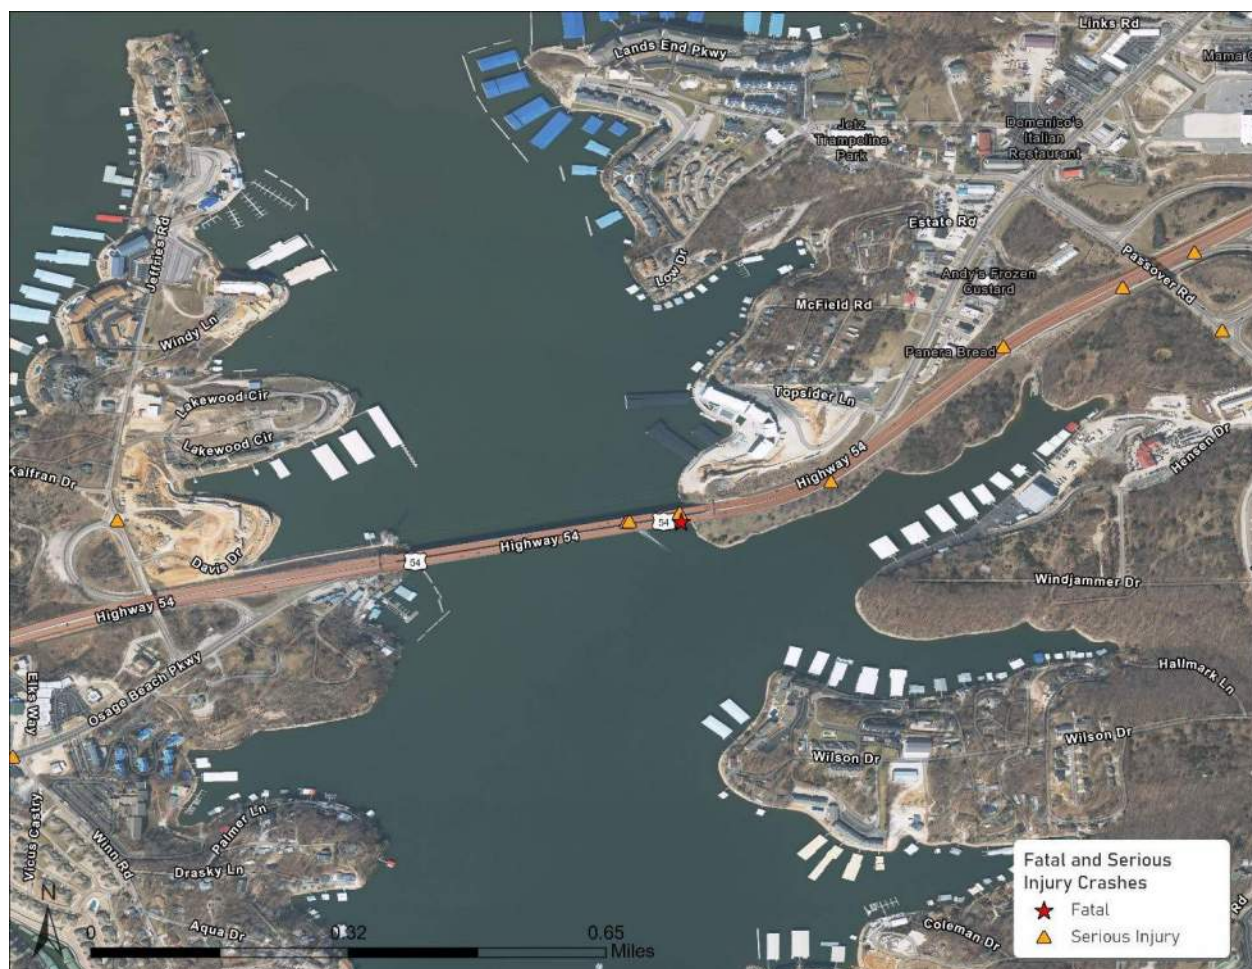
Figure 18 - Grand Glaize Bridge Aerial with Fatal and Serious Injury Crashes 2020-2024

The Grand Glaize Bridge is the primary connection between the eastern and western portions of Osage Beach, making it critical to local connectivity and safety considerations. The Grand Glaize Bridge accounts for **9%** of fatal and serious injury crashes in Osage Beach.

- **1** fatal
- **4** serious injury
- **8** minor injuries
- **40** property damage only crashes

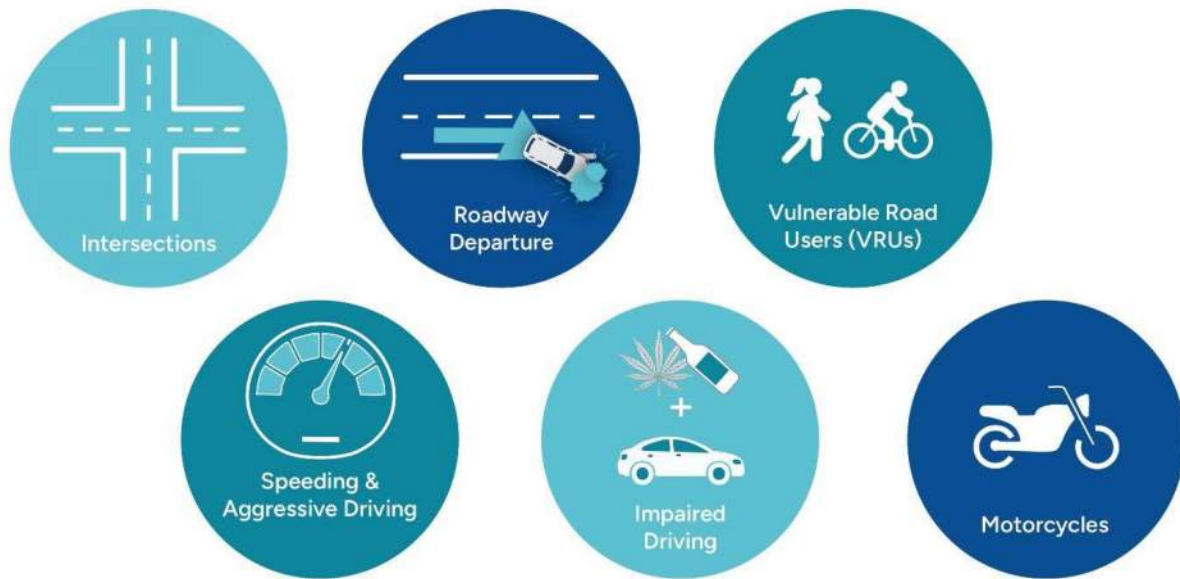
Figure 22 - Emphasis Areas

The emphasis areas outlined in this plan are derived from the [Missouri Strategic Highway Safety Plan \(SHSP\)](#) and have been tailored to address the specific safety challenges within the City of Osage Beach. These focus areas were selected based on an analysis of fatal and serious injury crashes over a five-year period (2020–2024) in Osage Beach. Together, these six emphasis areas will guide the development of actionable recommendations and infrastructure improvements throughout the Vision Zero Action Plan.

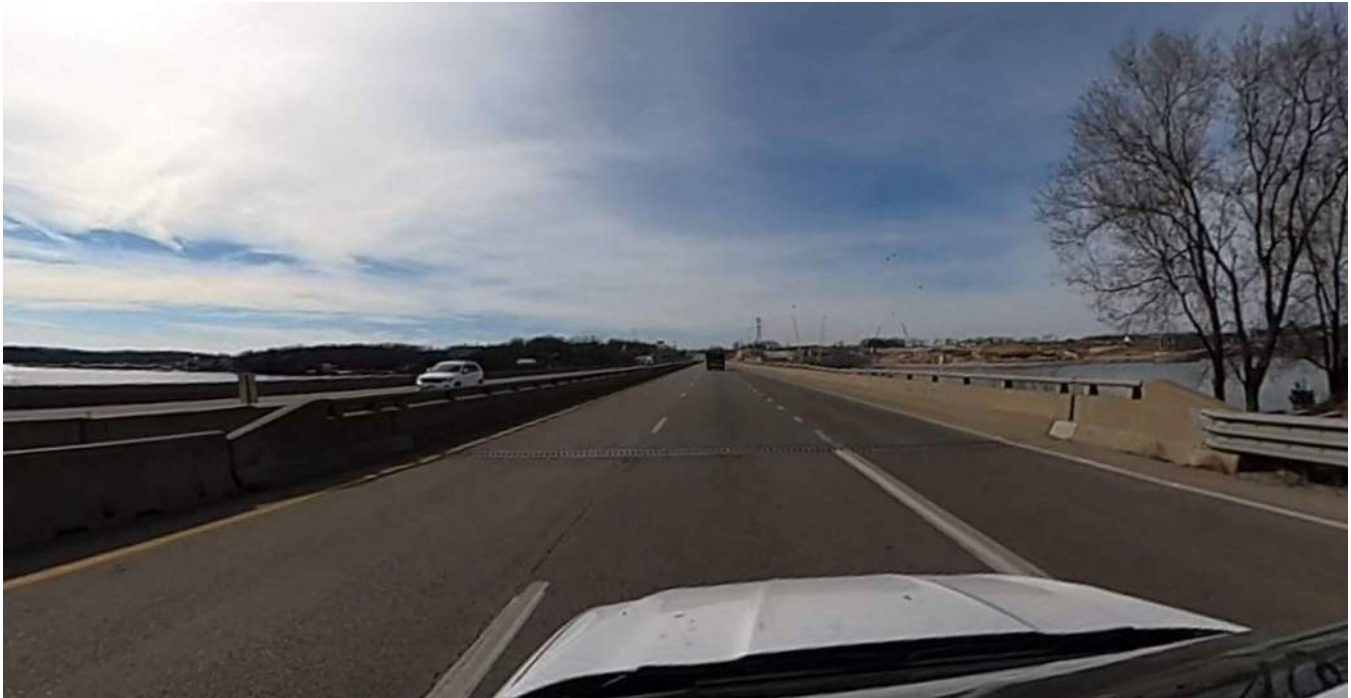
Figure 4 - Westbound Grand Glaize Bridge (02.11.2026)

The Grand Glaize Bridge serves as the primary connection between the eastern and western portions of Osage Beach, making it critical to local connectivity and safety. Currently, there are no facilities that allow non-motorized users to safely cross the bridge. Between 2020 and 2024, the bridge accounted for 9% of fatal and serious injury crashes in Osage Beach, including one crash involving a pedestrian.

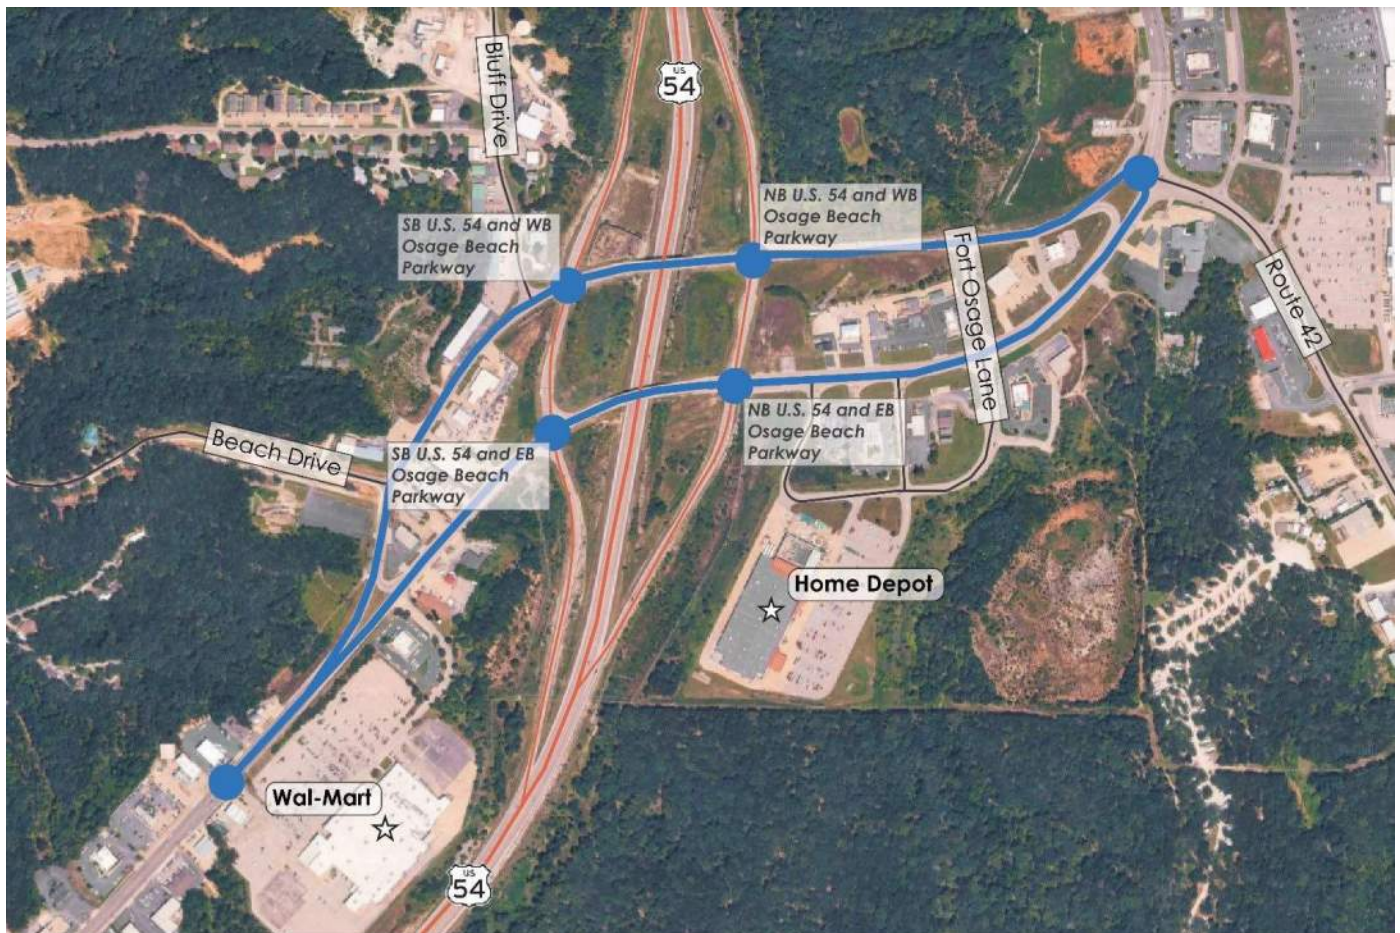
Figure 11 - Northern couplet interchange with U.S. 54 where a majority of crashes on Osage Beach Parkway occur

Table 6 summarizes crashes by severity at each of the major intersections of Osage Beach Parkway, most of which are signalized. The southernmost interchange of U.S. 54 and Osage Beach Parkway, located between Lazy Days Road and Commercial Ln, is the only unsignalized intersection in the table and the only intersection where a fatal crash took place. The four intersections associated with the northern couplet interchange with U.S. 54 (Figure 11) account for about a third of all major intersection crashes and three SSI crashes. The intersection of Route 42 and Osage Beach Parkway had the highest total of crashes at 47 with no SSI crashes. However, Barry Prewitt Memorial was a close second at 43 with one SSI crash. More in-depth analysis about each of these intersections is provided in the Intersection Specific Analysis section.

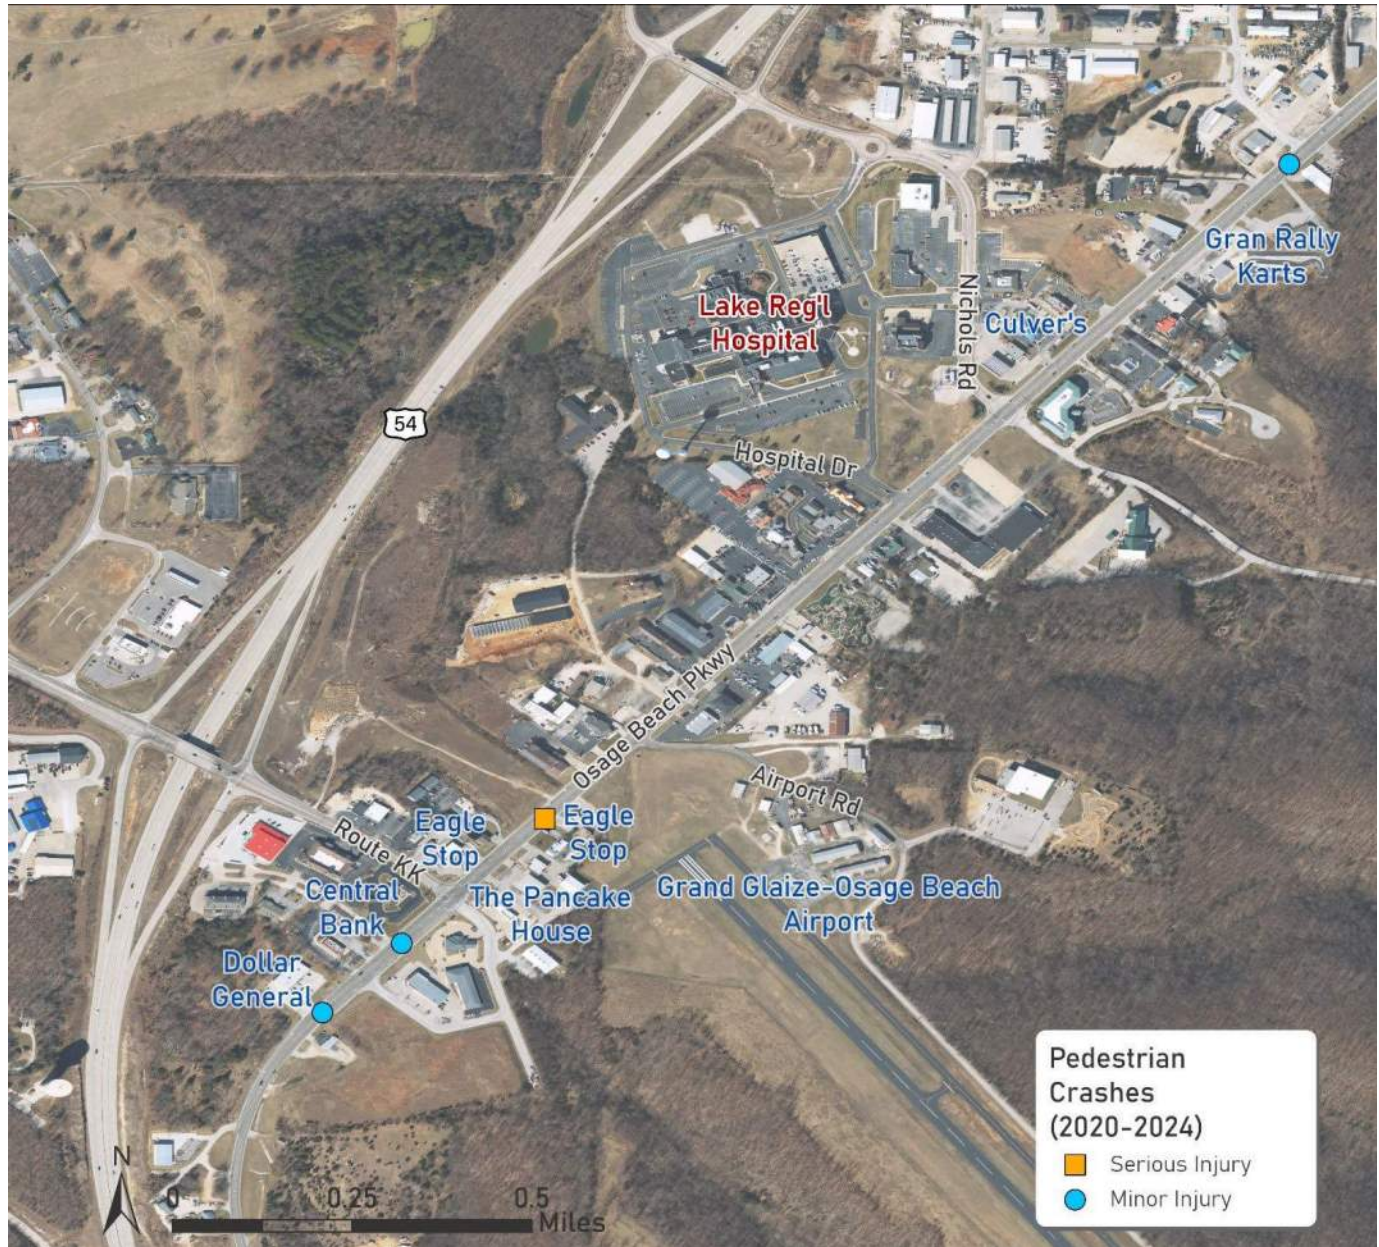
Figure 14 - Pedestrian Crash Locations on Osage Beach Parkway (2020 to 2024)

There were four crashes involving pedestrians crossing Osage Beach Parkway, all of which occurred outside of a signalized intersection. Figure 14 displays the locations of these crashes along Osage Beach Parkway, three of which occurred near the intersection with Route KK. In each case, the pedestrian was crossing Osage Beach Parkway, typically to access a nearby business such as a gas station or Dollar General.

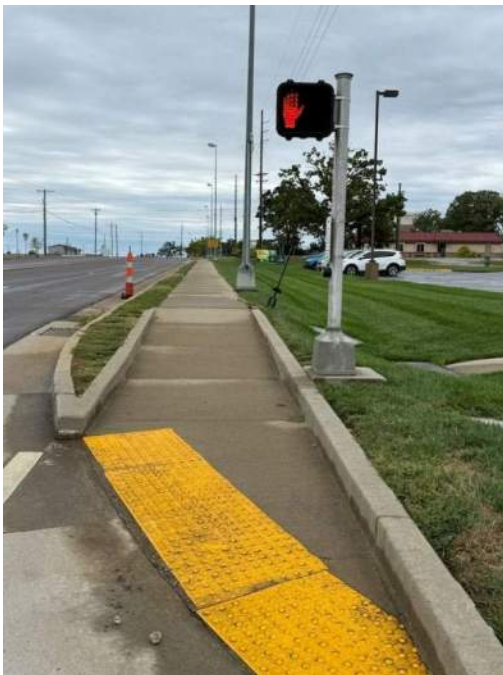
Figure 15 - Concrete Sidewalk

East of Passover Road, the north side features concrete sidewalks through Beach Drive. The south side has concrete sidewalks between Chef Street and Hatchery Street, followed by a mix of narrow asphalt shoulders and concrete sections through the southwest U.S. 54 southbound on-ramp. Between the U.S. 54 ramp terminals and Goldie Pearl Boulevard, sidewalks are absent on both sides of the parkway. From Goldie Pearl Boulevard to Barry Prewitt Memorial Drive, a concrete sidewalk runs along the east side and switches to the west side from Barry Prewitt Memorial Drive to the bridge over U.S. 54. There is no designated bicycle infrastructure along the entire corridor.

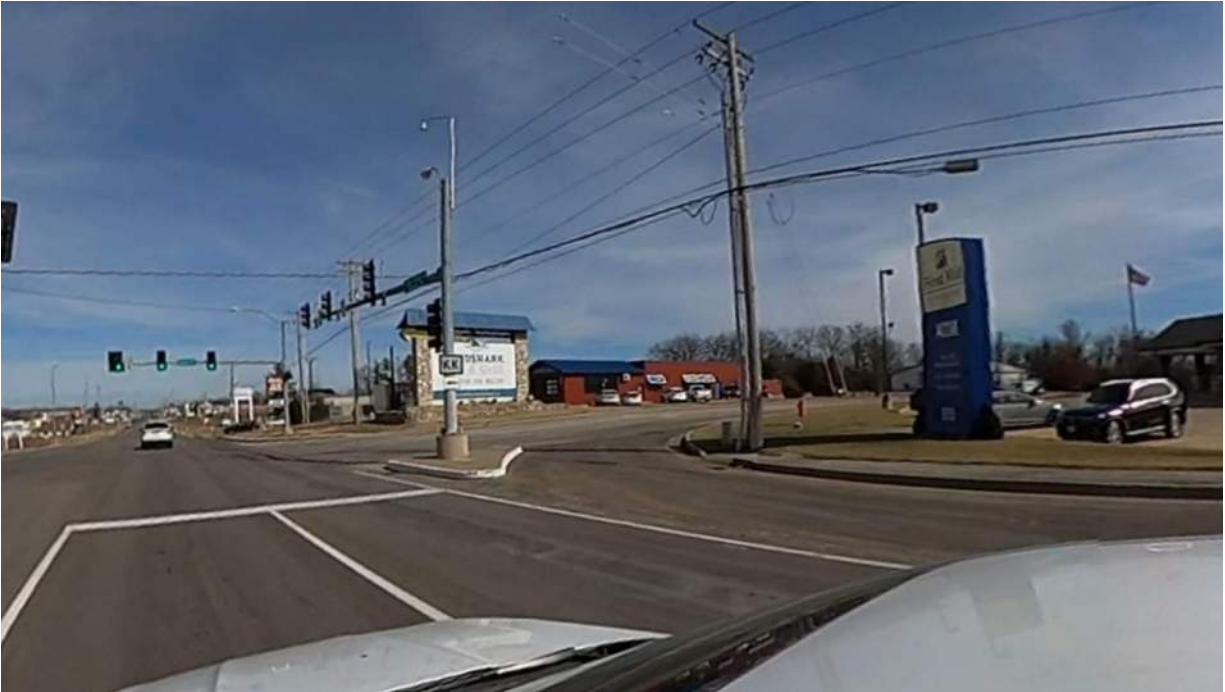
Figure 22 - Pedestrian Accommodation Osage Beach Parkway & Route KK (02.11.2026)

Along the northeast and southwest legs, a detached sidewalk runs along the north side, and a narrow asphalt shoulder runs along the south side. No pedestrian facilities exist on Route KK. Only one crosswalk exists at this intersection, located on the northwest side across Route KK. The crosswalk is equipped with an audible push button and a countdown timer. In addition, there is no ADA compliant infrastructure along the northeast and southwest legs.

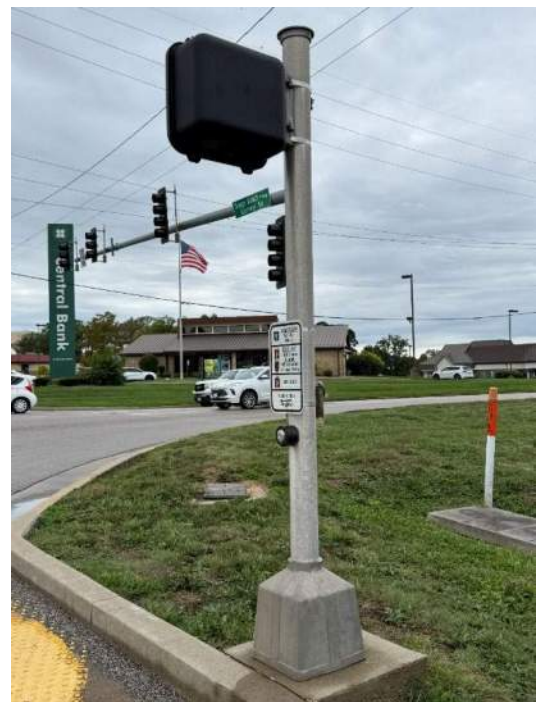
Figure 23 - Northwest Leg Pedestrian Accommodation Osage Beach Parkway & Route KK (10.10.2025)

**Sidewalk Presence and Condition:** No Sidewalk.

**Crosswalk Presence and Condition:** Standard crosswalk equipped with countdown timer. Crosswalk is faded.

**ADA Features:** Audible push button and truncated domes.

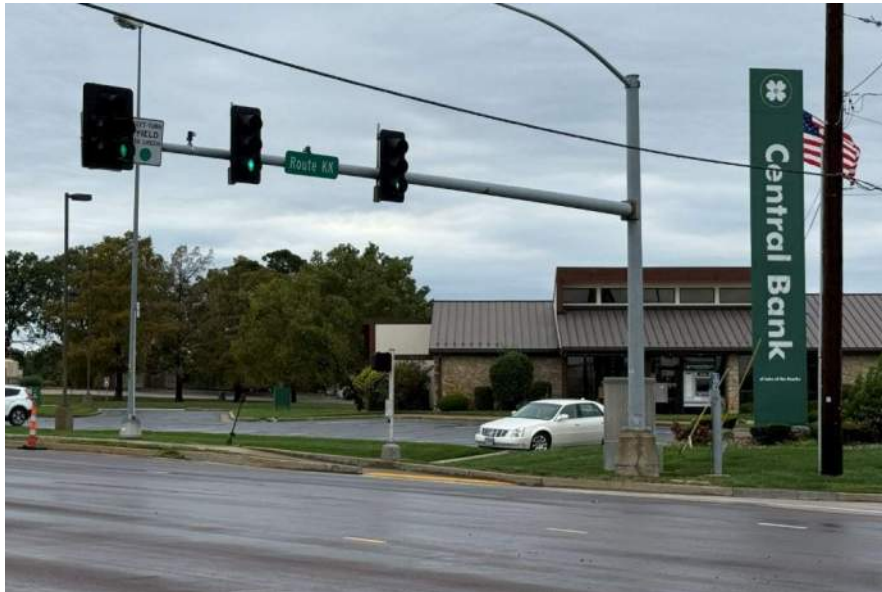
Figure 24 - Southwest Leg Pedestrian Accommodation Osage Beach Parkway & Route KK (10.10.2025)

**Sidewalk Presence and Condition:** Detached concrete sidewalk on west side in good condition.

**Crosswalk Presence and Condition:** No Crosswalk.

**ADA Features:** Truncated dome on the west side.

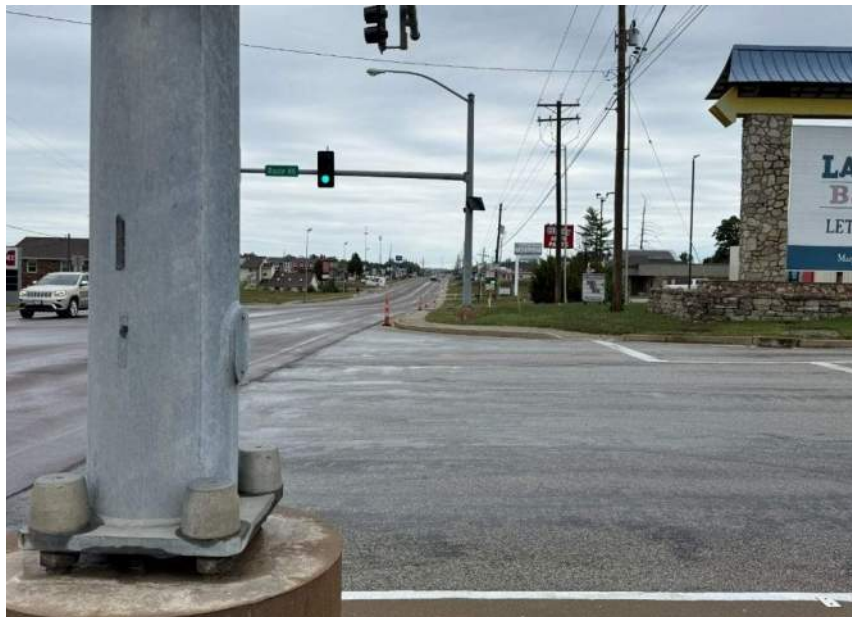
Figure 25 - Northeast Leg Pedestrian Accommodation Osage Beach Parkway & Route KK (10.10.2025)

**Sidewalk Presence and Condition:** Detached concrete sidewalk on north side in good condition.

**Crosswalk Presence and Condition:** No Crosswalk.

**ADA Features:** Not ADA-compliant.

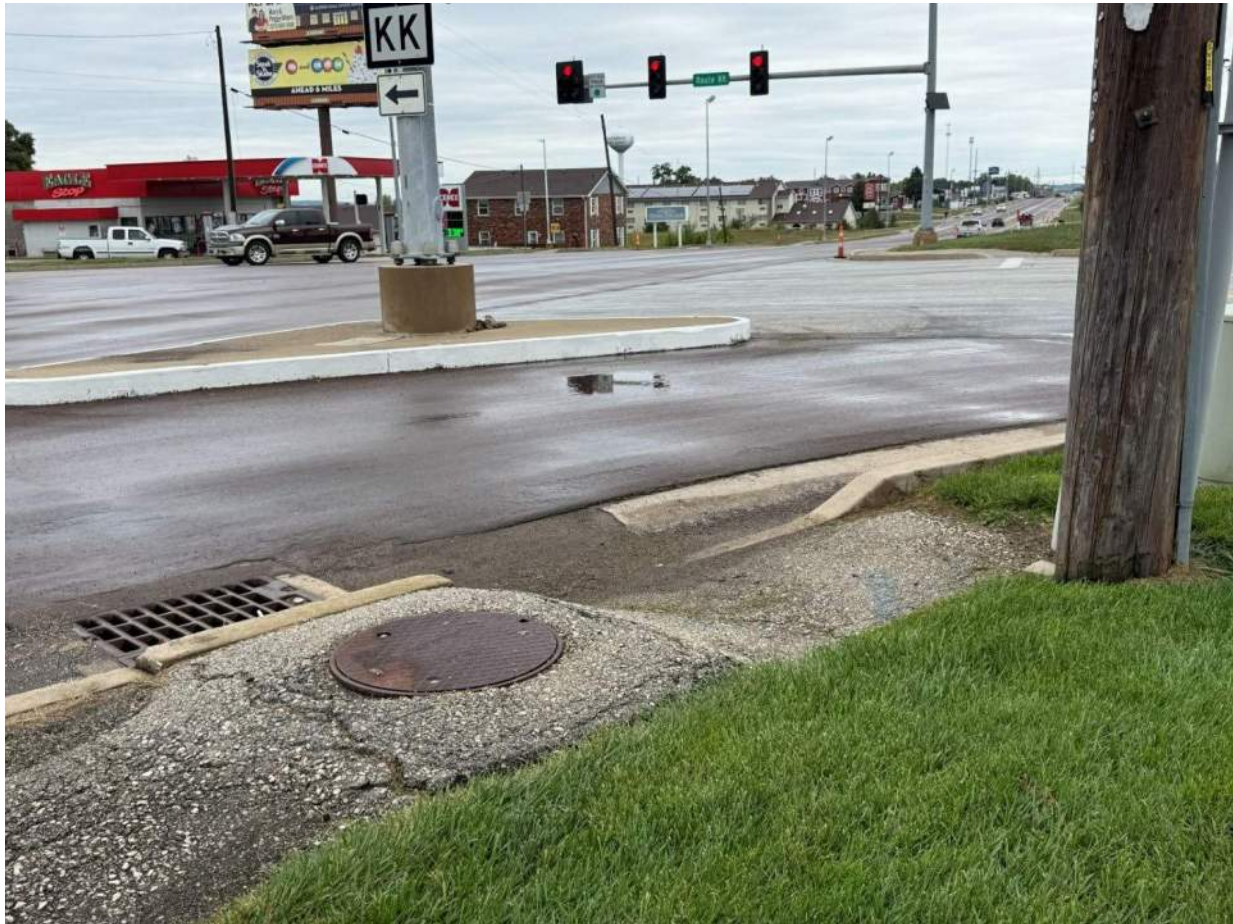
*Figure 26 - Southeast Leg Pedestrian Accommodation Osage Beach Parkway & Route KK (10.10.2025)*

**Sidewalk Presence and Condition:** No Sidewalk.

**Crosswalk Presence and Condition:** No Crosswalk.

**ADA Features:** Not ADA-compliant.

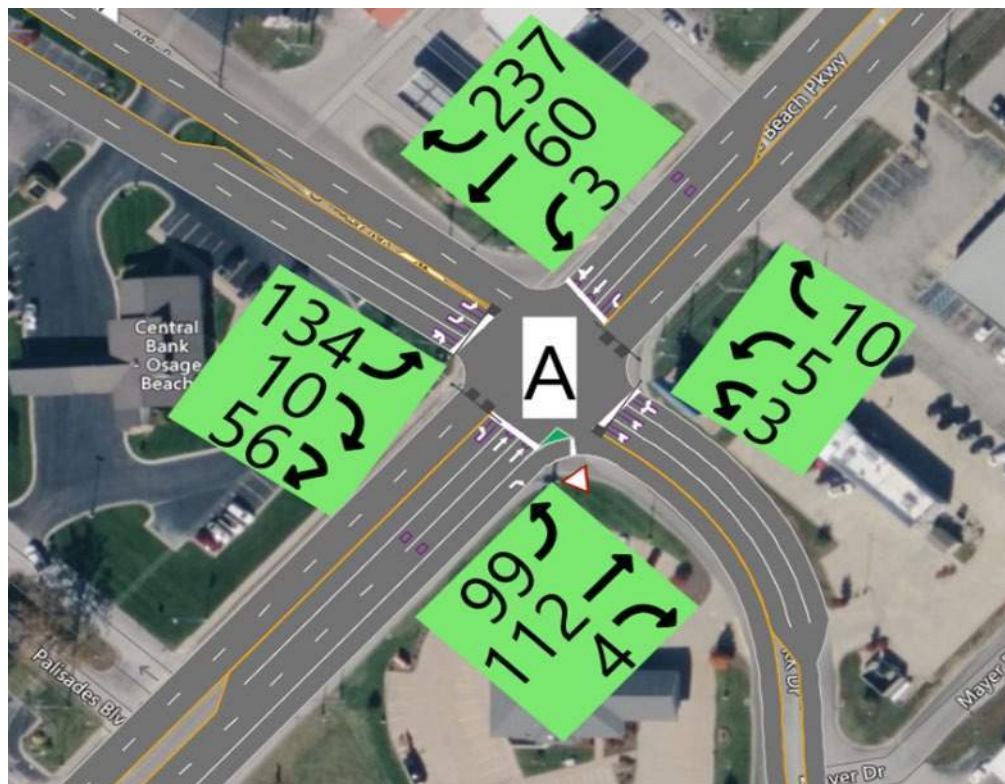
Figure 27 - PM Peak Hour Turning Movement Counts at Route KK

Figure 27 shows the PM peak hour turning movement counts at the Route KK intersection. Given these traffic counts, the intersection is operating at a level of service (LOS) A and is experiencing very little vehicle delay. See Table 8 below for an overview of LOS scale.

The turning movements experiencing the highest volumes are the southwest-bound right turn and southeast-bound left turn.

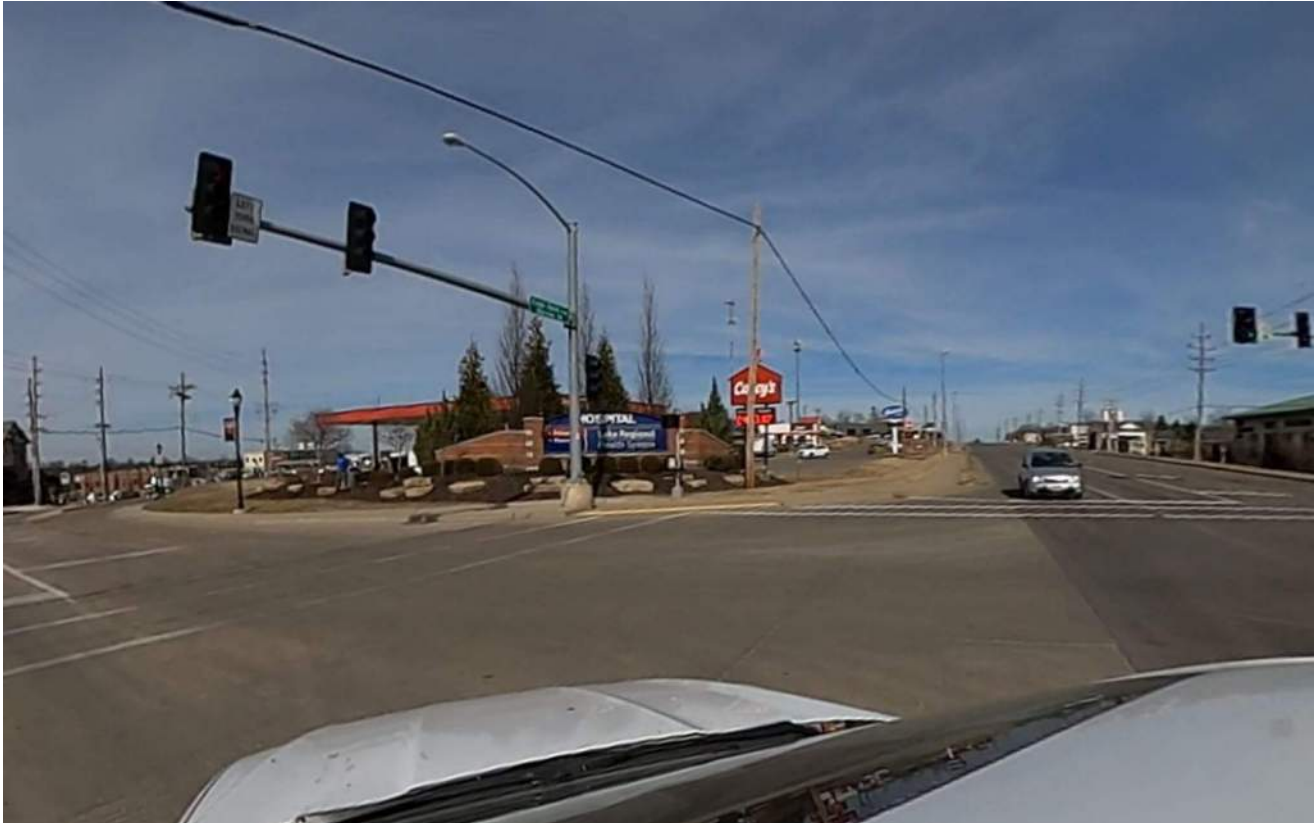
Figure 31 - Pedestrian Accommodation Osage Beach Parkway & Nichols Road (02.11.2026)

Detached sidewalks are present along the northeast, southwest, and northwest legs of the intersection. Pedestrian facilities include two marked crosswalks, including one located on the northeast leg crossing Osage Beach Parkway and one on the northwest leg crossing Nichols Road. The crosswalks are equipped with audible push buttons and countdown pedestrian signal timers. ADA-compliant infrastructure is provided on all legs except the southeast leg of Old State Park Road.

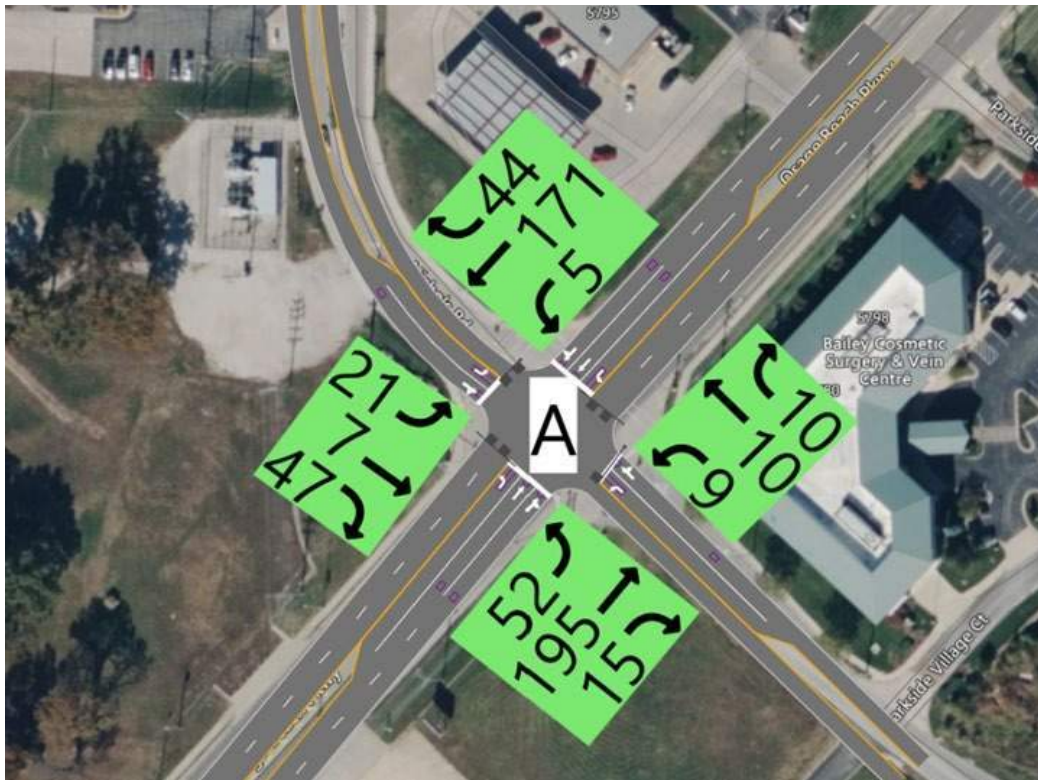
Figure 32 - PM Peak Hour Turning Movement Count at Nichols Road

Figure 32 shows the PM peak hour turning movement counts at the Nichols Road intersection. Given these traffic counts, the intersection operates at a LOS A and is experiencing very little vehicle delay. The turning movements experiencing the highest volumes are the through movements on Osage Beach Parkway.

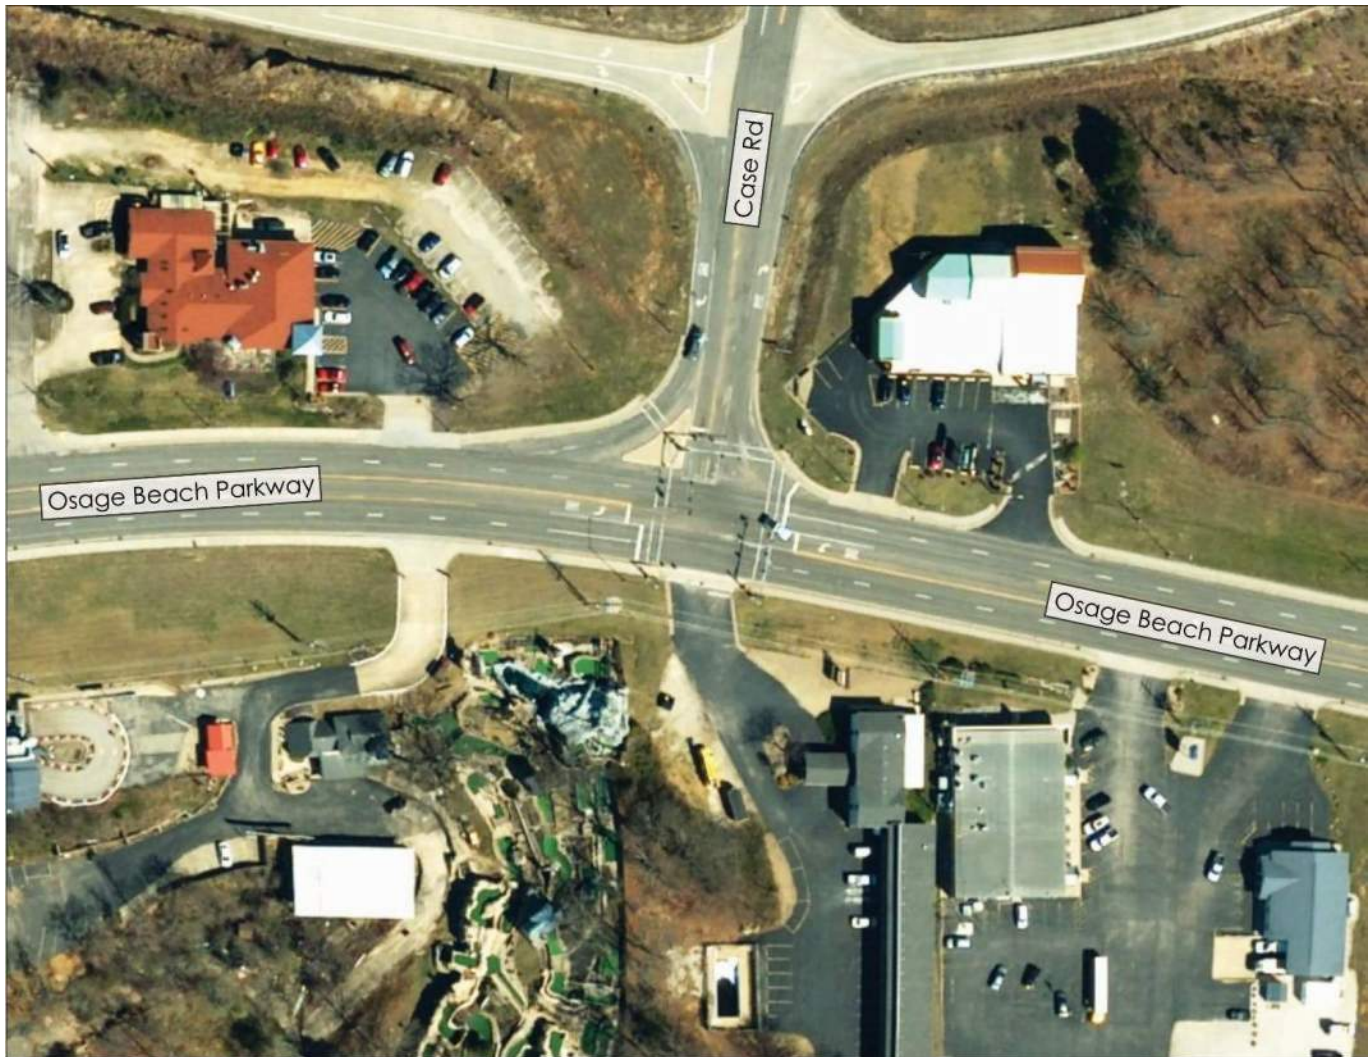
Figure 34 - Aerial image of the Osage Beach Parkway & Case Road

The intersection is signalized with four approaches. The west and east legs of Osage Beach Parkway both consist of two through lanes in each direction and a dedicated left-turn lane. Right-turns from Osage Beach Parkway must be made from the right shared through lane. The north leg of Case Road consists of a shared through or left-turn lane, a channelized right-turn lane, and one northbound receiving lane. The south leg serves as the access point for the Scottish Inns hotel and consists of one lane in each direction, all turn movements must be made from the shared through lane. All four approaches operate with protected-permissive left-turn phasing.

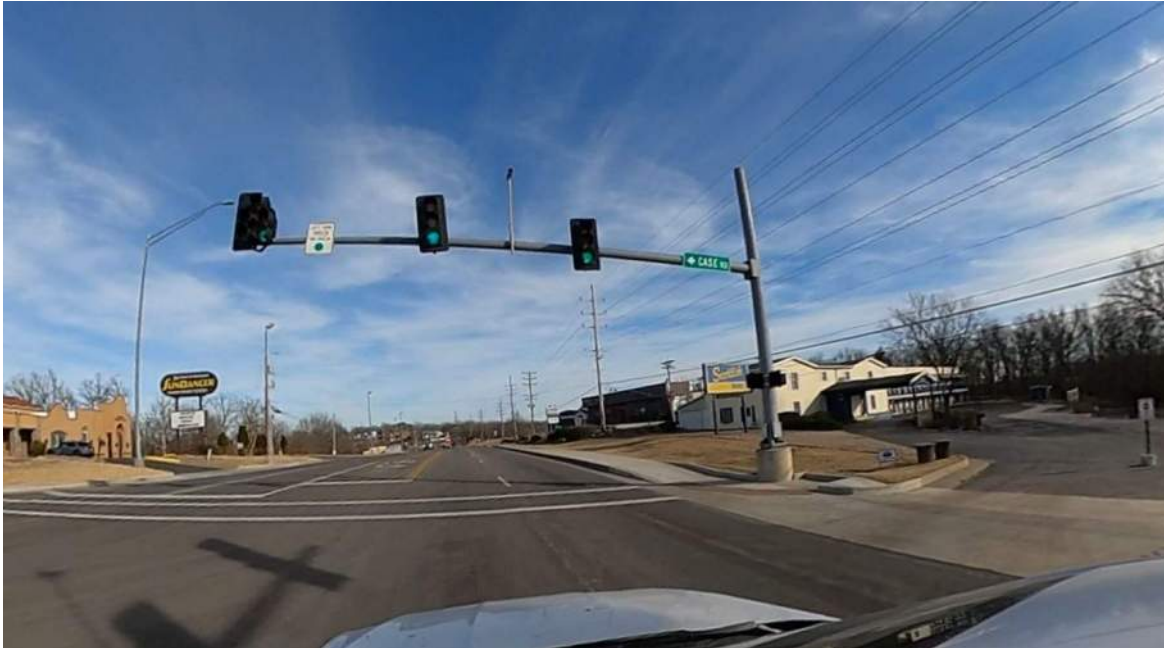
*Figure 35 - Pedestrian Accommodation Osage Beach Parkway & Case Road (02.11.2026)*

Pedestrian accommodations are provided on three of the four approaches to the intersection. Concrete sidewalks in serviceable condition are present on the east and west legs, while no sidewalks are provided on the north or south legs. Marked crosswalks are present on the north, east, and west legs; the north leg crosswalk is faded, while the east and west leg crosswalks are in good condition and equipped with countdown pedestrian signal timers. ADA features, including audible pedestrian pushbuttons and truncated domes, are provided on all approaches; however, sidewalk connectivity is limited on the north and south legs.

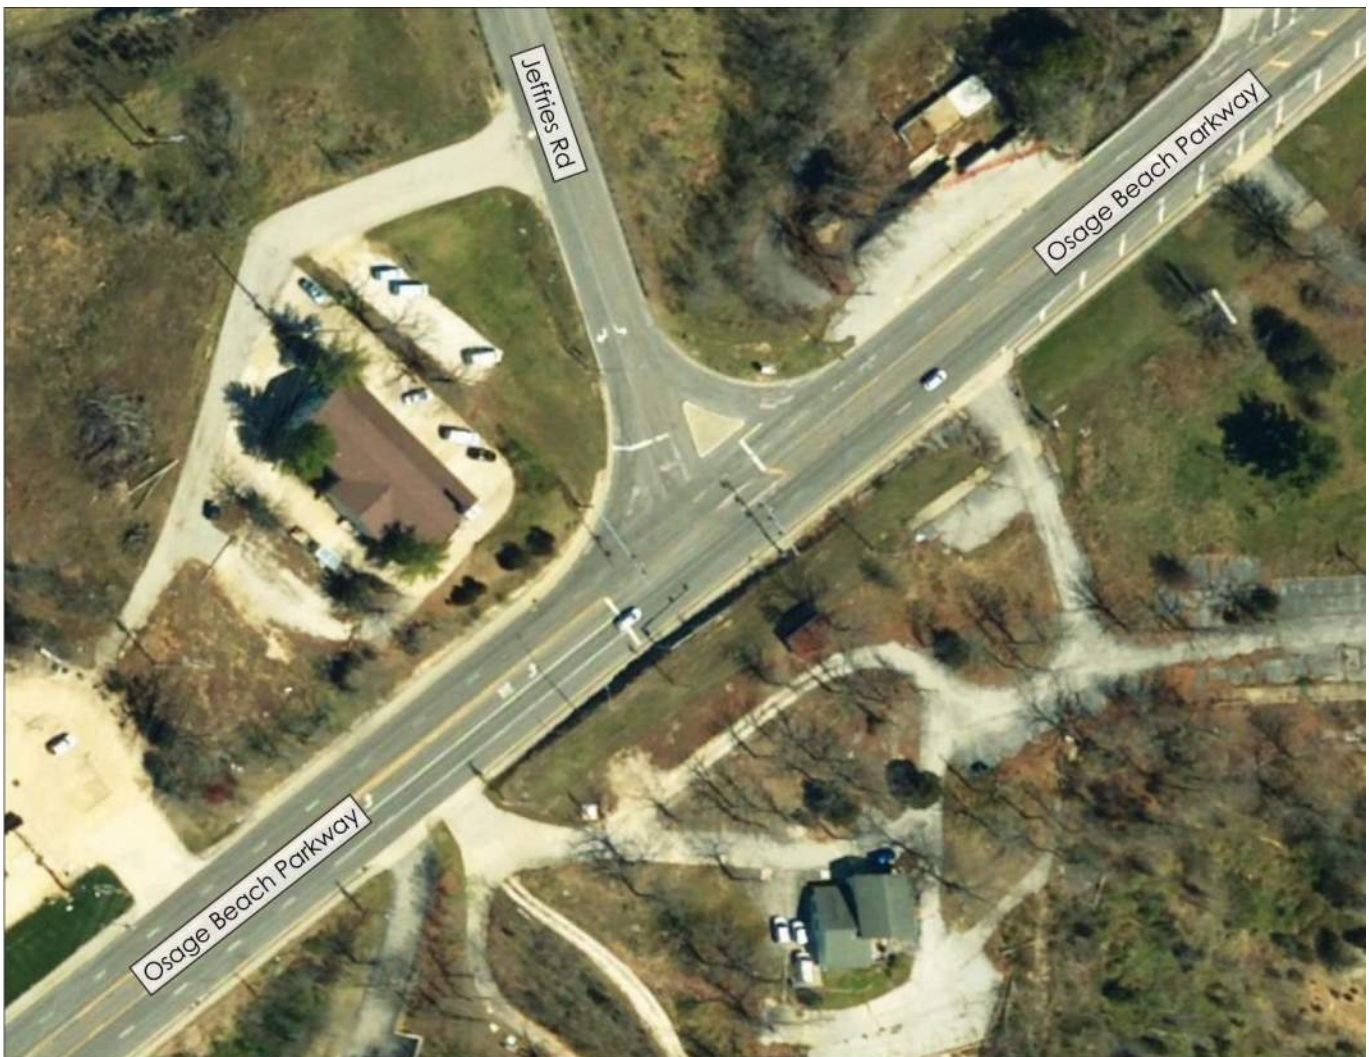
Figure 37 - Aerial image of the Osage Beach Parkway & Jeffries Road

The intersection of Osage Beach Parkway and Jeffries Road provides direct access to U.S. 54 and serves a mix of residential and commercial uses. Development to the south includes single-family homes, restaurants, hotels, and The Moorings at Malibu Marina, while the north side includes boat rentals, restaurants, condominiums, hotels, and additional single-family residential.

The intersection is signalized with three approaches. The west leg of Osage Beach Parkway consists of two through lanes in each direction and a dedicated left-turn lane. The east leg of Osage Beach Parkway consists of two through lanes in each direction and a channelized right-turn lane. The north leg of Jeffries Road consists of dedicated left- and right-turn lanes and one northbound receiving lane. The north leg operates on protected left-turn phasing only, while the west leg operates on protected-permissive phasing.

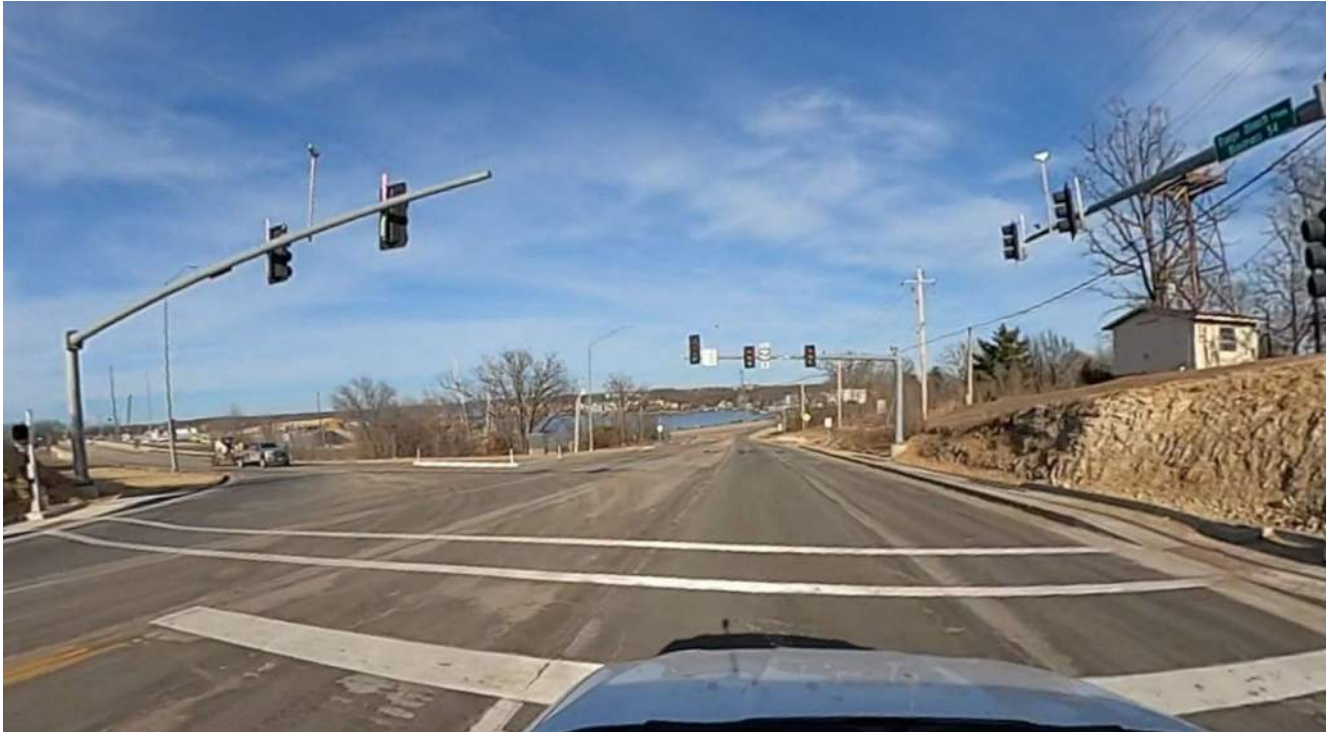
Figure 38 - Pedestrian Accommodation Osage Beach Parkway & Jeffries Road (02.11.2026)

Pedestrian facilities at the intersection are limited and vary by approach. No sidewalks, crosswalks, or ADA-compliant infrastructure are provided on the north leg. The west leg includes concrete sidewalks in serviceable condition and a marked high-visibility crosswalk equipped with audible pedestrian pushbuttons and truncated domes. On the east leg, a concrete sidewalk is present along the south side of the roadway; however, no marked crosswalks or ADA-compliant pedestrian features are provided.
