# OSAGE BEACH VISION ZERO ACTION PLAN

Existing Conditions Report

January 2026

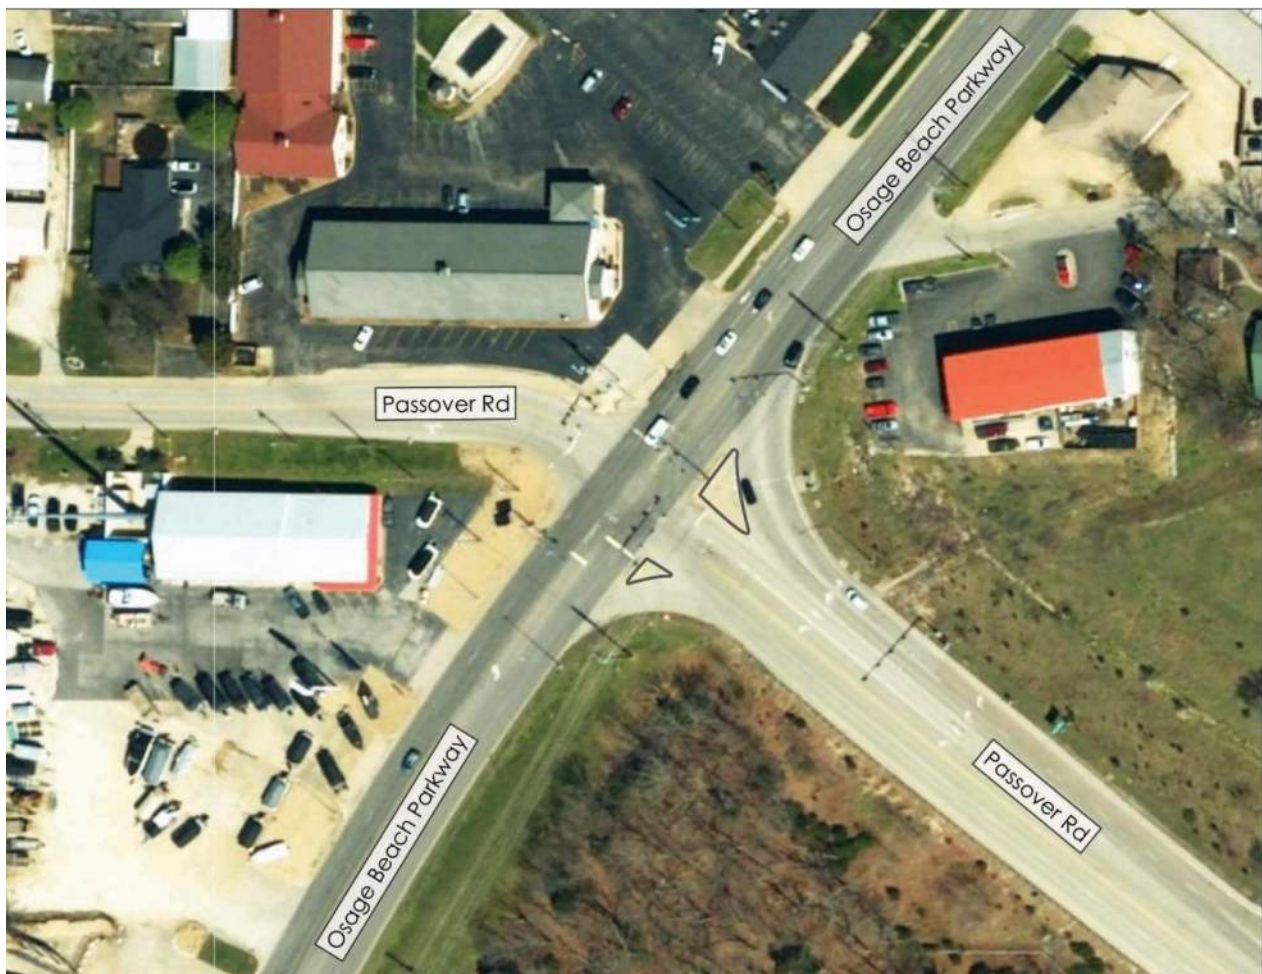
Figure 41 - Aerial image of the Osage Beach Parkway & Passover Road

The intersection of Osage Beach Parkway and Passover Road serves a mix of residential, commercial, and institutional development in the surrounding area. Development to the west includes restaurants, hotels, small businesses, and lakeside condominiums, while the southeast includes Yacht Club Powersports, Osage Beach Rehab & Health Care Center, and multifamily residential.

The intersection is signalized with four approaches. The southwest leg of Osage Beach Parkway consists of two through lanes in each direction, a dedicated left-turn lane, and a channelized right-turn lane. The northeast leg of Osage Beach Parkway consists of two through lanes in each direction and a dedicated left-hand turn lane. Right-turns from the northeast leg must be made from the right shared through lane. The northwest leg of Passover Road consists of a dedicated left-turn lane, a shared through or right-turn lane, and one northwest-bound receiving lane. The southeast leg of Passover Road consists of one through lane, a dedicated left-turn lane, two southeast-bound receiving lanes, and two channelized right-turn lanes. The southwest and northeast legs of Osage Beach Parkway operate on protected-permissive left-turn phasing, while the northwest and southeast legs of Passover Road operate on protected left-turn phasing only.

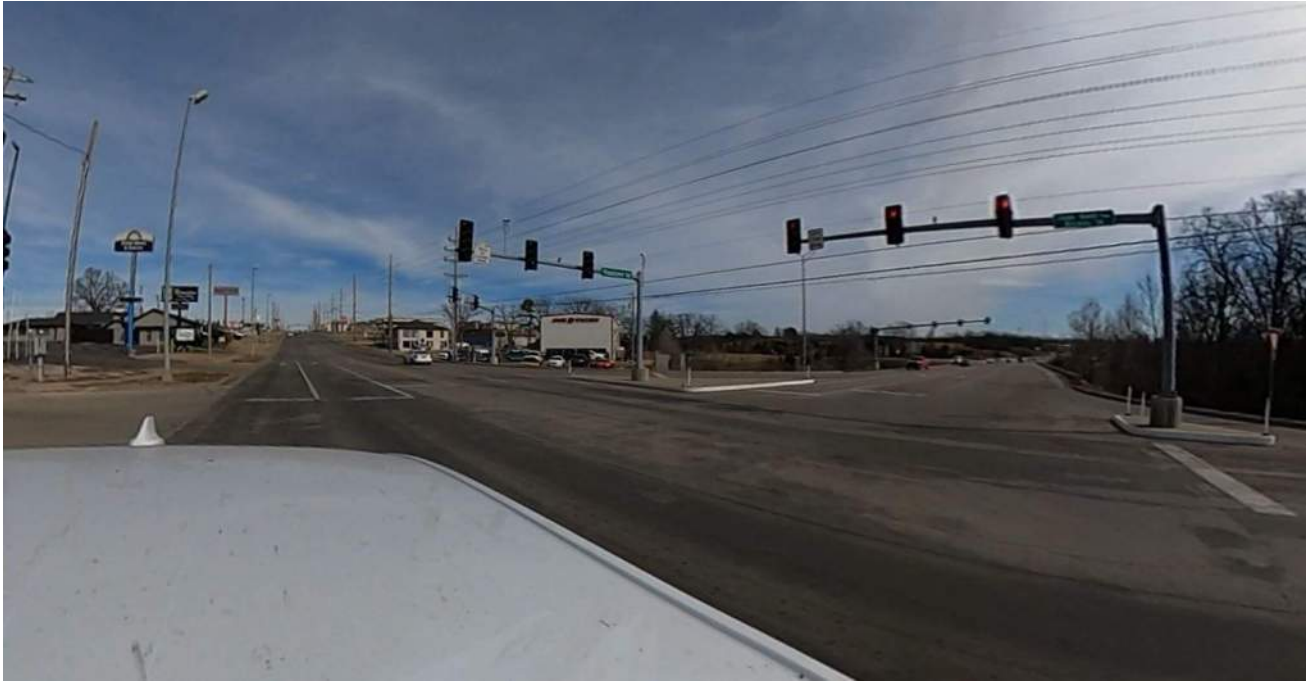
*Figure 42 - Pedestrian Accommodation Osage Beach Parkway & Passover Road (02.11.2026)*

Pedestrian accommodations at the intersection are limited. A concrete sidewalk is present only along the north side of the northeast leg. No sidewalks are provided on the northwest, southwest, or southeast legs. No marked crosswalks are present at the intersection. ADA features are minimal and consist of a truncated dome located on the north side of the northeast leg; no other ADA-compliant pedestrian infrastructure is provided.

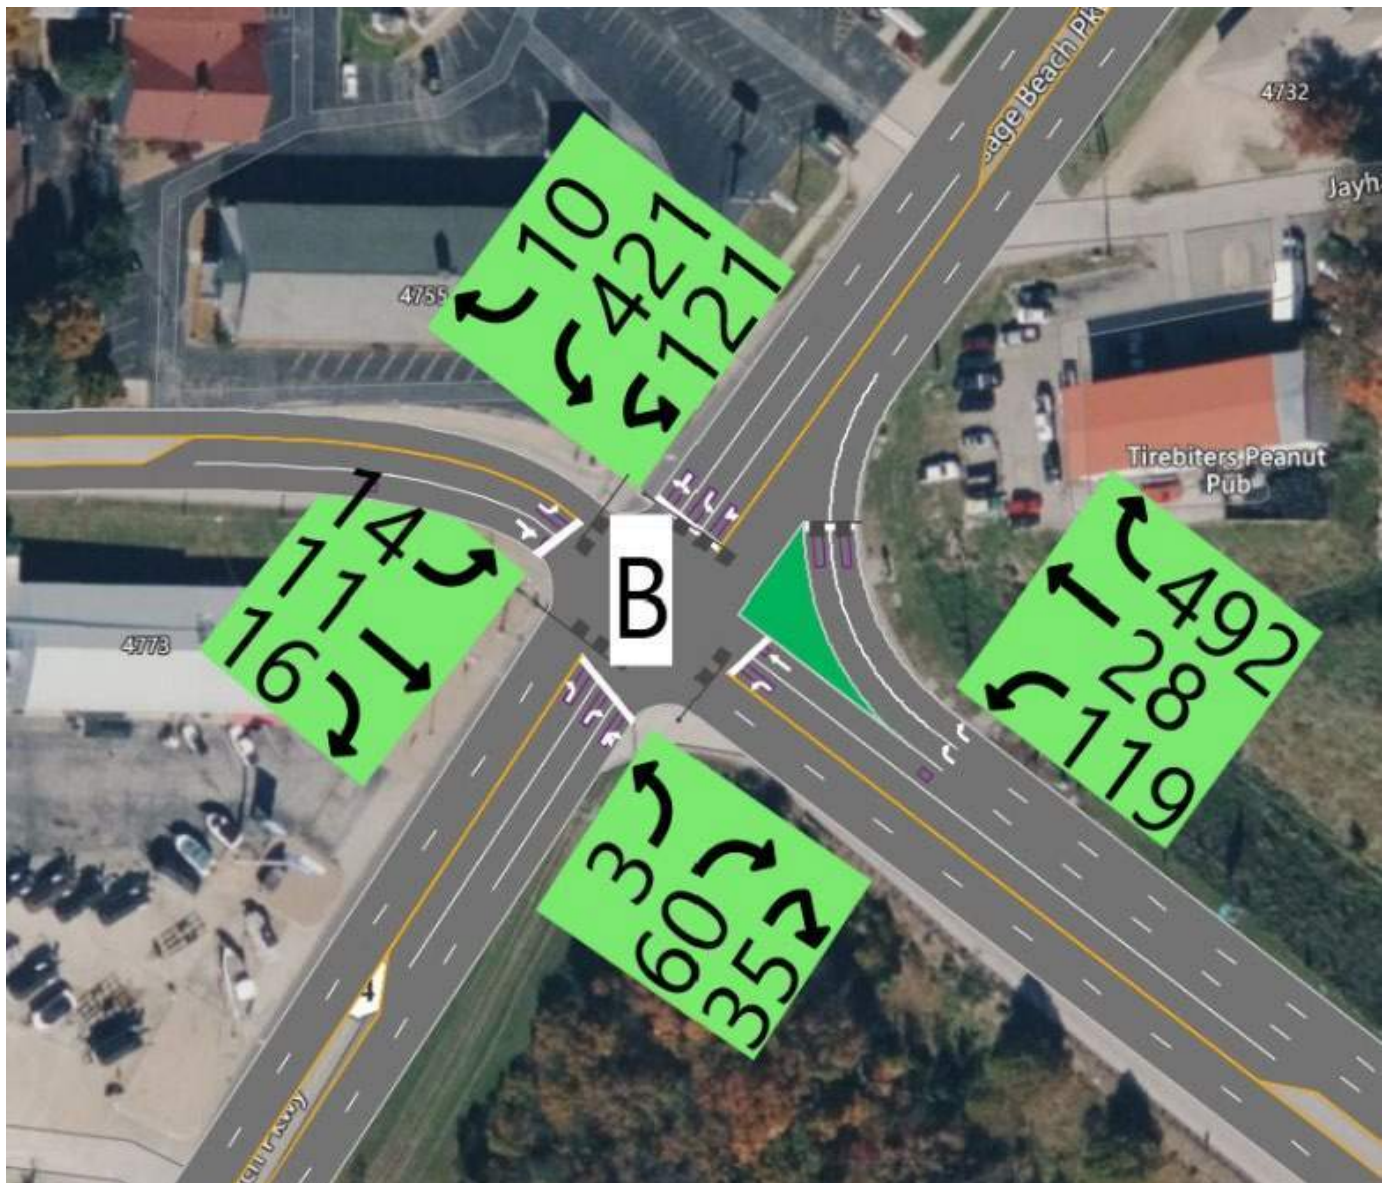
Figure 43 - PM Peak Hour Turning Movement Counts at Passover Road

Figure 43 displays the PM peak hour turning movement counts at Passover Road and Osage Beach Parkway. The highest turning movement volumes are the westbound right turn and southbound through on Osage Beach Parkway. Given these turning movement volumes, the traffic at this intersection operates at an LOS of B and is considered stable flow. The northwest-bound left turn is the movement that experiences the most delay during the PM peak hour with a LOS D, which is considered stable vehicle flow with volume near capacity.

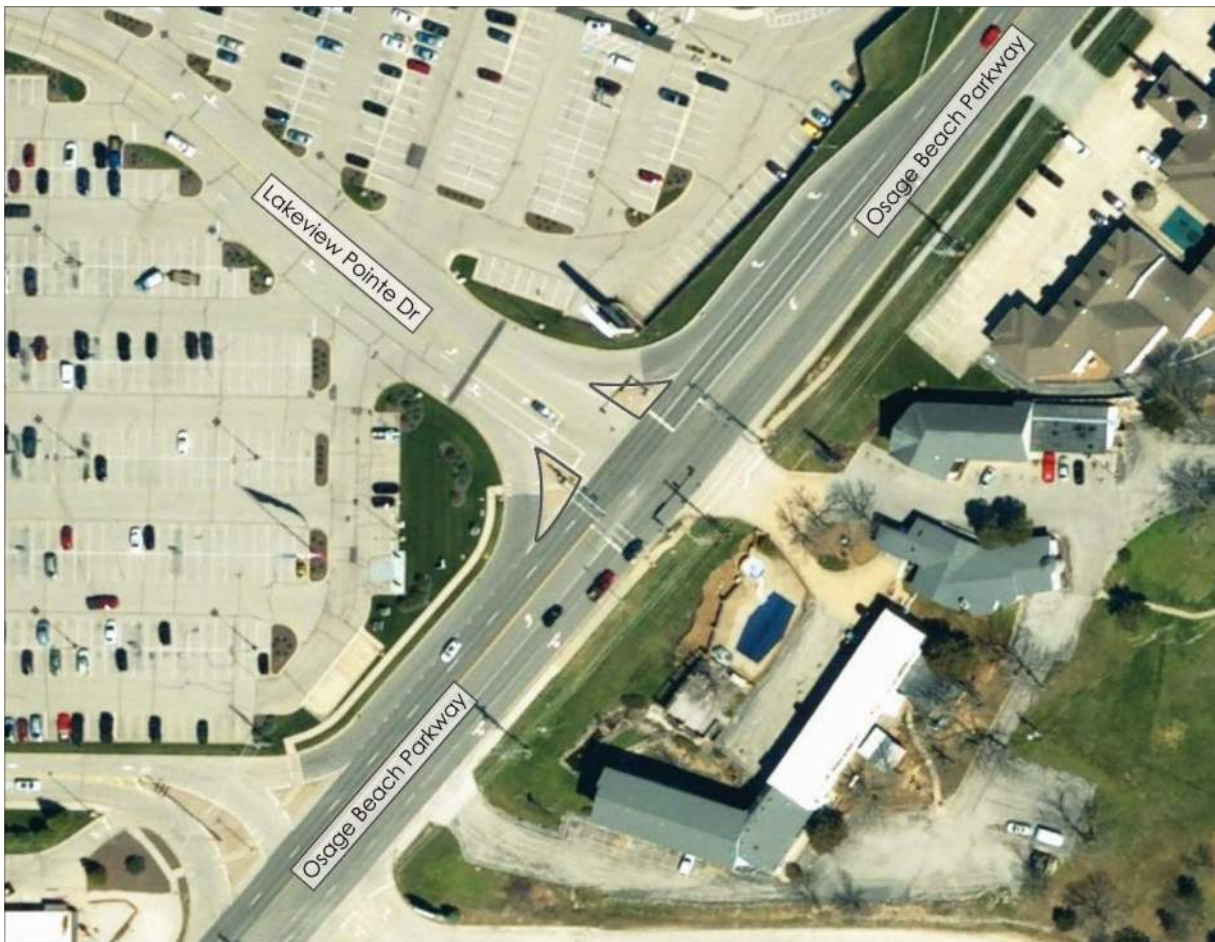
Figure 45 - Aerial image of the Osage Beach Parkway & Lakeview Pointe Drive

The intersection of Osage Beach Parkway and Lakeview Pointe Drive serves adjacent commercial development, including restaurants, the Marine Corps Recruiting Center, and major retail destinations such as Hobby Lobby, Dierbergs Markets at Lakeview Pointe, and the Osage Beach Outlet Marketplace, as well as additional clothing and specialty retail outlets.

The intersection is signalized with four approaches. The southwest leg of Osage Beach Parkway consists of two through lanes in each direction and a dedicated left-turn lane. Right-turns from this approach must be made from the right shared through lane. The northeast leg of Osage Beach Parkway consists of two through lanes in each direction, a dedicated left-turn lane, and a channelized right-turn lane. The northwest leg of Lakeview Pointe Drive consists of a dedicated left-turn lane, a shared through or left-turn lane, a channelized right-turn lane, and two northwest-bound receiving lanes. The southeast leg serves as the access drive for Quail's Nest hotel and consists of a shared through/left-/right-turn lane and one southeast-bound receiving lane. Left-turn phasing is protected from the northwest approach and protected-permissive on all other approaches.

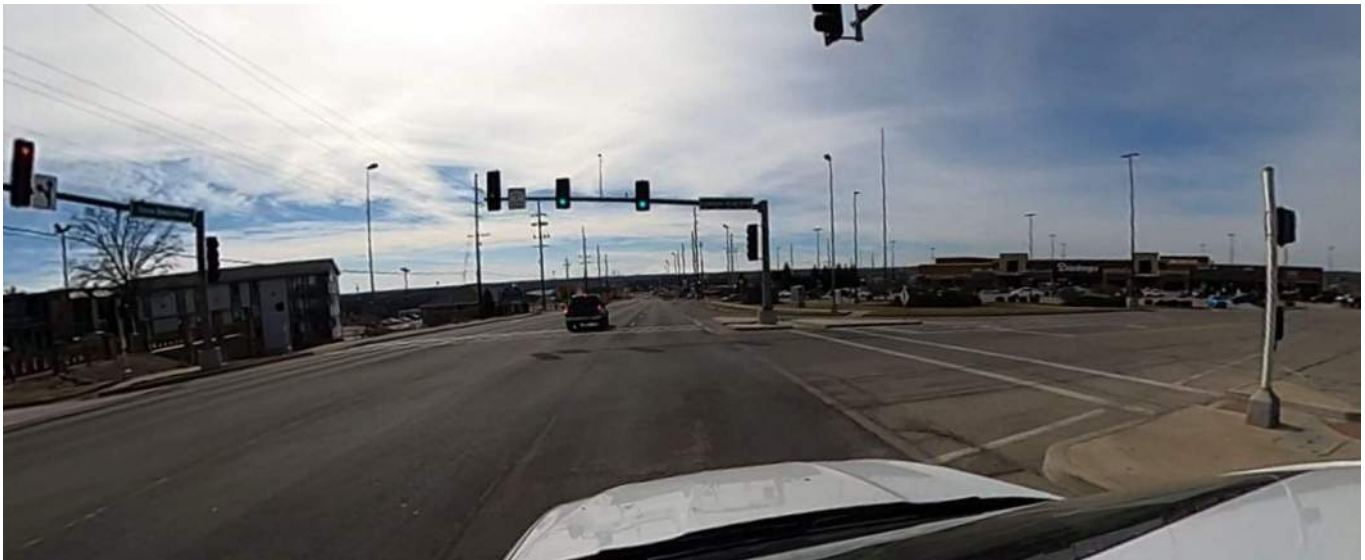
*Figure 46 - Pedestrian Accommodation Osage Beach Parkway & Lakeview Pointe Drive*

**Crosswalk Presence and Condition:** Standard crosswalk equipped with countdown timer.

**ADA Features:** Audible push buttons with truncated domes.

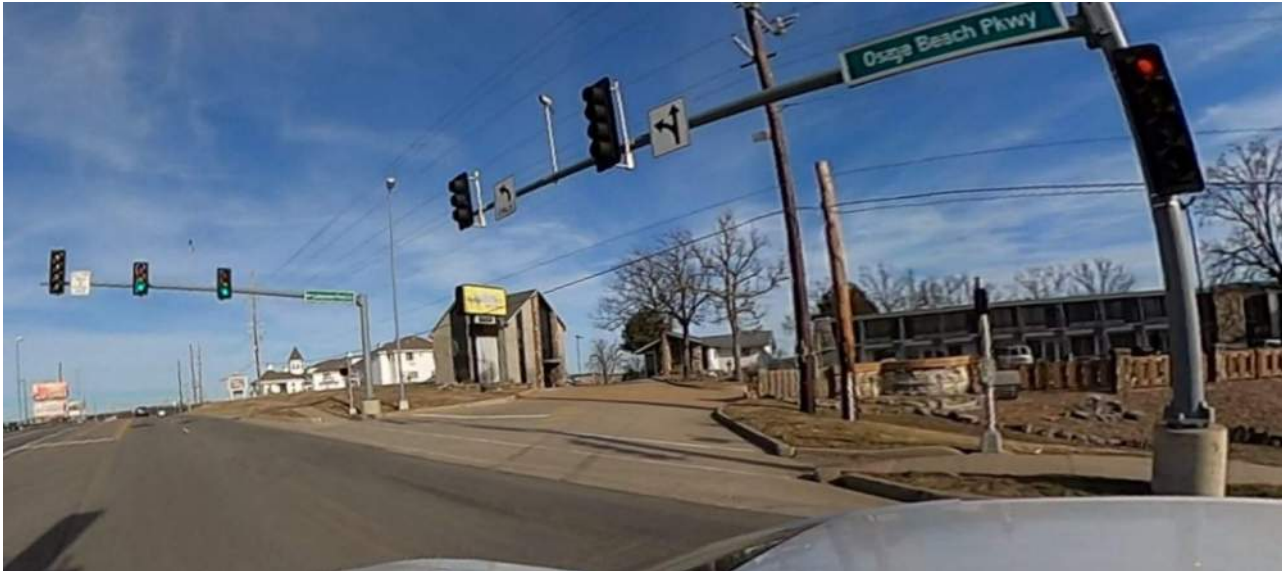
Figure 47 - Pedestrian Accommodation Osage Beach Parkway & Lakeview Pointe Drive

**Crosswalk Presence and Condition:** Standard crosswalk equipped with countdown timer.

**ADA Features:** Audible push buttons with truncated domes.

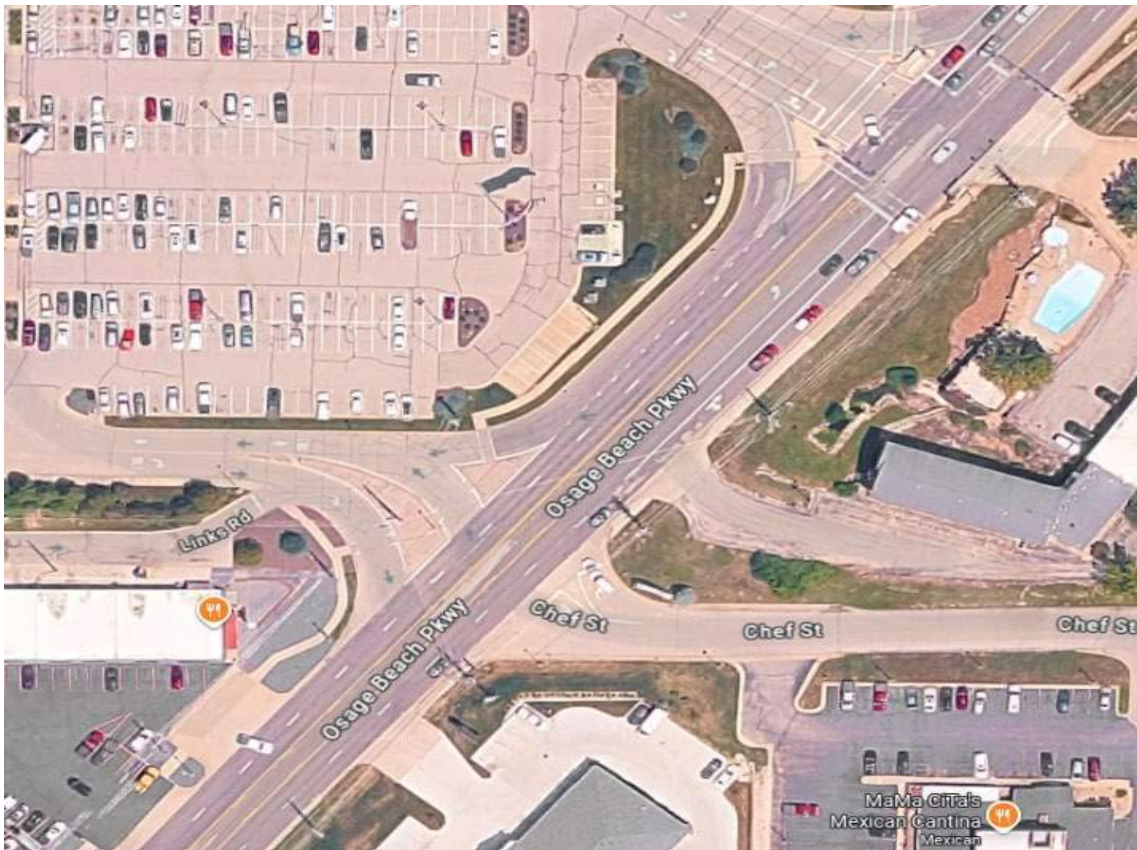
Figure 49 - Aerial image of Lakeview Pointe Drive and the nearby driveway

- 3 out of 4 approaches have working audible pedestrian signal heads, truncated domes, and standard crosswalk markings. The northeast leg does not have pedestrian accommodations.
- Countdown timers for the crosswalks are short, approximately 15 seconds.
- This grocery store serves a lot of people in the area and attracts pedestrian activity.
- There is another unsignalized intersection about 250 feet to the west.

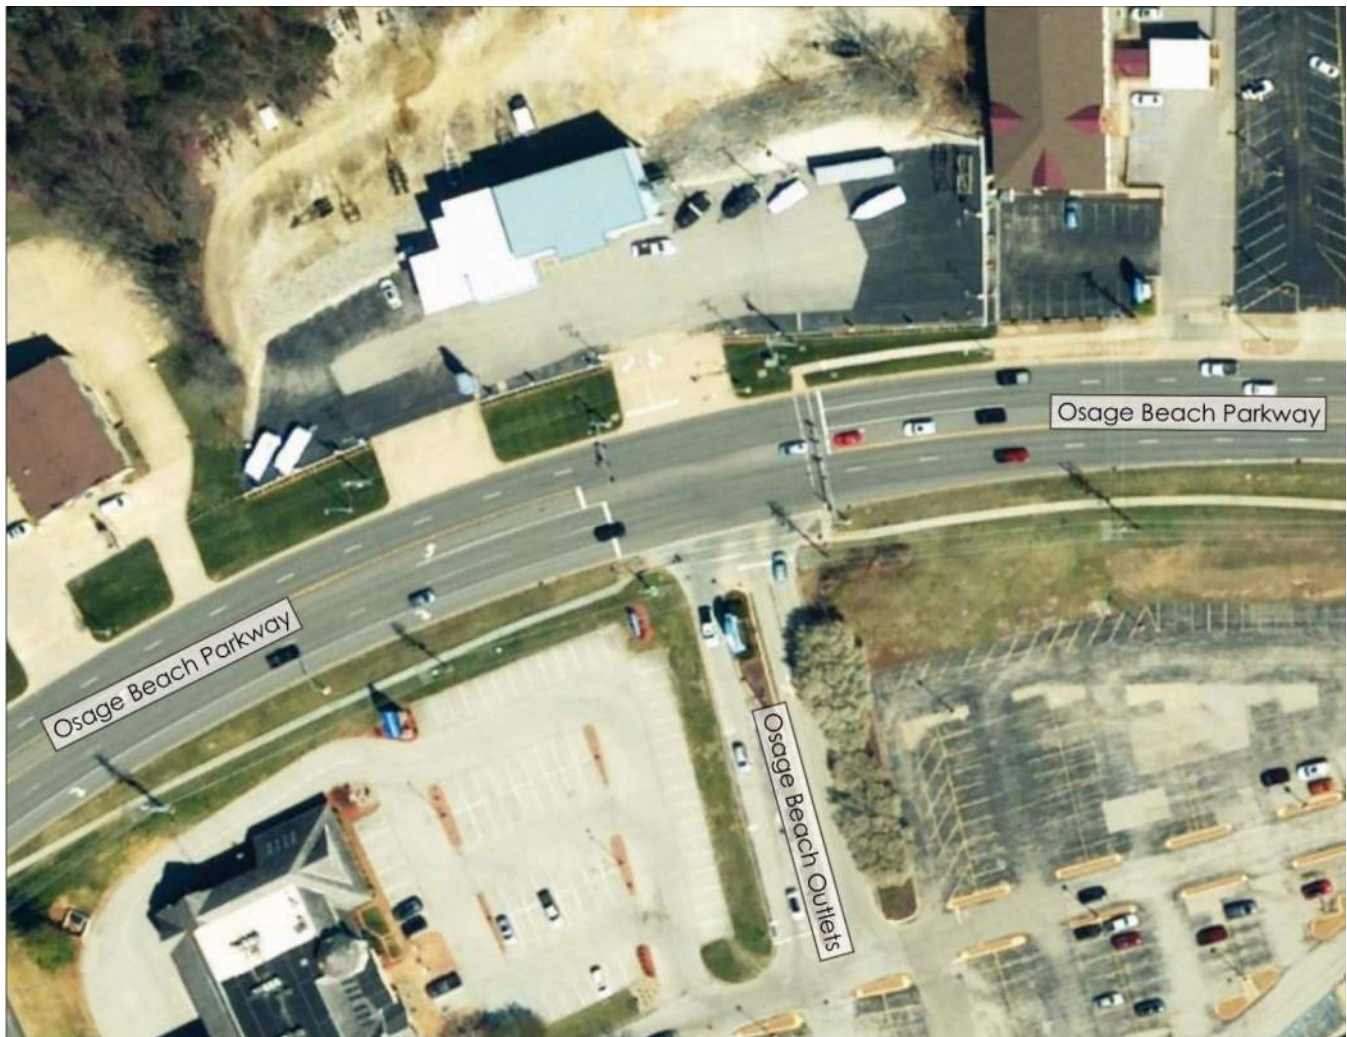
Figure 50 - Aerial image of the Osage Beach Parkway & Osage Beach Premium Outlets Access Drive

The intersection of Osage Beach Parkway and Osage Beach Premium Outlets access drive serves a mix of commercial and office uses. To the north, development includes the indoor family amusement center Miner Mike's, a hotel, a boat retail business, and a vacation home rental agency. To the south, the area includes legal and financial offices and various clothing and jewelry outlet stores.

The intersection is signalized with four approaches. The west leg of Osage Beach Parkway consists of two through lanes in each direction, a dedicated left-turn lane, and a dedicated right-turn lane. The east leg of Osage Beach Parkway consists of two through lanes in each direction and a dedicated left-turn lane. Right-turns from this approach must be made from the right shared through lane. The north leg serves as the access point for MarineMax and consists of a shared through or left-turn lane, a dedicated right-turn lane, and one northbound receiving lane. The south leg provides access to the Osage Beach Premium Outlets and consists of a shared through or left-turn lane, a dedicated right-turn lane, and one southbound receiving lane. The east approach operates on protected-permissive left-turn phasing, while the north, south, and west approaches operate on permissive left-turn phasing.

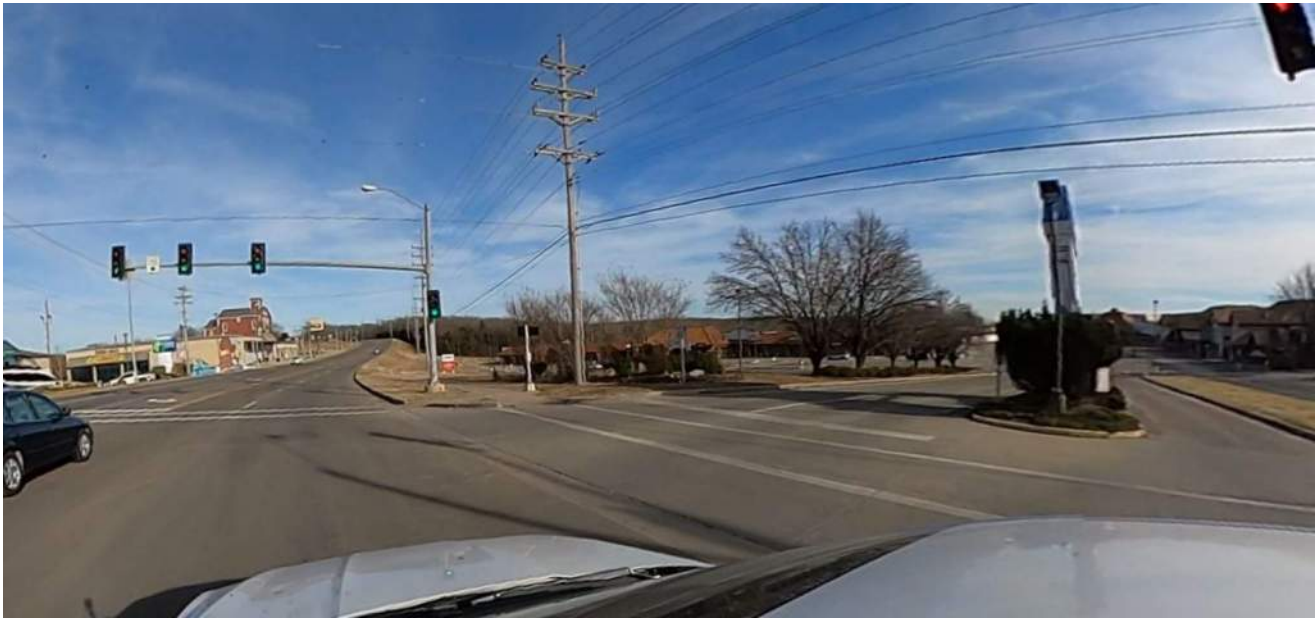
*Figure 51 - Pedestrian Accommodation Osage Beach Parkway & Osage Beach Premium Outlets Access Drive (02.11.2026)*

Detached concrete sidewalks are present along both legs of Osage Beach Parkway, except for the south side of the west leg, which features a narrow asphalt path. No pedestrian accommodation exists on the north and south legs of the intersection. Painted crosswalks with push buttons and countdown timers exist on the east and south sides of the intersection. The sidewalk on the north side continues across the MarineMax access point, serving as an unsignalized crosswalk. No crosswalk exists along the west side of the intersection.

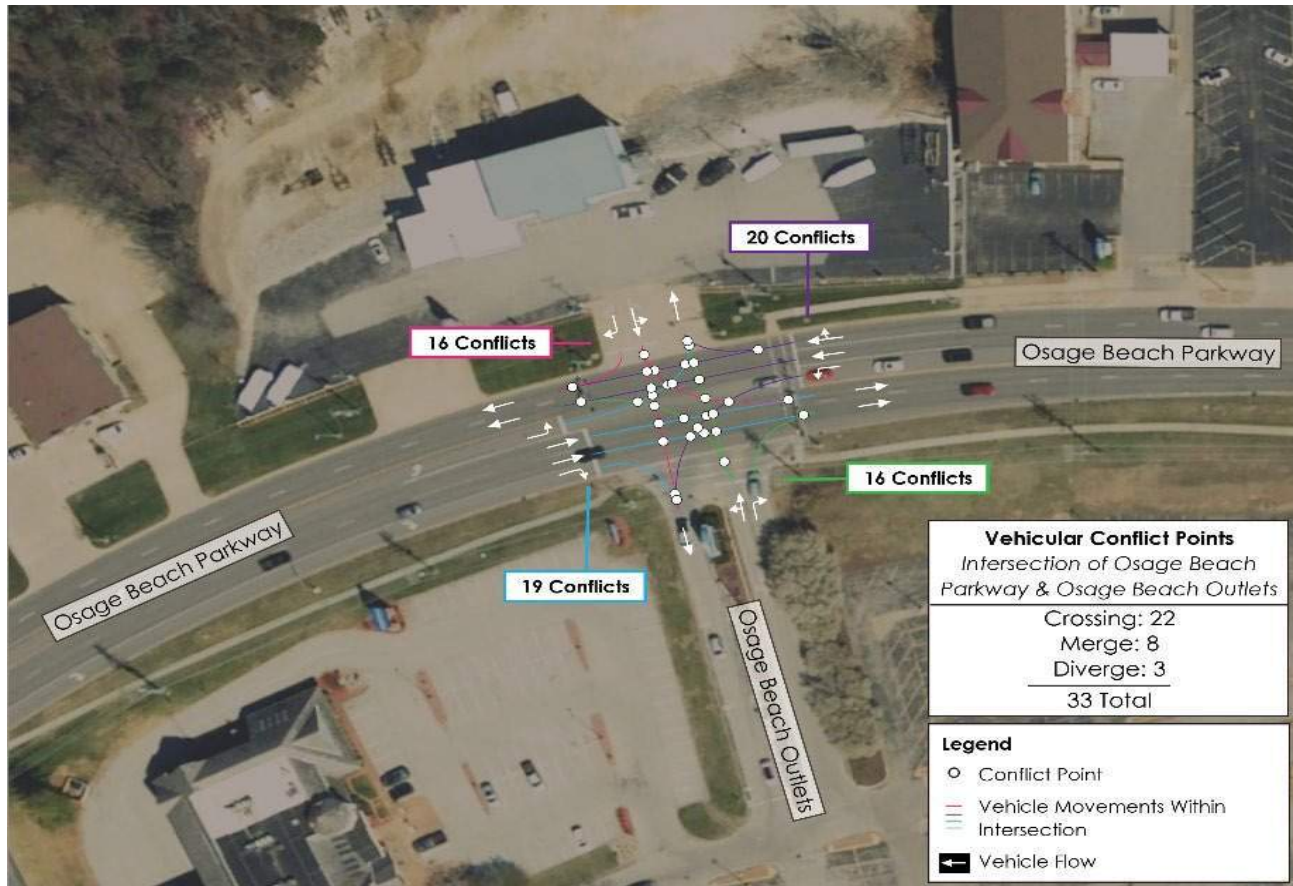
Figure 52 - Conflict Point Diagram of Osage Beach Parkway & Osage Beach Premium Outlets Intersection

Figure 52 illustrates the 33 potential conflict points that exist at this intersection.

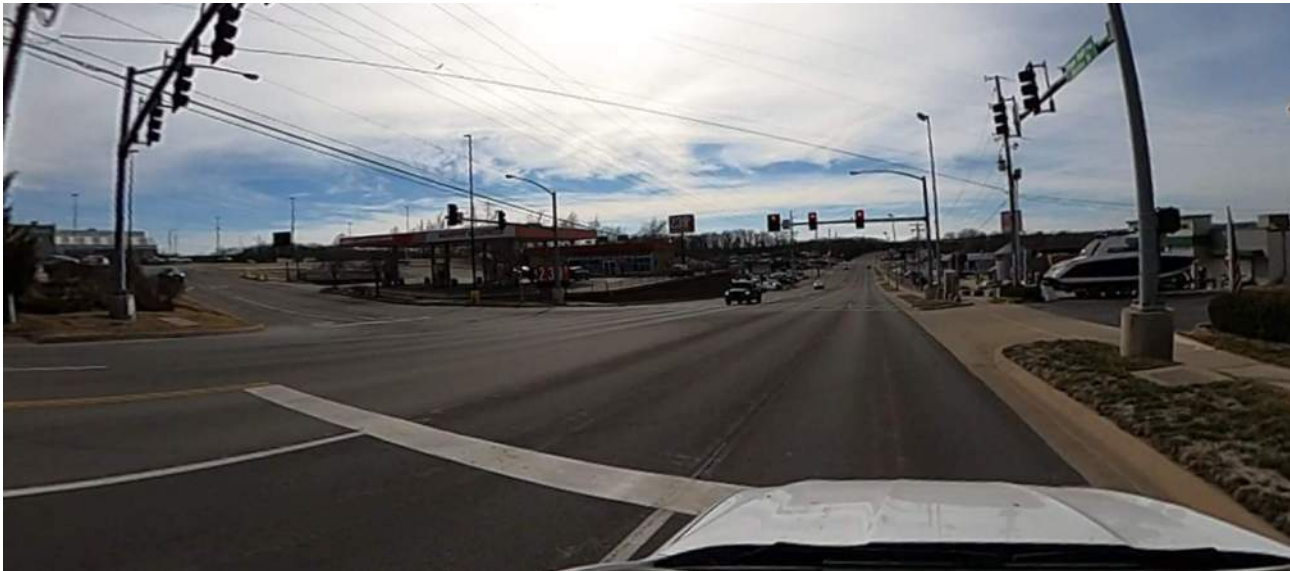
Figure 54 - Pedestrian Accommodation Osage Beach Parkway & Wal-Mart (02.11.2026)

Both legs of Osage Beach Parkway have pedestrian paths approaching the intersection. The north side has a detached concrete sidewalk, while the south side has an attached narrow asphalt path. The northwest and southeast approaches do not have any existing pedestrian paths. Painted crosswalks with push buttons and countdown timers exist on the southwest and northwest sides of the intersection. No crosswalks exist on the northeast and southeast approaches.

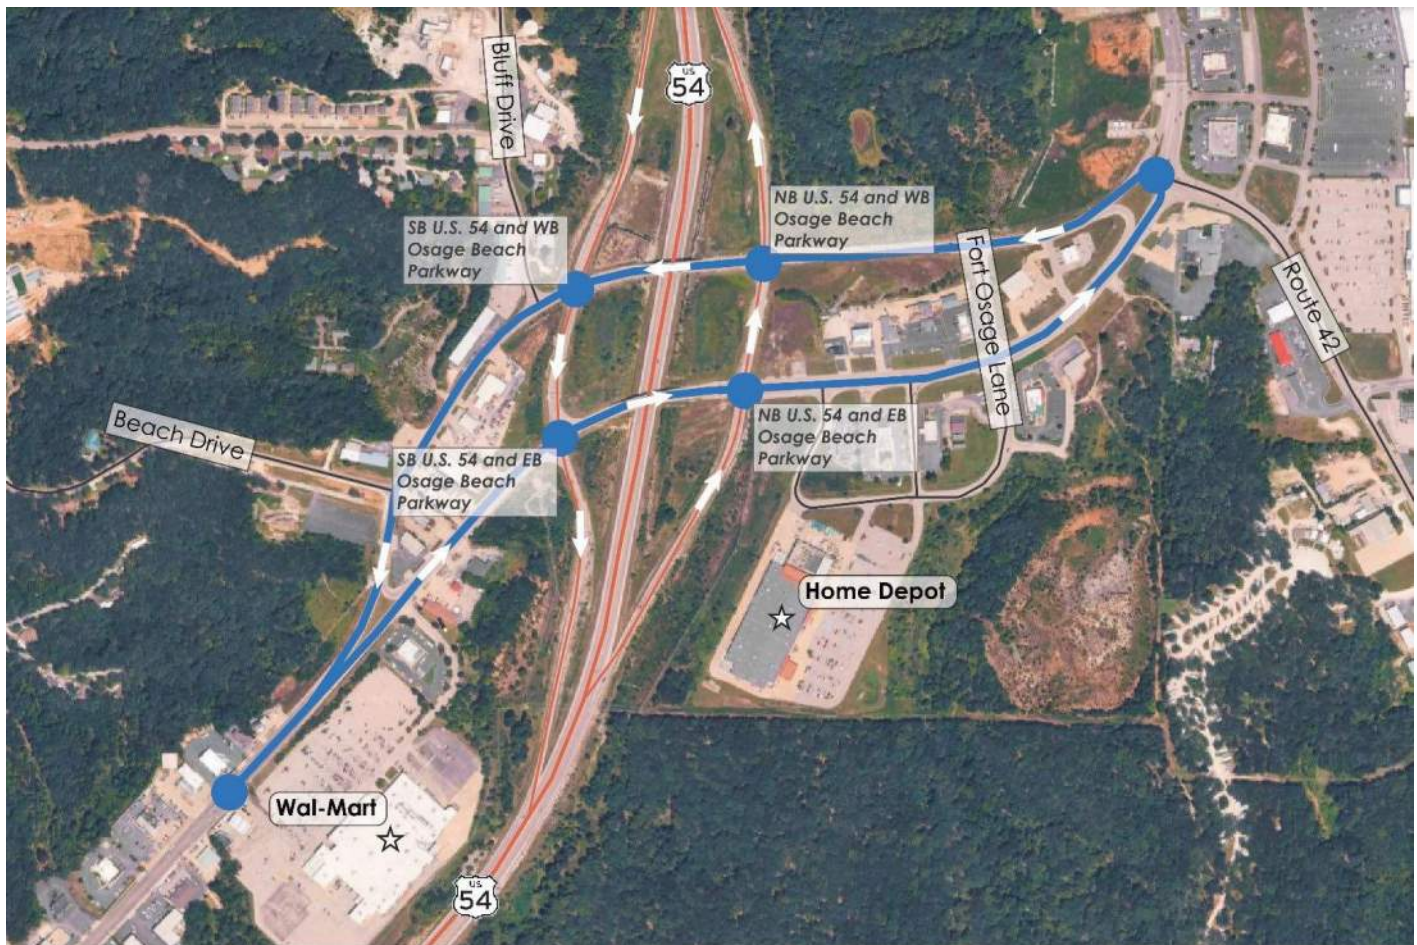
Figure 56 - Northern couplet interchange with U.S. 54 where a majority of crashes on Osage Beach Parkway occur

Intersections 10–13 consist of four closely spaced U.S. 54 ramp terminal intersections that function together as a single interchange system north of the Grand Glaize Bridge. The intersections form a couplet that accommodates all movements between U.S. 54 and Osage Beach Parkway, with traffic exiting U.S. 54 distributed through signalized ramp terminals and traffic from Osage Beach Parkway accessing U.S. 54 via adjacent on-ramps. Due to the close spacing, operations at each intersection directly influence conditions at the others. As a result, recommended improvements should be considered collectively to ensure consistent operations and avoid shifting congestion or safety concerns between intersections.

The U.S. 54 couplet serves major commercial development in Osage Beach, including the East Shopping Center and surrounding restaurants and retail on the east side, and Walmart Supercenter, the Osage Beach Outlet Marketplace, and additional commercial uses on the west side.

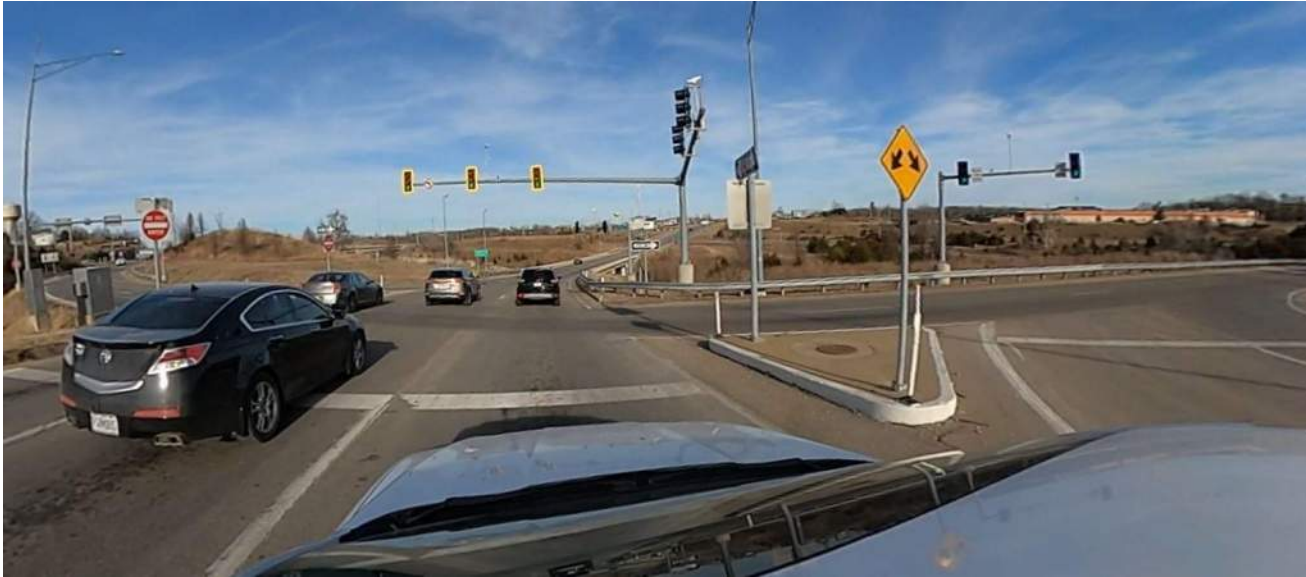
Figure 58 - Pedestrian Accommodation EB Osage Beach Parkway SB U.S. 54 Ramp Terminal (02.11.2026)

There are no pedestrian accommodations at this intersection.

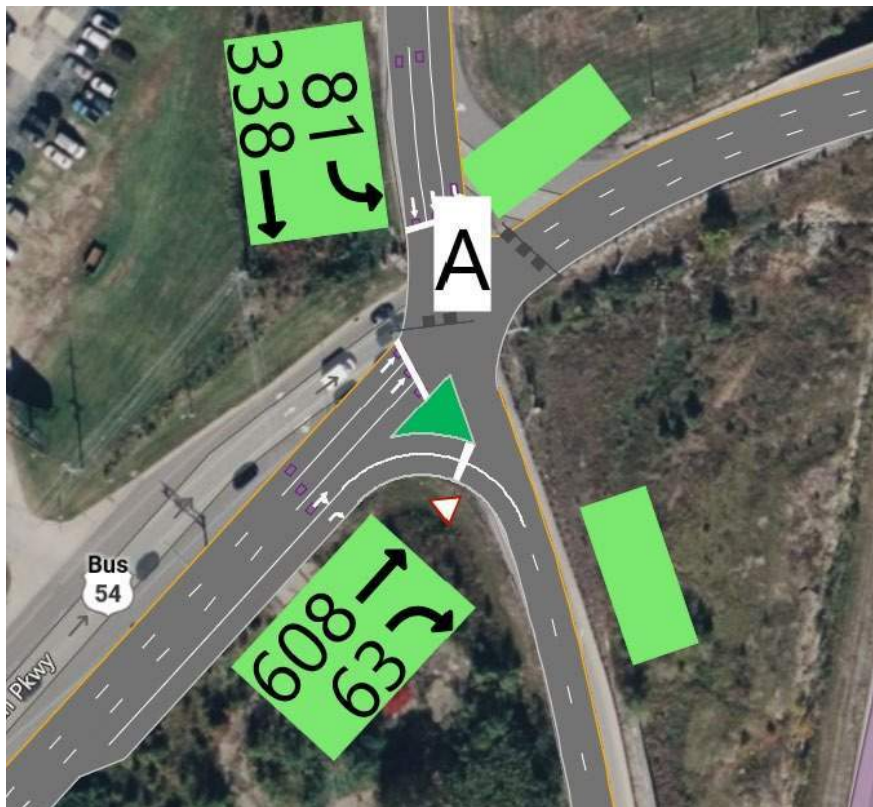
Figure 59 - Turning Movement Counts at EB Osage Parkway & SB U.S. 54

Figure 59 displays the PM peak hour turning movement counts at the SB U.S. 54 ramps. The two through movements are the dominate movements through the intersection. Given the turning movement counts, the intersection is operating at an LOS A and is experiencing free flow traffic.

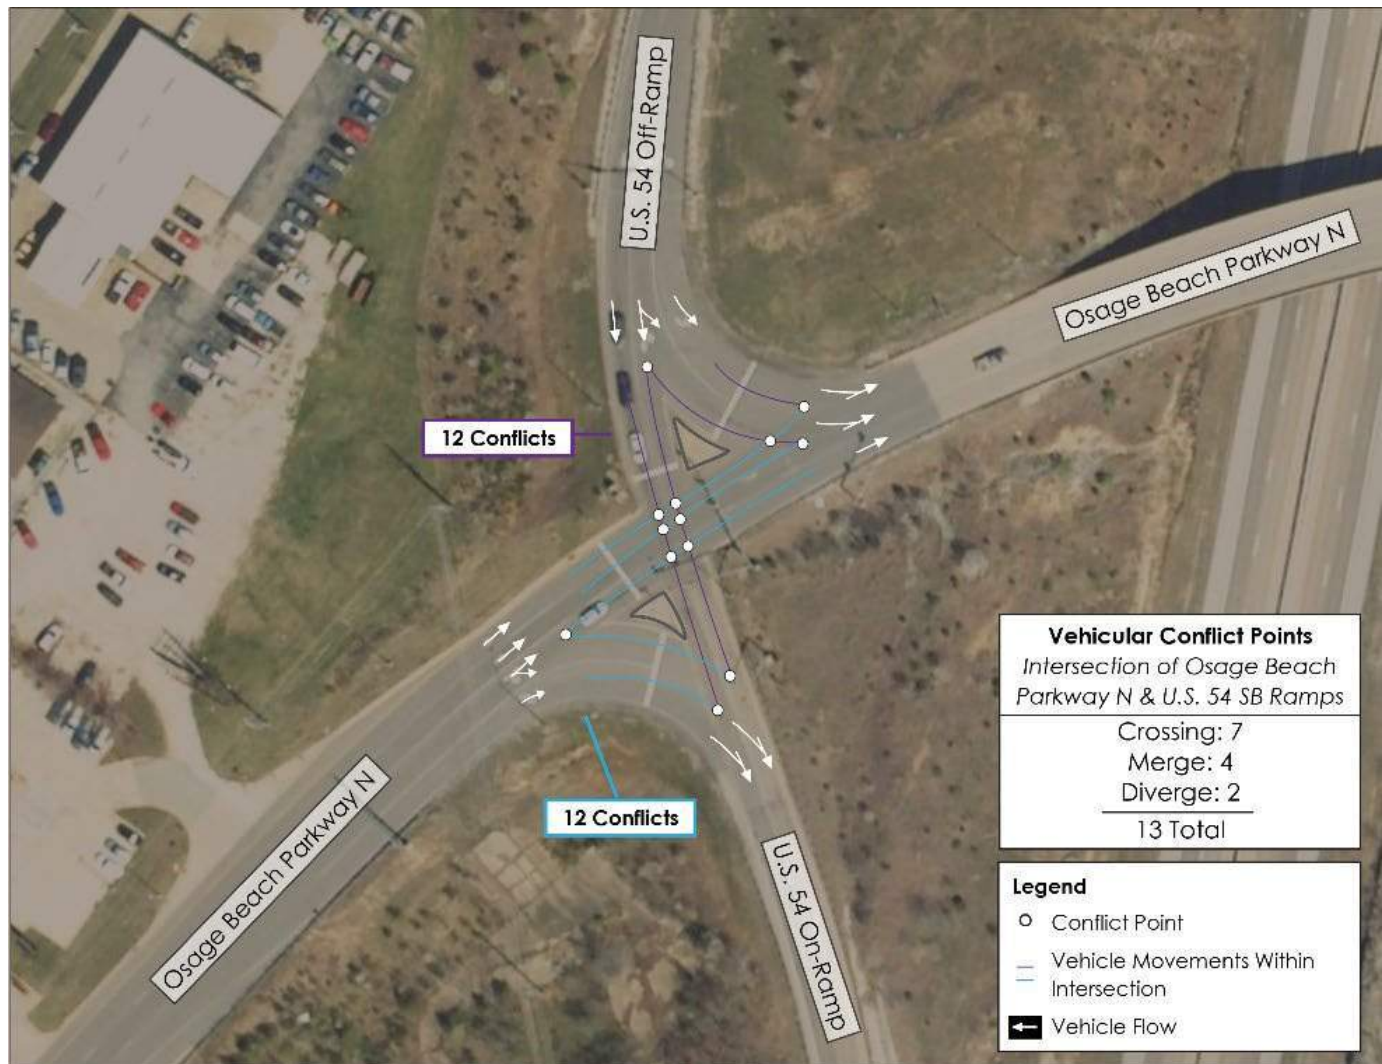
Figure 60 - Conflict Point Diagram of EB Osage Beach Parkway & SB U.S. 54 Ramp Terminals Intersection

Figure 60 illustrates the 13 potential conflict points that exist at this intersection.

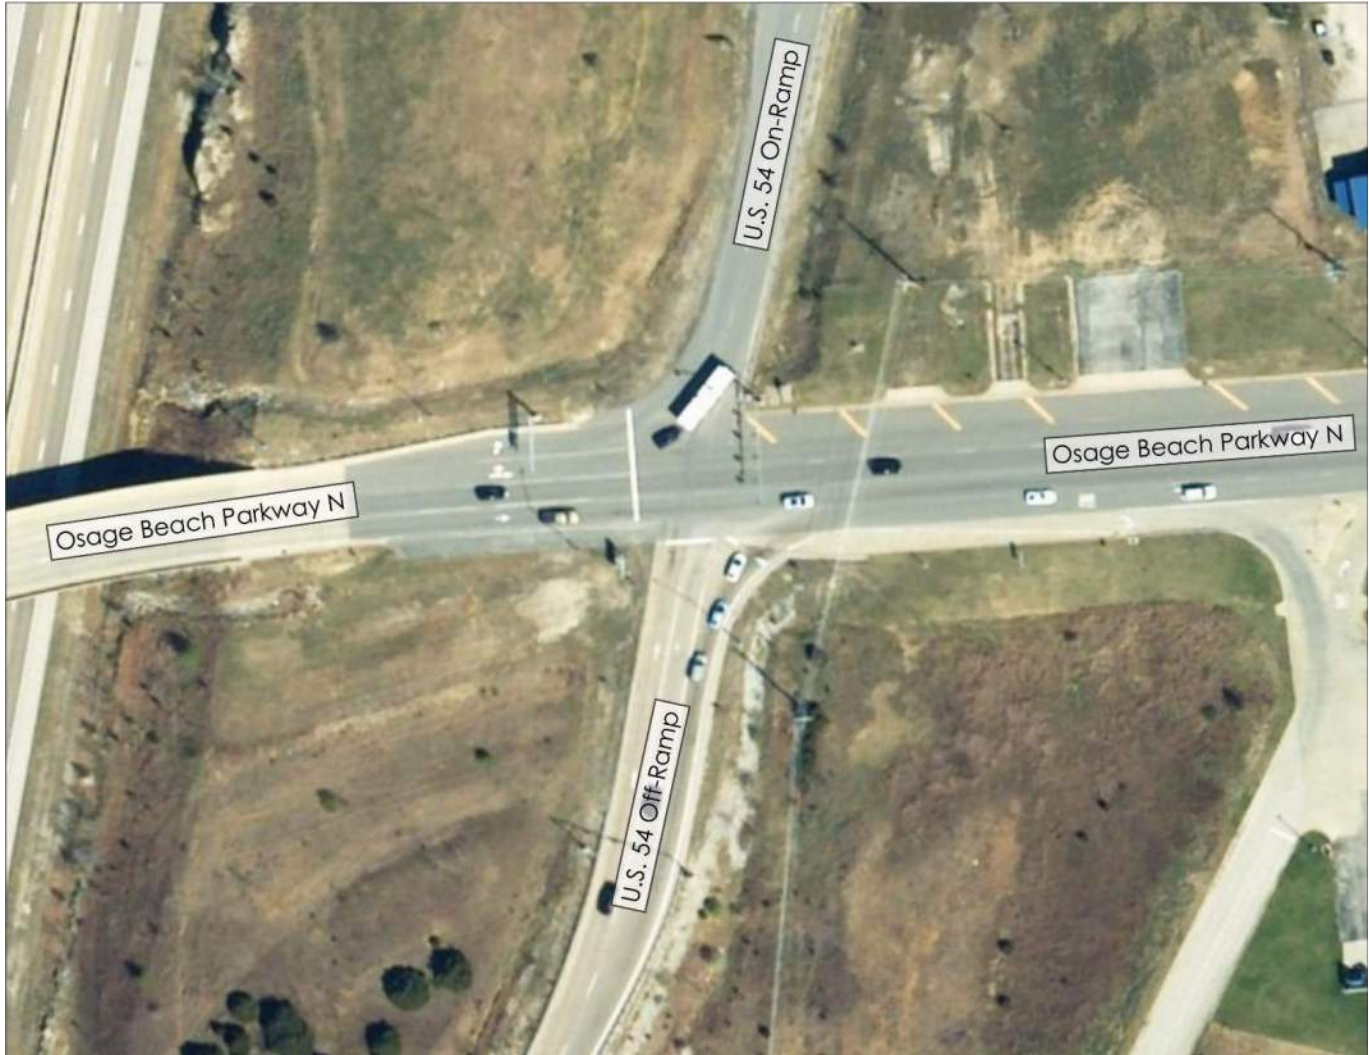
Figure 61 - Aerial image of the EB Osage Beach Parkway & NB U.S. 54 Ramp Terminals

The intersection of EB Osage Beach Parkway and the NB U.S. 54 Ramp Terminals is signalized with two approaches. The west leg consists of two east-bound through lanes and dual left-turn lanes, with the inside left-turn lane also functioning as an eastbound through lane. Right-turn movements are prohibited from this approach. The south leg consists of a northbound through lane and dual right-turn lanes, with the inside right-turn lane also serving as a northbound through lane. Left-turn movements are prohibited from this approach.

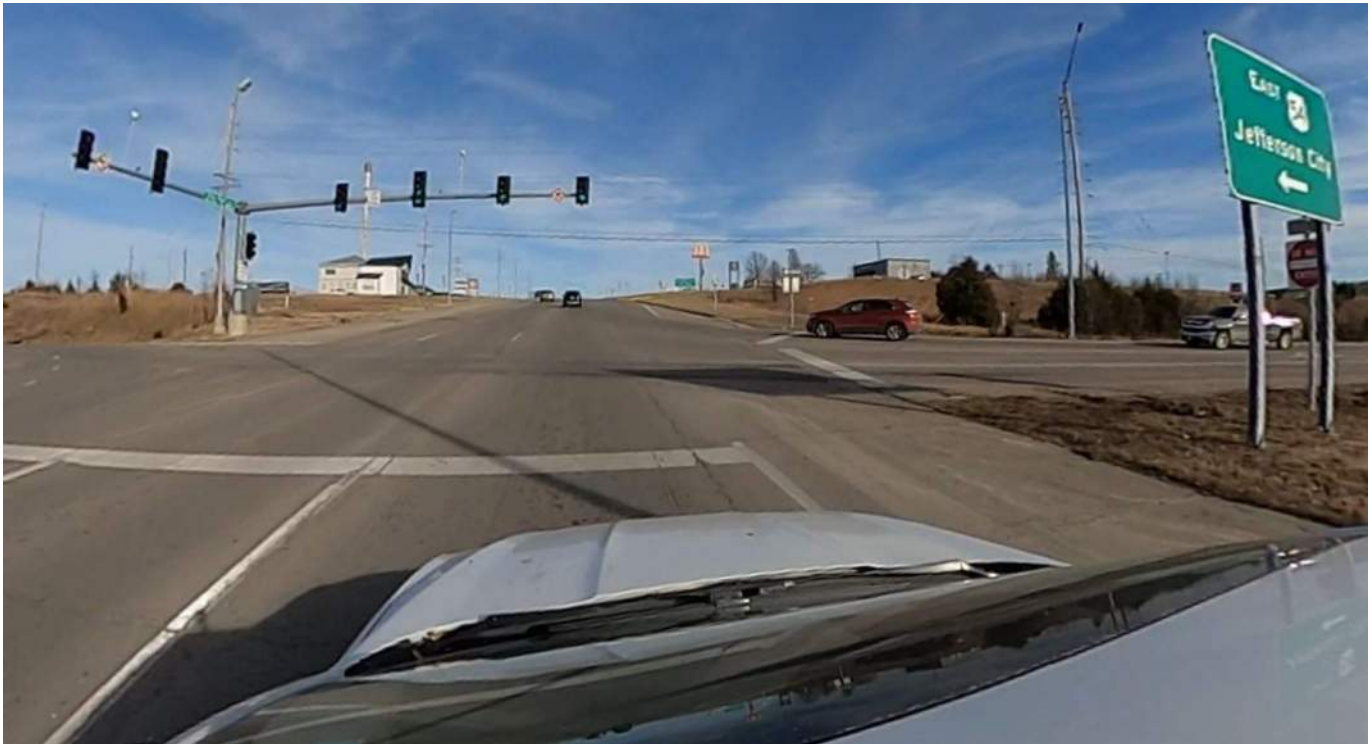
Figure 62 - Pedestrian Accommodation EB Osage Beach Parkway NB U.S. 54 Ramp Terminal (02.11.2026)

There are no pedestrian accommodations at this intersection.

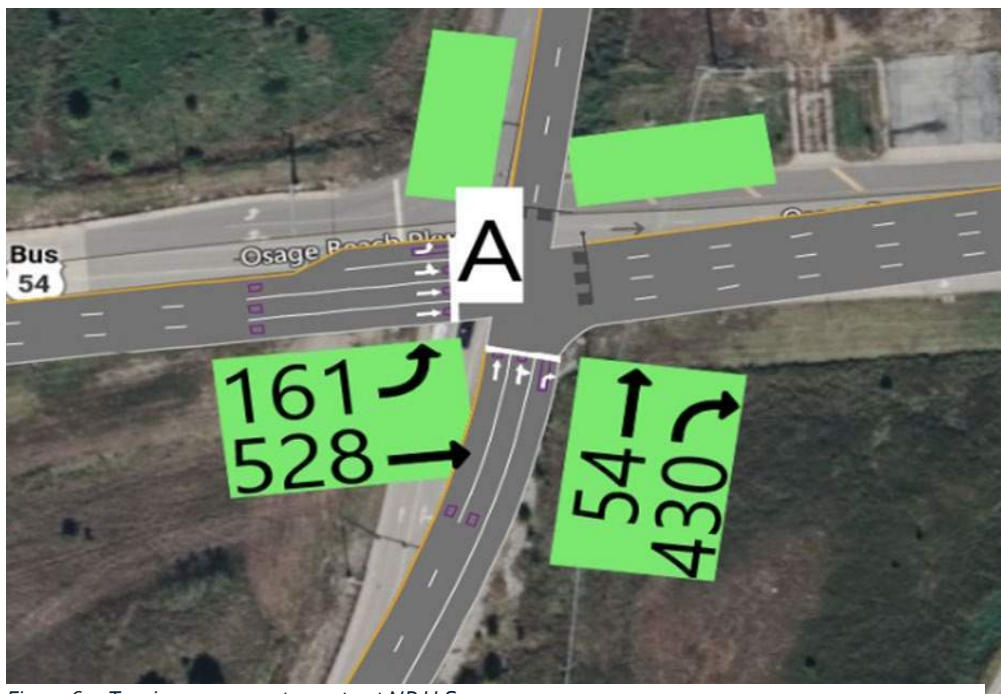
Figure 63 - Turning movement counts at NB U.S. 54 ramps

Figure 63 shows the PM peak hour turning movement counts at the NB U.S. 54 ramps. The eastbound through and northbound right turn are the dominant movements at the intersection. Given these turning movement counts the intersection operates at LOS A and is experiencing free flow traffic.
