# OSAGE BEACH VISION ZERO ACTION PLAN

Existing Conditions Report

January 2026

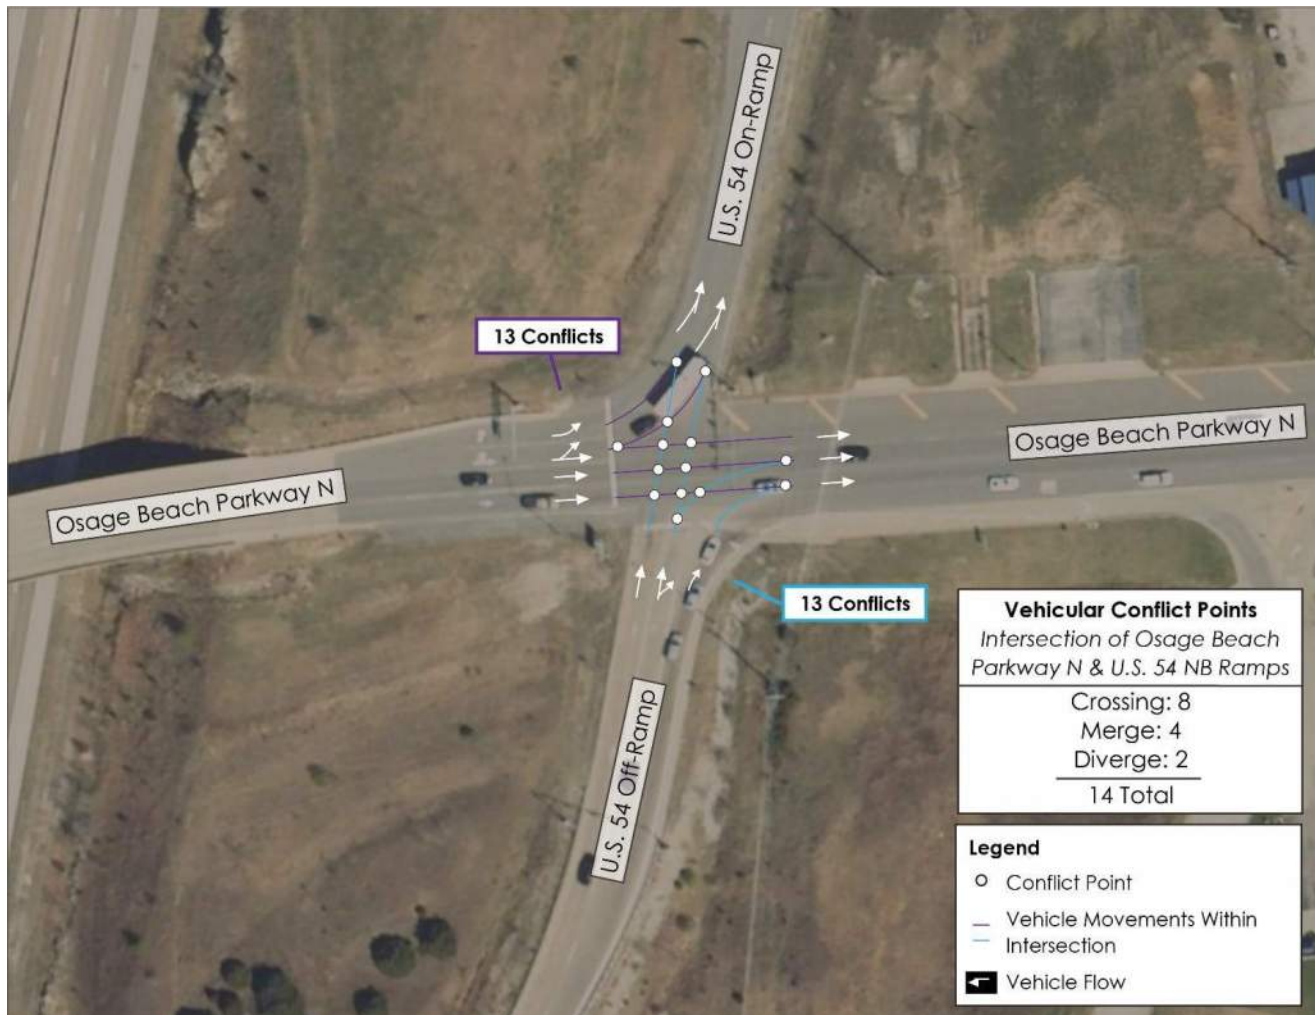
Figure 64 - Conflict point diagram at EB Osage Beach Parkway & NB U.S. 54 Ramps

Figure 64 illustrates the 14 potential conflict points that exist at this intersection.

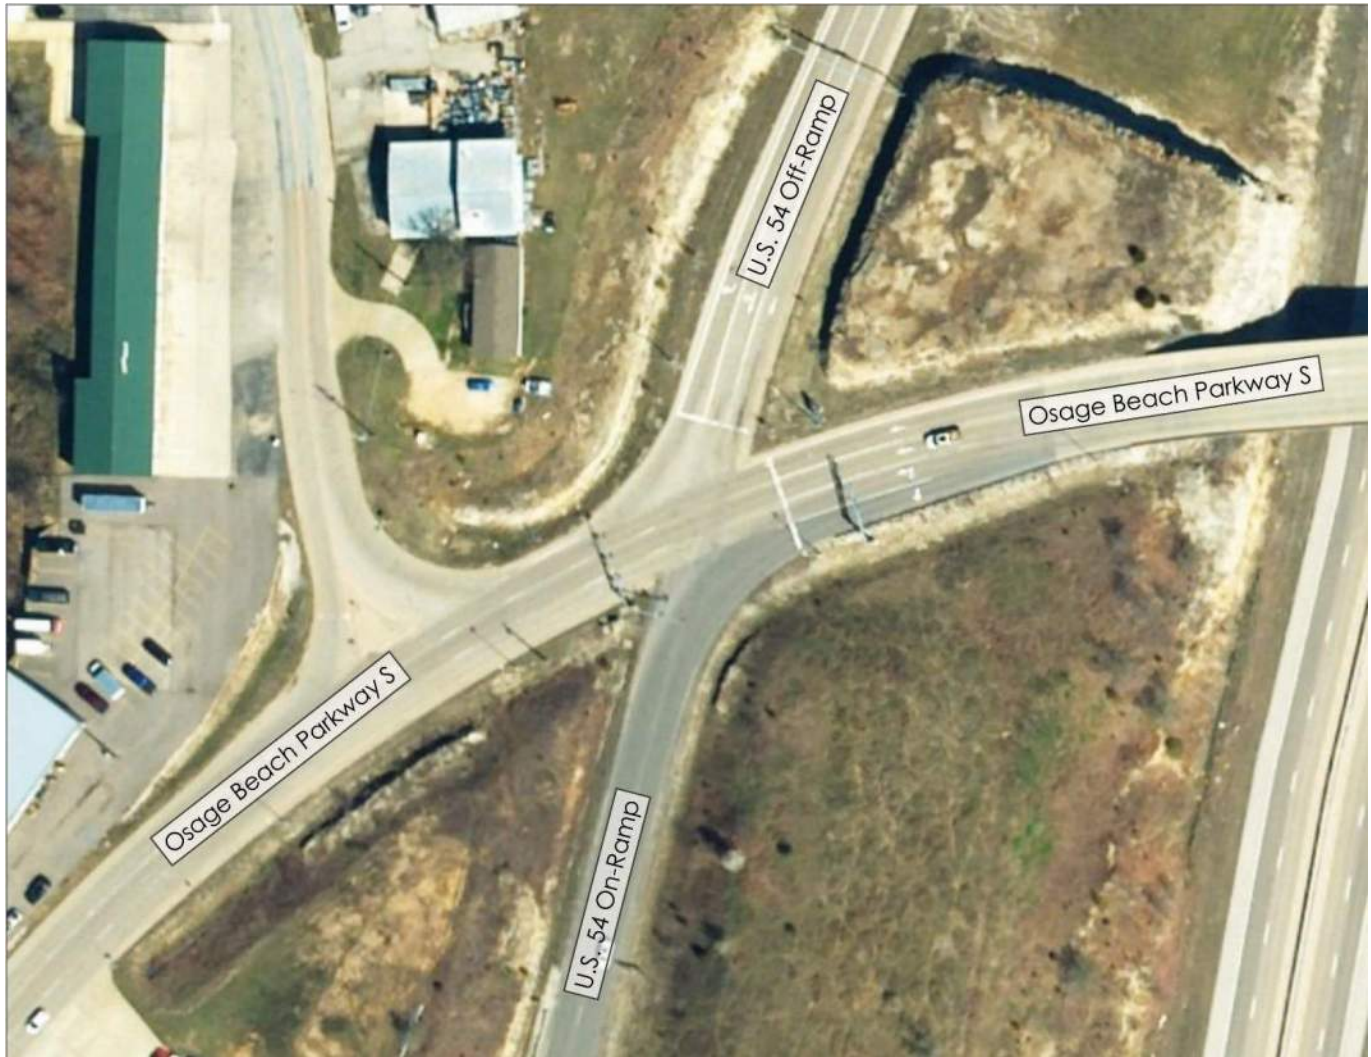
Figure 65 - Aerial image of the Osage Beach Parkway & WB U.S. 54 Ramp Terminals

The intersection of WB Osage Beach Parkway and the SB U.S. 54 Ramp Terminals is signalized with two approaches. The east leg consists of two westbound through lanes and dual left-turn lanes, with the inside left-turn lane also functioning as a westbound through lane. Right-turn movements are prohibited from this approach. The north leg consists of a southbound through lane and dual right-turn lanes, with the inside right-turn lane also serving as a southbound through lane. Left-turn movements are prohibited from this approach.

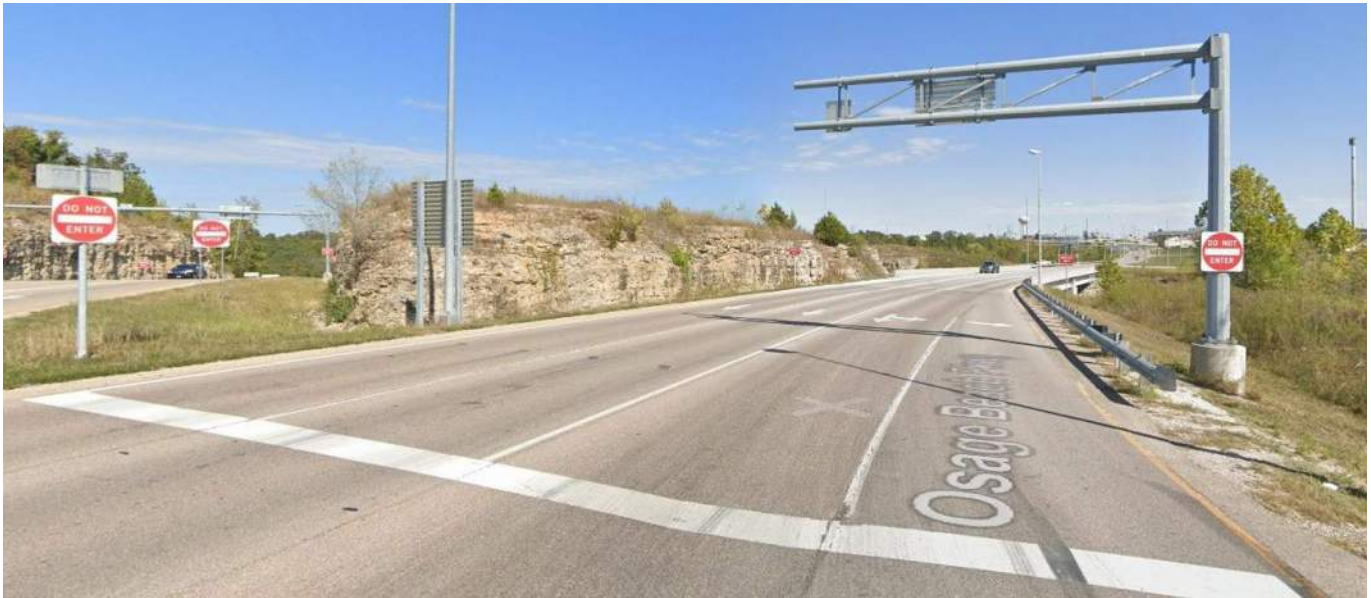
Figure 66 - Pedestrian Accommodation WB Osage Beach Parkway & SB U.S. 54 Ramp Terminal (10.2025)

There are no pedestrian accommodations at this intersection.

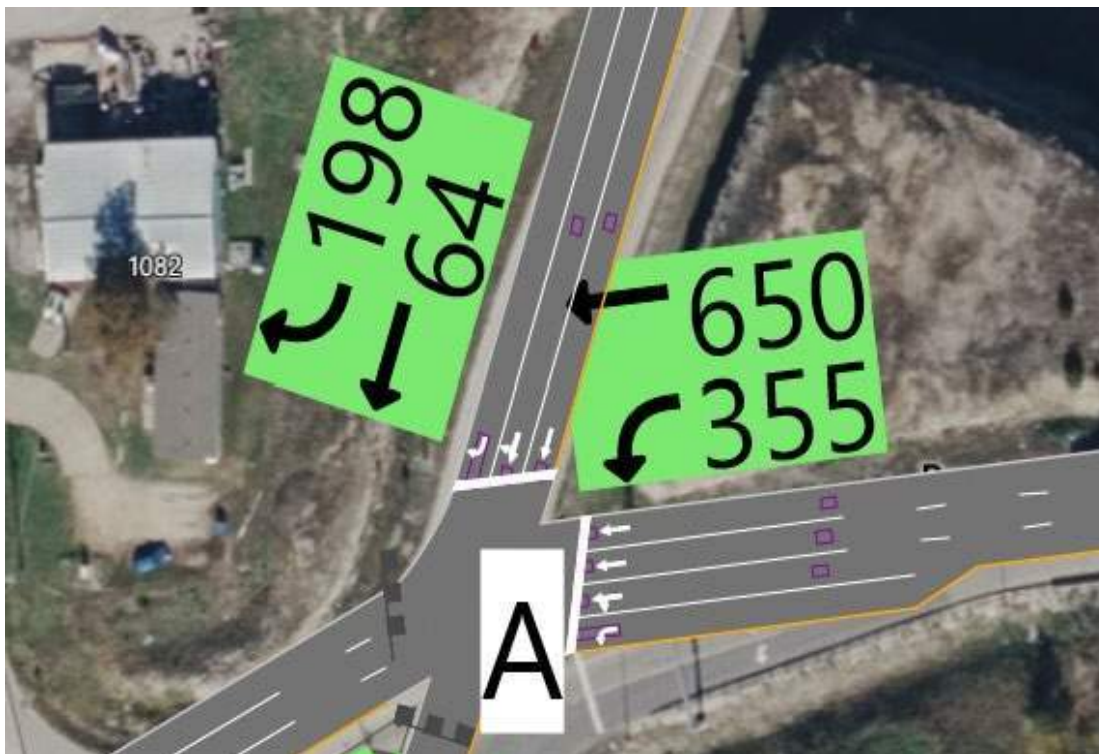
Figure 67 - Turning movement counts for the PM peak hour at WB Osage Beach Parkway & SB U.S. 54 ramps

Figure 67 displays the PM peak hour turning movement counts at WB Osage Beach Parkway and SB U.S. 54. The two dominant turning movements by volume are both on Osage Beach Parkway with about a third of westbound traffic turning left mostly to head onto southbound U.S. 54. Given the traffic volumes, the intersection operates at LOS A and is experiencing free flow traffic with little delay.

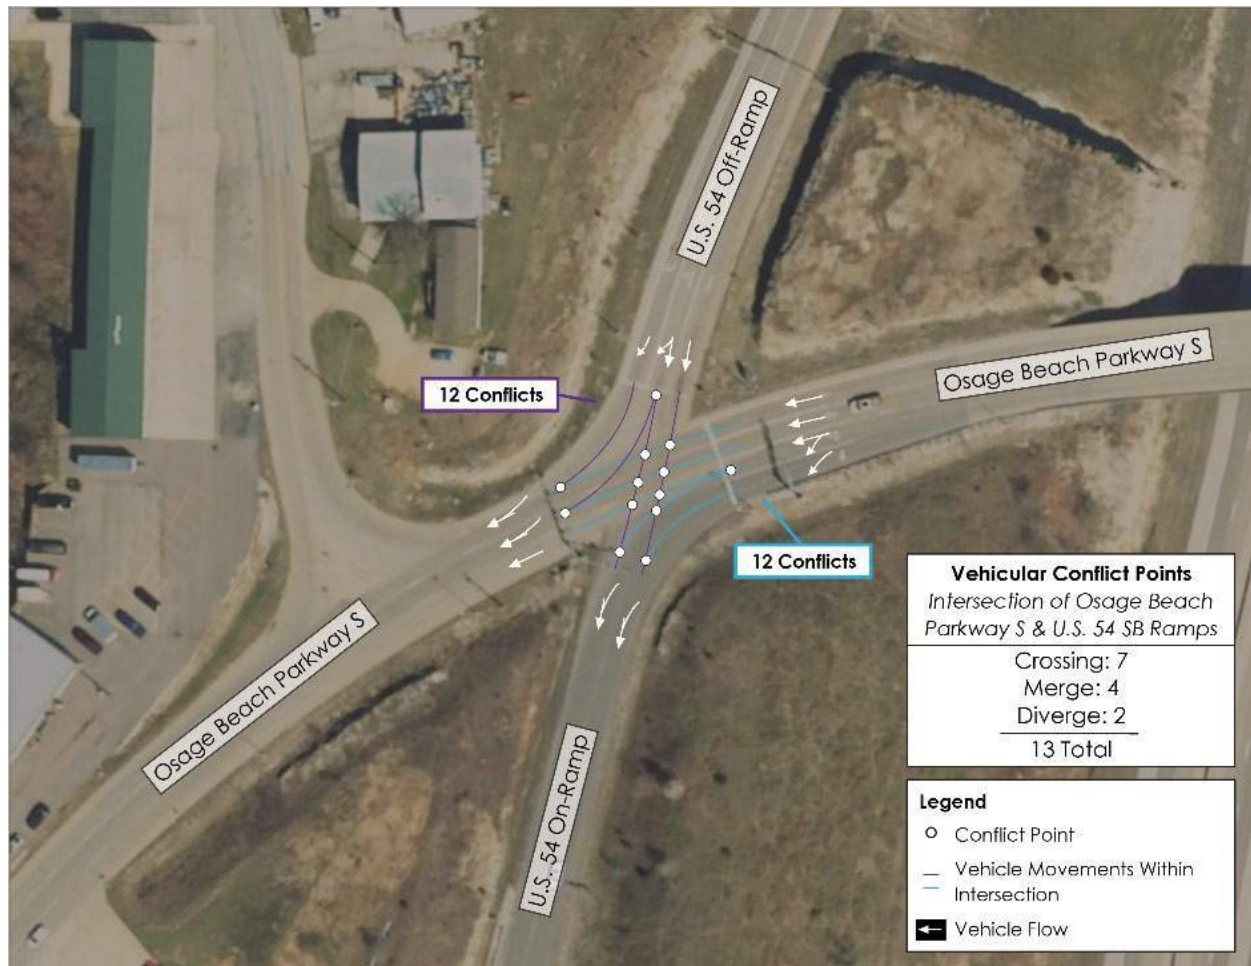
Figure 68 - Conflict Point Diagram of WB Osage Beach Parkway and SB U.S. 54 Ramp Terminals Intersection

Figure 68 illustrates the 13 potential conflict points that exist at this intersection.

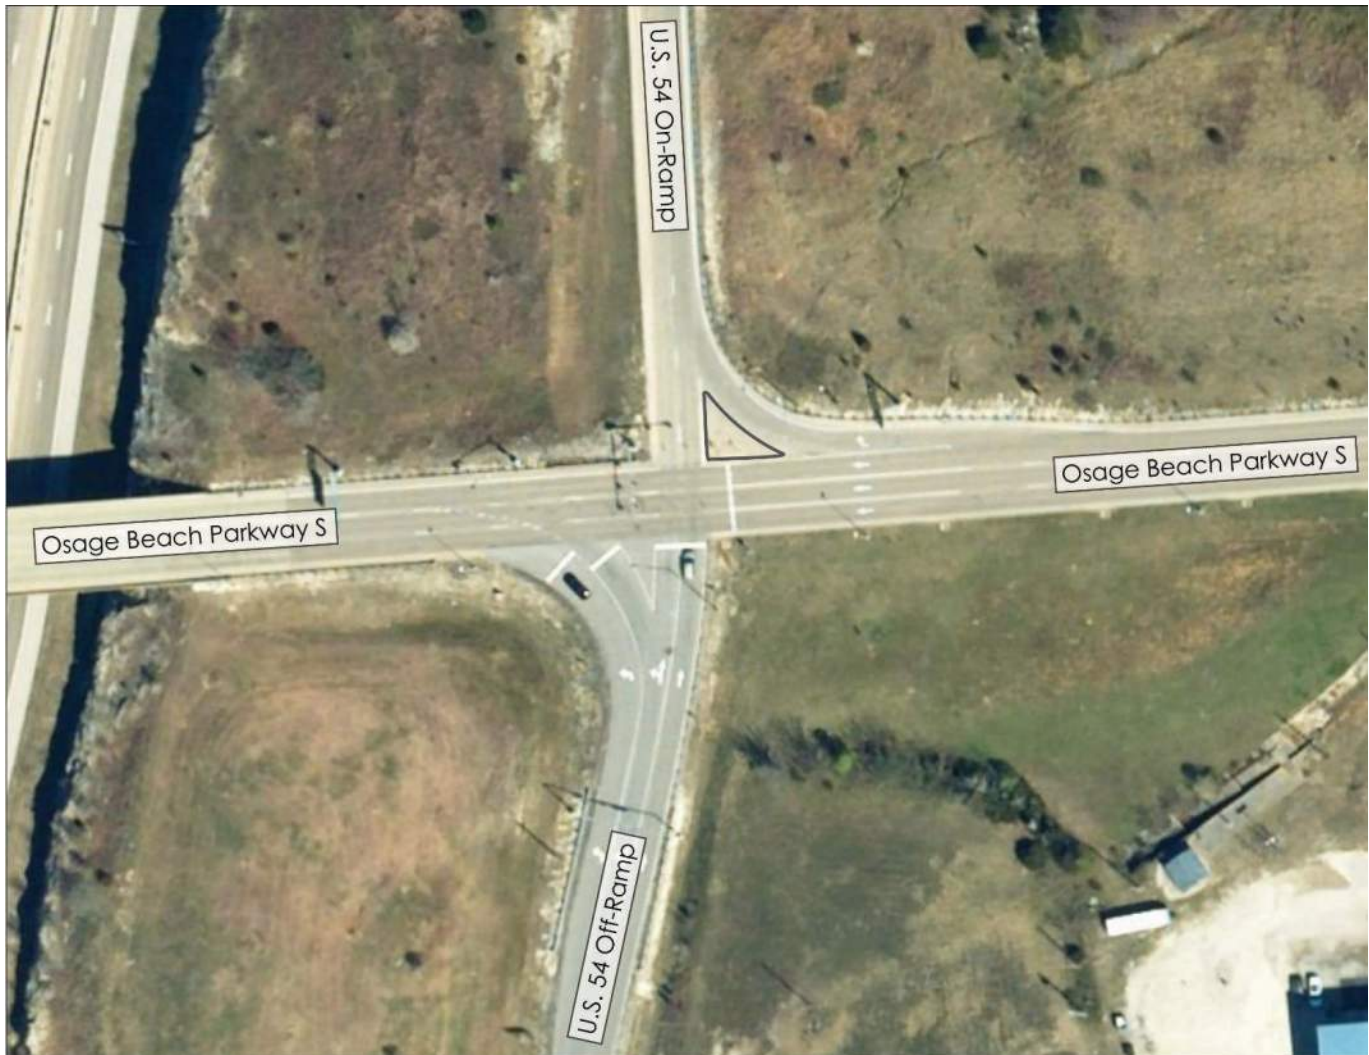
Figure 69 - Aerial image of the WB Osage Beach Parkway & NB U.S. 54 Ramp Terminals

The intersection of WB Osage Beach Parkway and the NB U.S. 54 Ramp Terminal is signalized with two approaches. The east leg consists of three westbound through lanes and a channelized right-turn lane. Left-turn movements are prohibited from this approach. The south leg consists of a northbound through lane and dual left-turn lanes, with the inside left-turn lane also serving as a northbound through lane. Right-turn movements are prohibited from this approach.

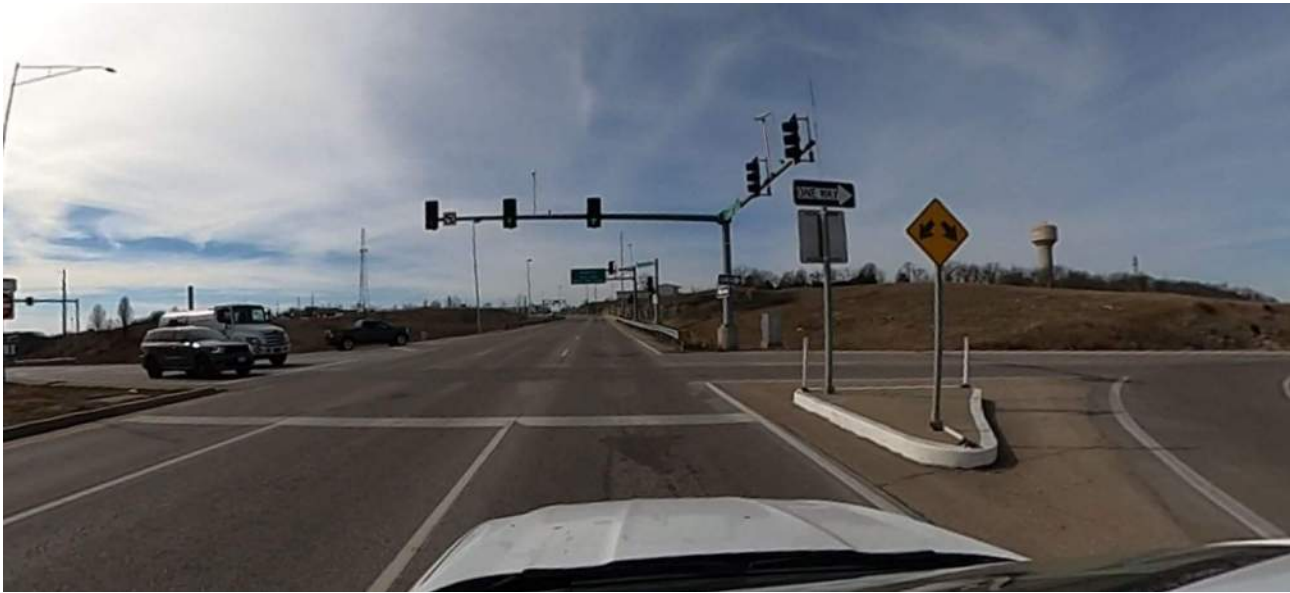
Figure 70 - WB Osage Beach Parkway & NB U.S. 54 Ramp Terminal (02.11.2026)

No pedestrian accommodations exist at this intersection.

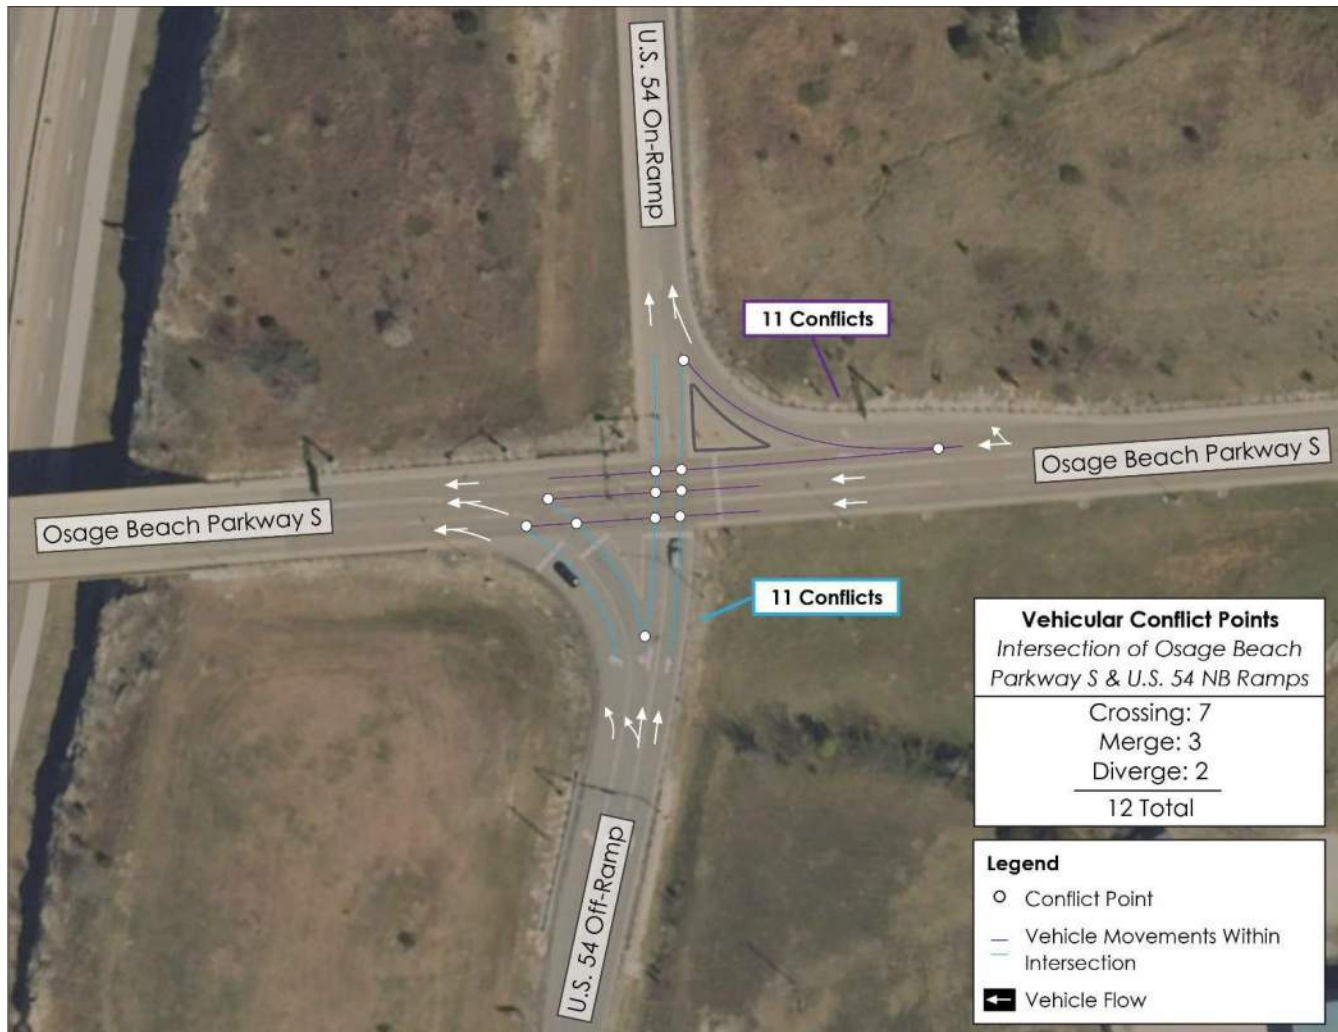
Figure 72 - Conflict Point Diagram of WB Osage Beach Parkway & NB U.S. 54 Ramp Terminals Intersection

Figure 72 illustrates the 12 potential conflict points that exist at this intersection.

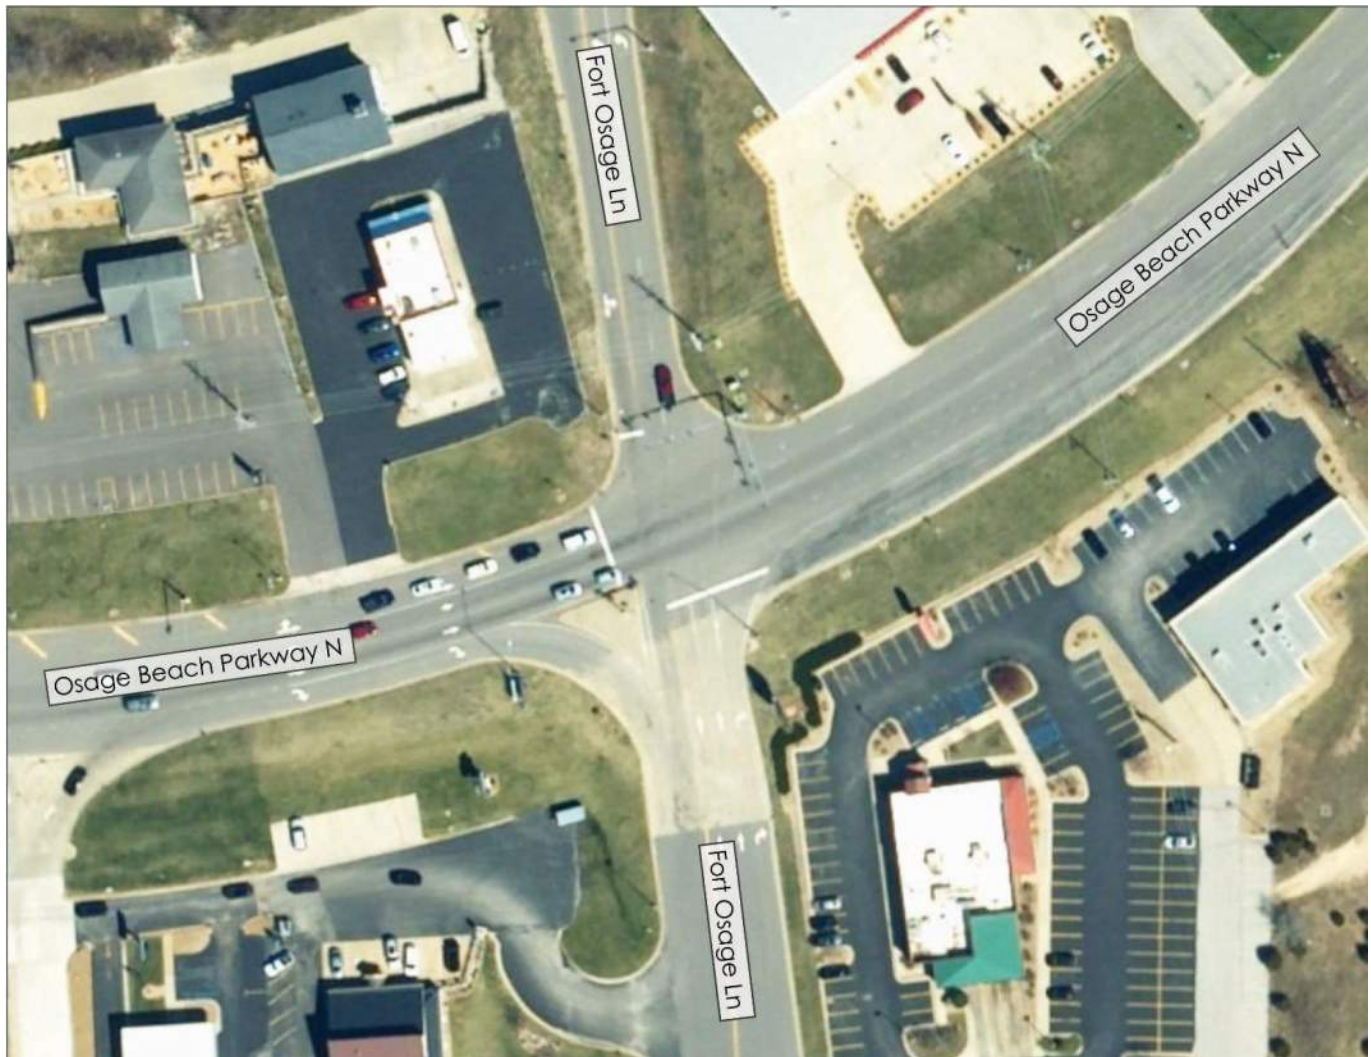
Figure 73 - Aerial image of the Eastbound Osage Beach Parkway & Fort Osage Lane

The intersection is signalized with three approaches. The west leg of Osage Beach Parkway consists of two through lanes, a shared through or left-turn lane, and a channelized right-turn lane. The north leg of Fort Osage Lane consists of a shared through or left-turn lane and two northbound receiving lanes. No right turns are permitted from this approach. The south leg of Fort Osage Lane consists of two through lanes, a dedicated right-turn lane, and a southbound receiving lane. No left-turns are permitted from this approach. The north and west approaches operate on protected-permissive left-turn signal phasing.

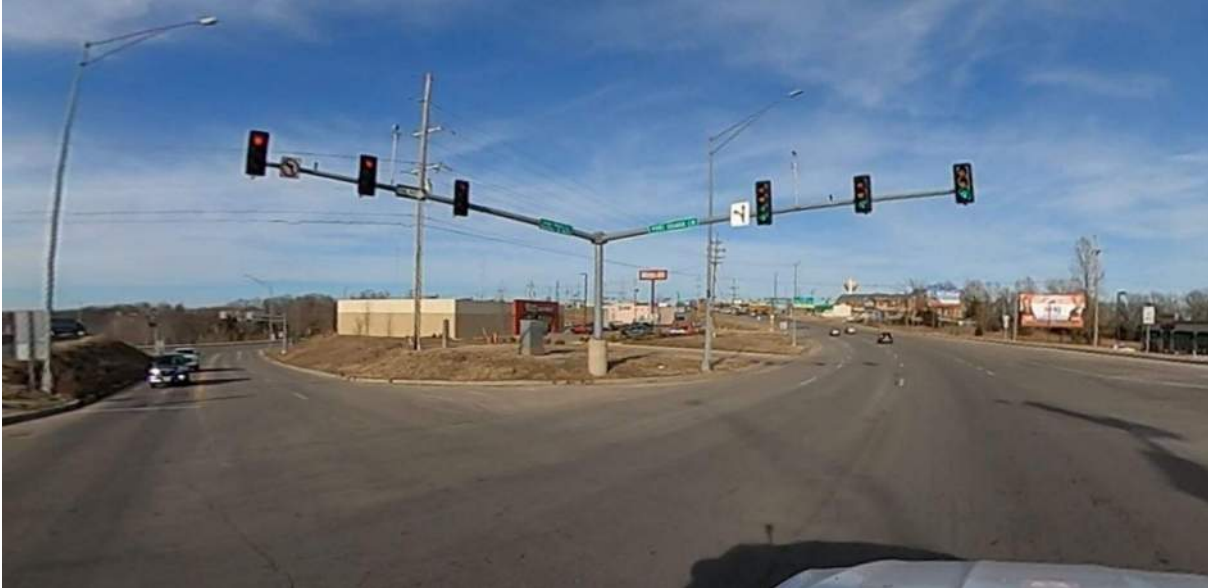
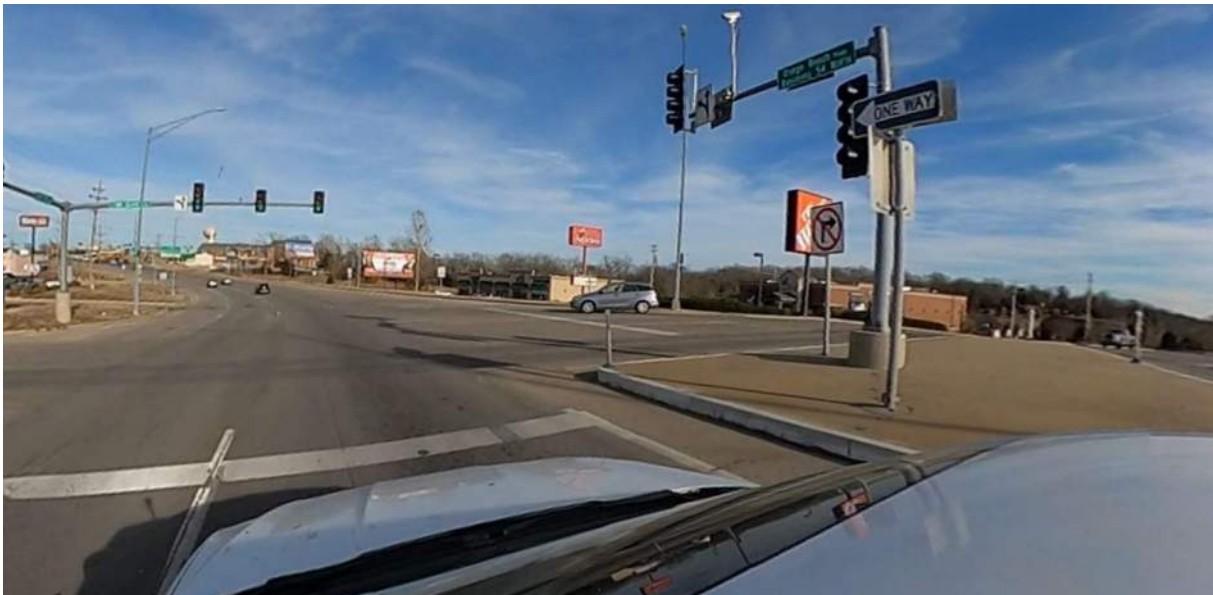
There is a ramp without truncated domes along the east side of the south leg. The ramp does not connect to sidewalk and is approximately 20 feet behind the stop bar. There are no other pedestrian facilities at this intersection.

*Figure 74 - Pedestrian Accommodation Eastbound Osage Beach Parkway & Fort Osage Lane (02.11.2026)*

*Figure 75 - Pedestrian Accommodation Eastbound Osage Beach Parkway & Fort Osage Lane (02.11.2026)*

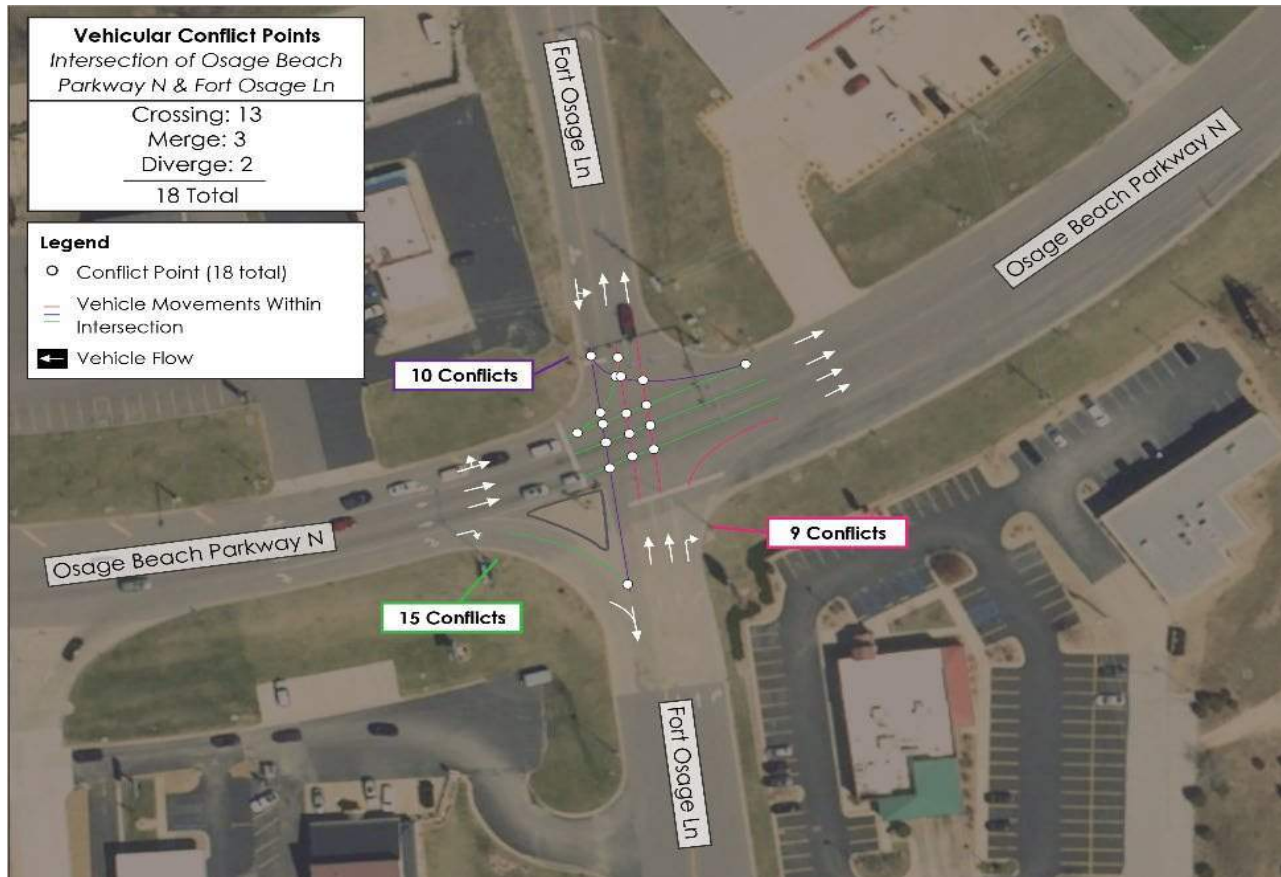
Figure 76 - Conflict Point Diagram of Eastbound Osage Beach Parkway & Fort Osage Lane Intersection

Figure 76 illustrates the 18 potential conflict points that exist at this intersection. The eastbound approach experiences the most conflict point exposure with four approach lanes.

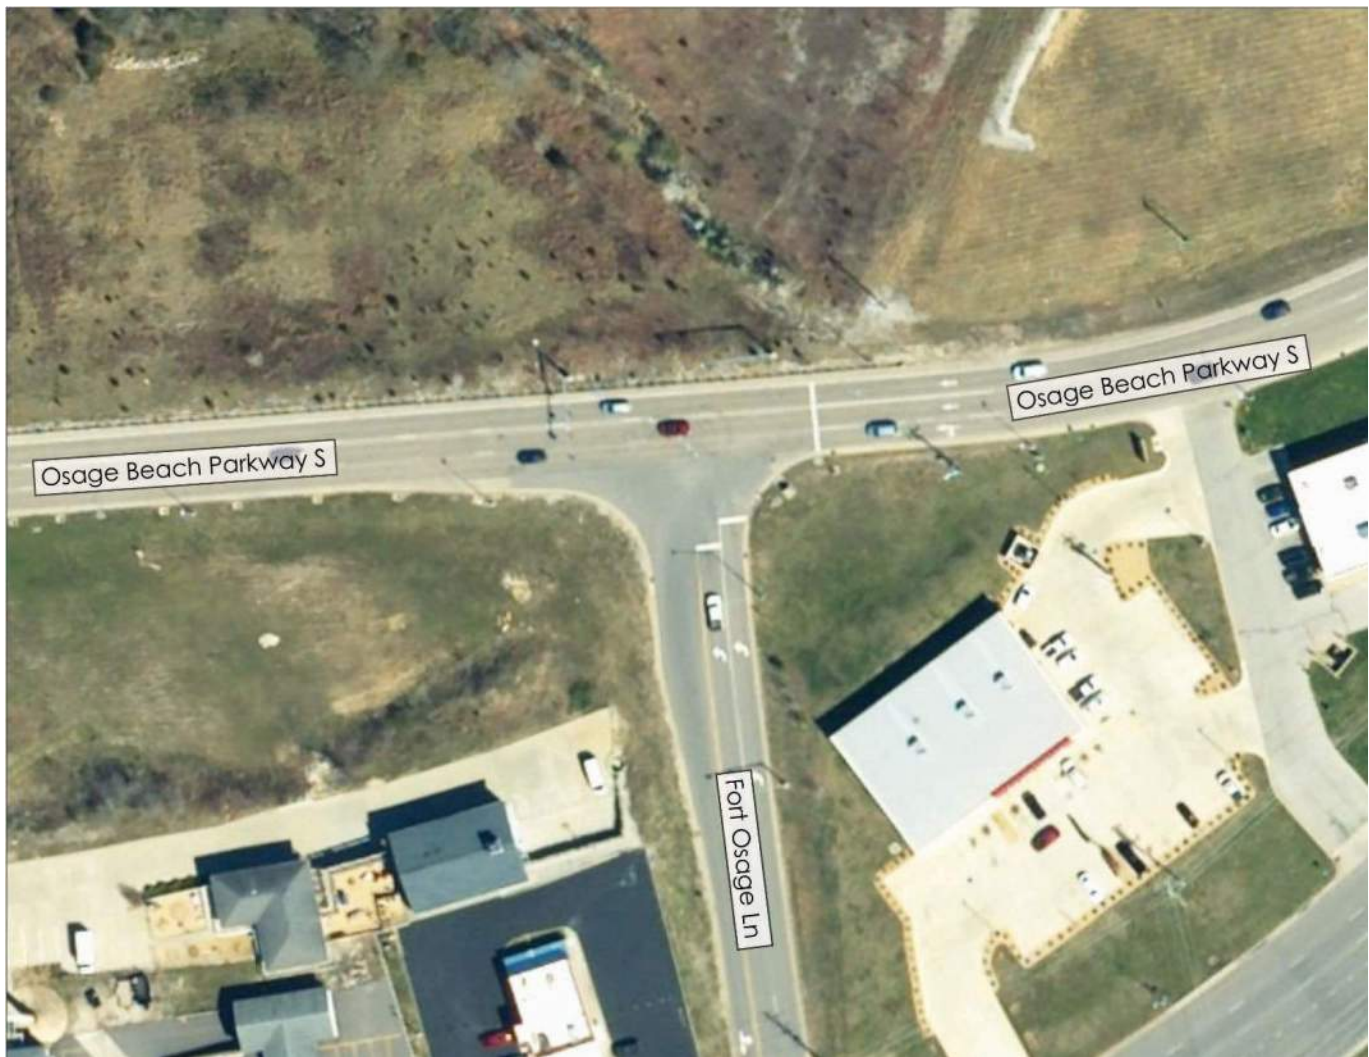
Figure 77 - Aerial image of the Westbound Osage Beach Parkway & Fort Osage Lane

The intersection is signalized with two approaches. The east leg of Osage Beach Parkway consists of two westbound through lanes and a shared through or left-turn lane. The south leg of Fort Osage Lane consists of dual left-turn lanes and one southbound receiving lane. No right-turns are permitted at this intersection. Both approaches operate on protected left-turn phasing.

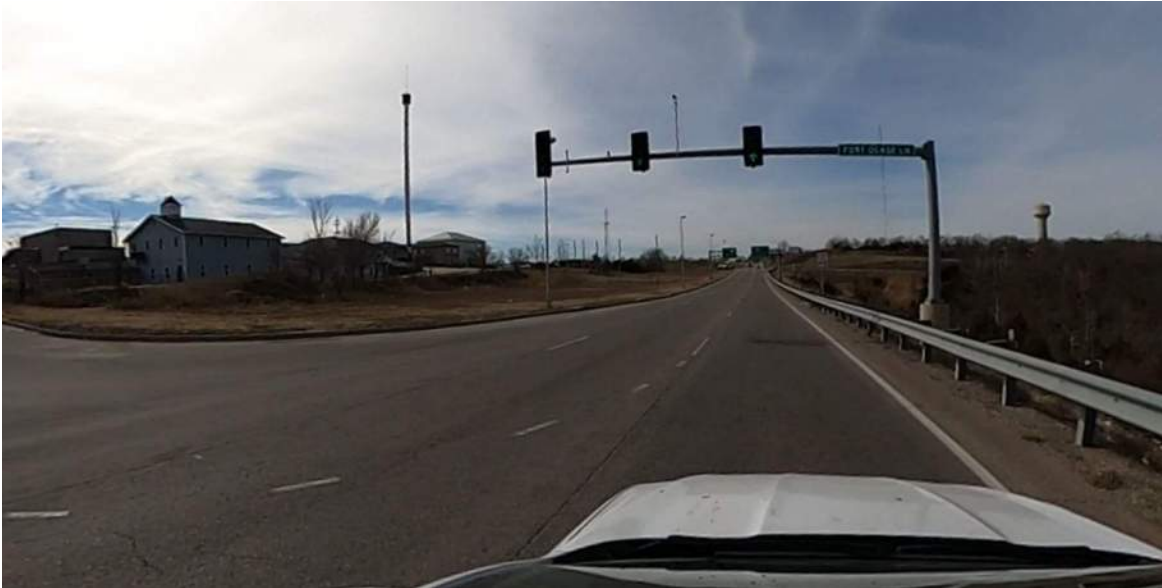
Figure 78 - Pedestrian Accommodation Westbound Osage Beach Parkway & Fort Osage Lane (02.11.2026)

There are no pedestrian accommodations at this intersection.

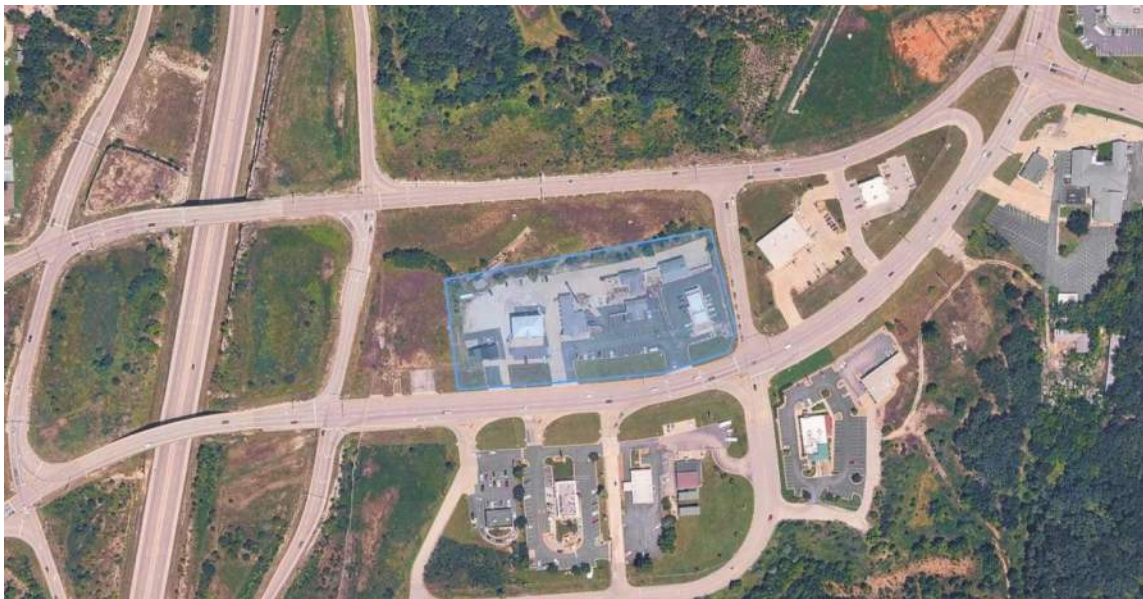
- There are businesses with frontage only onto eastbound Osage Beach Parkway which creates access issues for westbound Osage Beach Parkway traffic.

Figure 8o - Osage Beach Parkway businesses with frontage only onto eastbound Osage Beach Parkway.

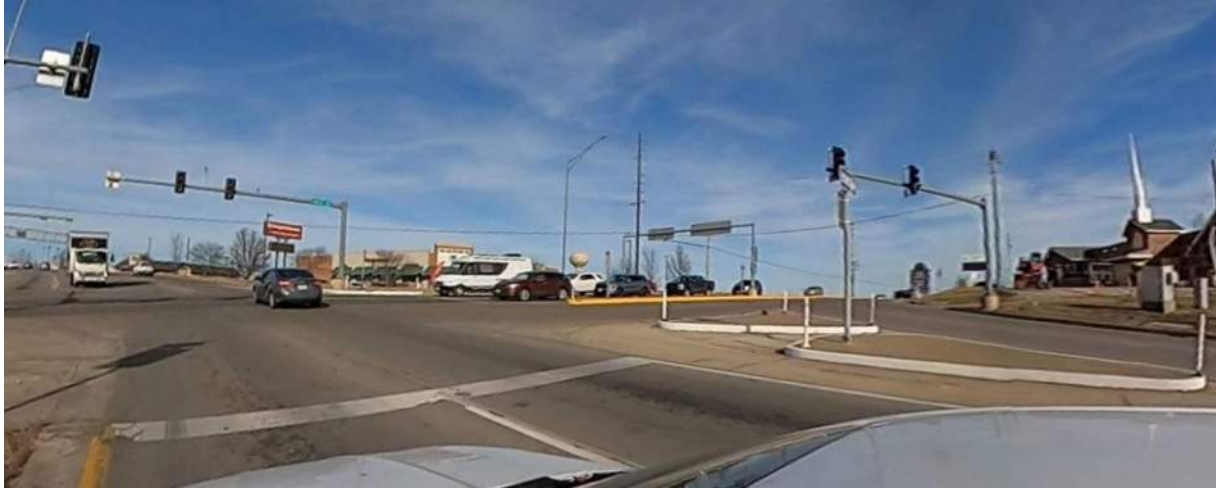
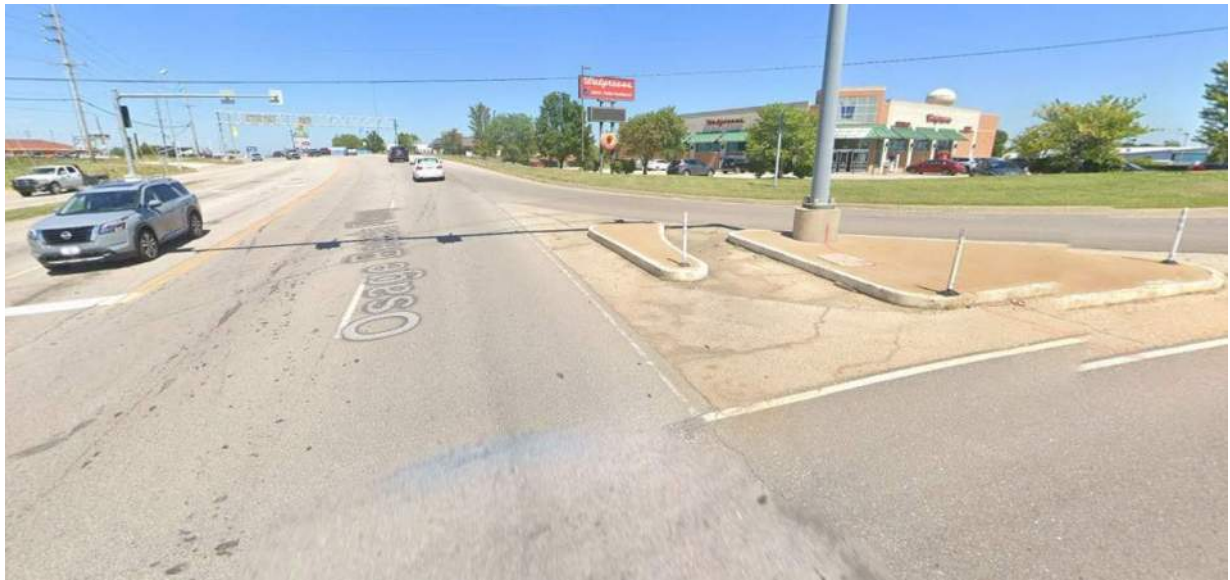
There are no sidewalks or crosswalks present at the intersection. The east leg has two refuge islands, but they do not lead to ramps or sidewalks on either side of the intersection. These islands do not have additional ADA features such as truncated domes, audible push buttons, or countdown timers.

*Figure 82 - Pedestrian Accommodation Osage Beach Parkway & Route 42 (02.11.2026)*

*Figure 83 - Pedestrian Accommodation Osage Beach Parkway & Route 42 (08.2023)*

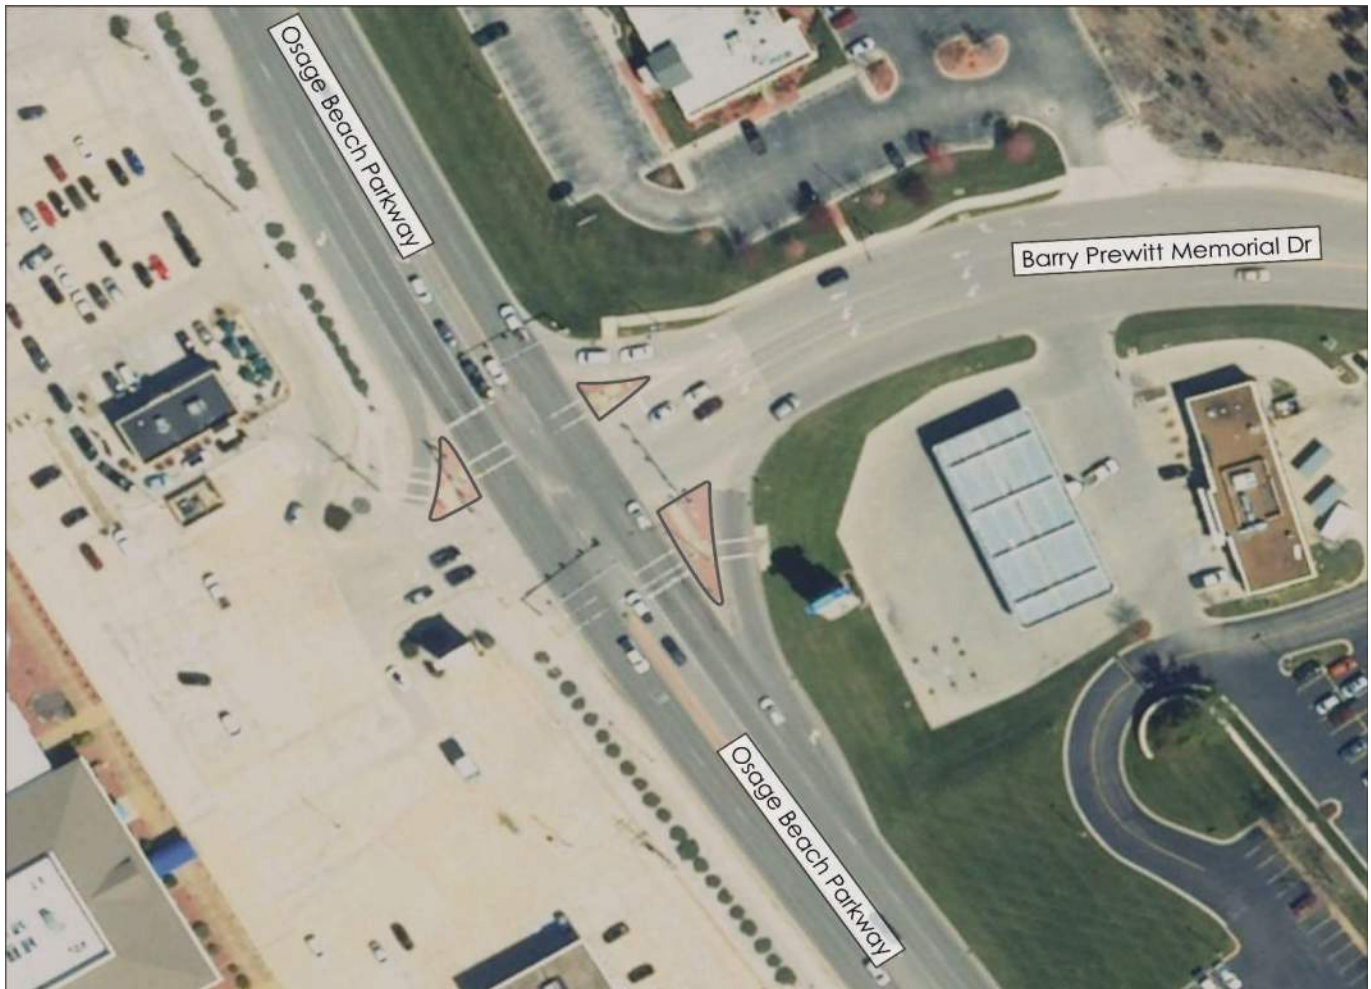
Figure 85 - Aerial image of the Osage Beach Parkway & Barry Prewitt Memorial Drive

The intersection is signalized with four approaches. The north and south legs of Osage Beach Parkway both consist of two through lanes in each direction, a dedicated left-turn lane, and a channelized right-turn lane. The west leg of Barry Prewitt Memorial Drive consists of a dedicated left-turn lane, a share through or right-turn lane, and one westbound receiving lane. The east leg of Barry Prewitt Memorial Drive consists of two dedicated left-turn lanes, a westbound through lane, two eastbound receiving lanes, and a channelized right-turn lane. All four approaches operate on protected left-turn phasing.

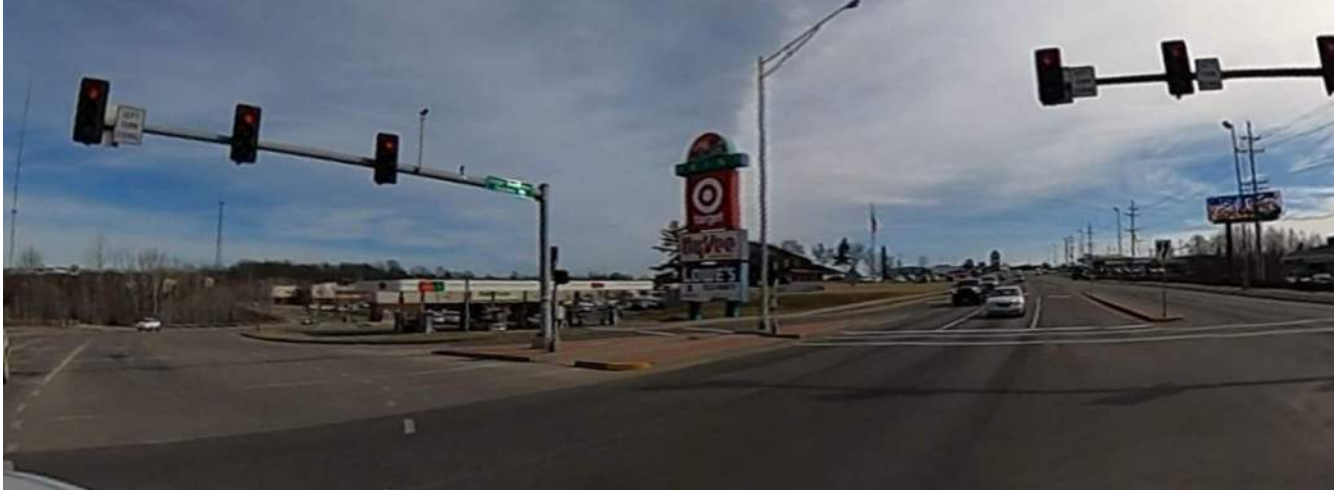
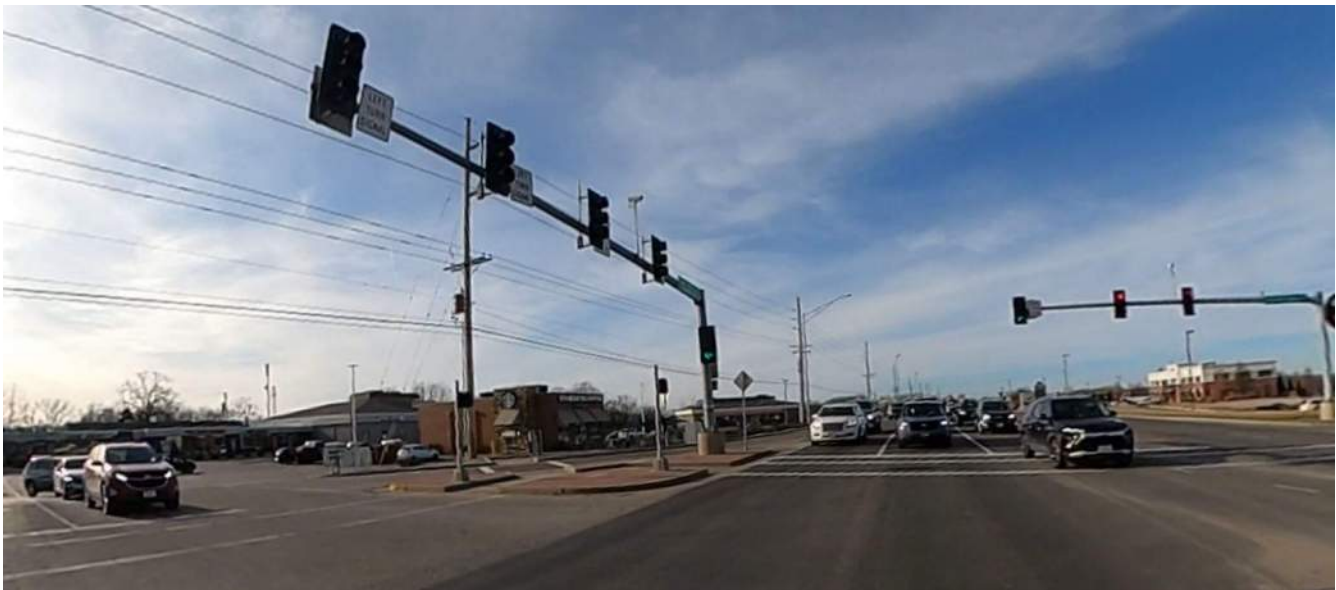
There are sidewalks in good condition along the northeast, southeast, and northwest legs on one side of the roadway. The refuge islands are in good condition and have audible push buttons and countdown timers. Longitudinal crosswalks connect each leg of the intersection.

Figure 86 - Pedestrian Accommodation Osage Beach Parkway & Barry Prewitt Memorial Drive

Figure 87 - Pedestrian Accommodation Osage Beach Parkway & Barry Prewitt Memorial Drive

**Sidewalk Presence and Condition:** Sidewalk is present within the refuge island and follows the parking lot along the SB side of the northwest leg. There are no sidewalks present on the NB side headed north. Sidewalks appear to be in good condition.

**Crosswalk Presence and Condition:** Longitudinal crosswalks are present to cross Osage Beach Parkway and the SB right turn lane.

**Sidewalk Presence and Condition:** Sidewalks are present to connect the crosswalks crossing Barry Prewitt Memorial Drive as well as Osage Beach Parkway. They do not continue SB along the Osage Beach Parkway. Sidewalks appear to be in good condition.

**Crosswalk Presence and Condition:** Longitudinal crosswalks are present to cross Barry Prewitt Memorial Drive.

**Sidewalk Presence and Condition:** There are sidewalks present in the refuge islands and to the north and south. The northern sidewalk follows Barry Prewitt Memorial Drive and around the rear of Hy-Vee. The southern sidewalk does not connect to the Hy-Vee Gas Station but does follow Osage Beach Parkway to the south. Sidewalks appear to be in good condition.

**Crosswalk Presence and Condition:** Longitudinal crosswalks are present to cross Barry Prewitt Memorial Drive and the NB right turn lane.

**Sidewalk Presence and Condition:** Sidewalks are present at the refuge island as well as headed south along the NB side of Osage Beach Parkway. Sidewalks appear to be in good condition.

**Crosswalk Presence and Condition:** Longitudinal crosswalks are present to cross Osage Beach Parkway and the EB right turn lane.
