# OSAGE BEACH VISION ZERO ACTION PLAN

Existing Conditions Report

January 2026

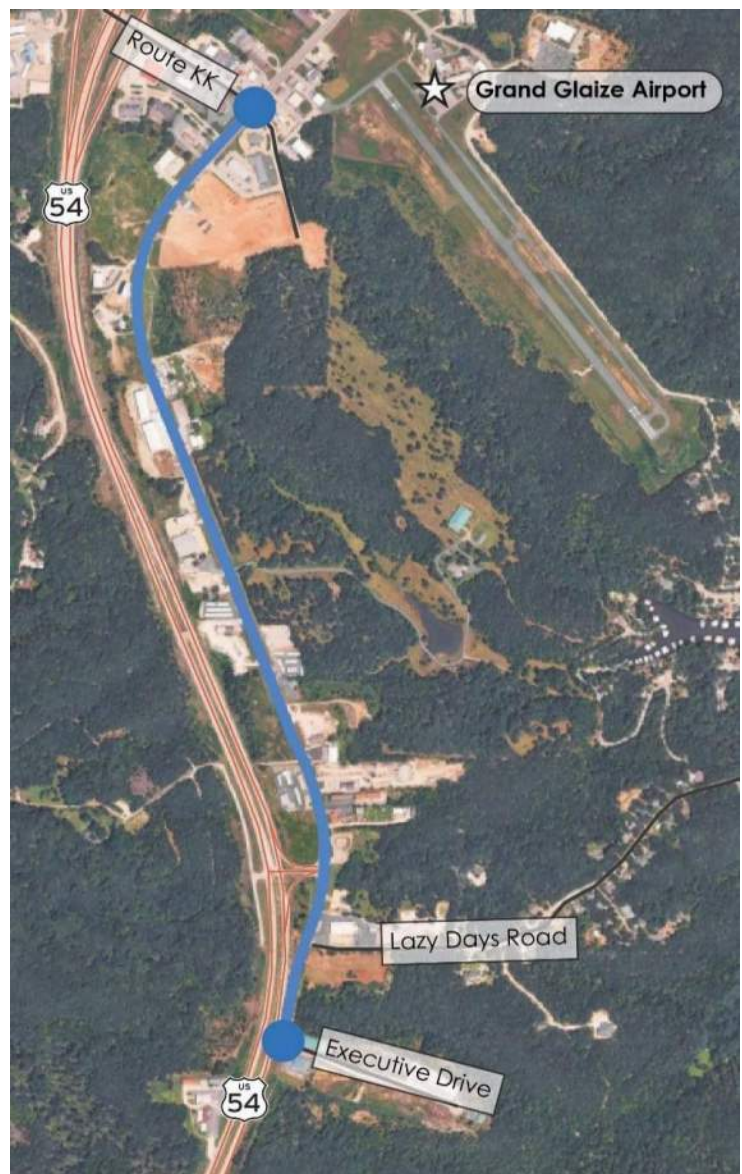
Figure 89 - Aerial image of Osage Beach Parkway Segment 1: Executive Drive to Route KK

The Osage Beach Parkway segment from Executive Drive to Route KK is a three-lane road with a center turn lane and is 1.35 miles long, as shown in Figure 89. The land surrounding this segment is mostly commercial and vacant land. Some of the major commercial locations include the Harley Davidson dealership at Lazy Days Road, PMP Park at Executive Drive, and Slumberland Furniture. There are residential uses off Lazy Days Road further to the east. There are two planned developments, a hotel on the northwest side of the corridor and a storage unit facility off Route KK and Osage Beach Parkway.

There are six unsignalized intersections along this segment including the intersection with the U.S. 54 on and off ramps. There are 51 driveways connected to this segment and about 37 driveways per mile, or about 3.6 driveways per 500 feet.

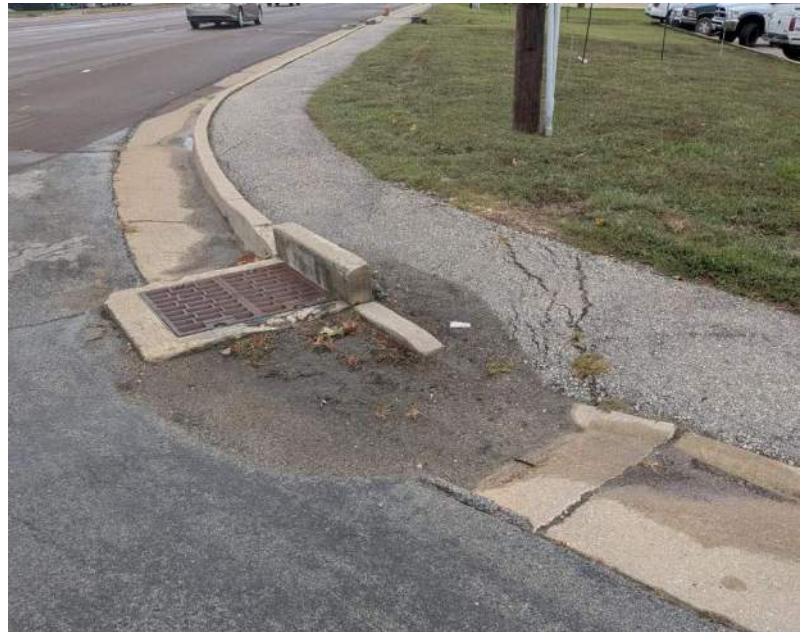
SOURCE: WILSON & COMPANY (OCTOBER 2025).

Figure 90 - Photo of asphalt shoulder on southeast side of Osage Beach Parkway just west of Route KK.

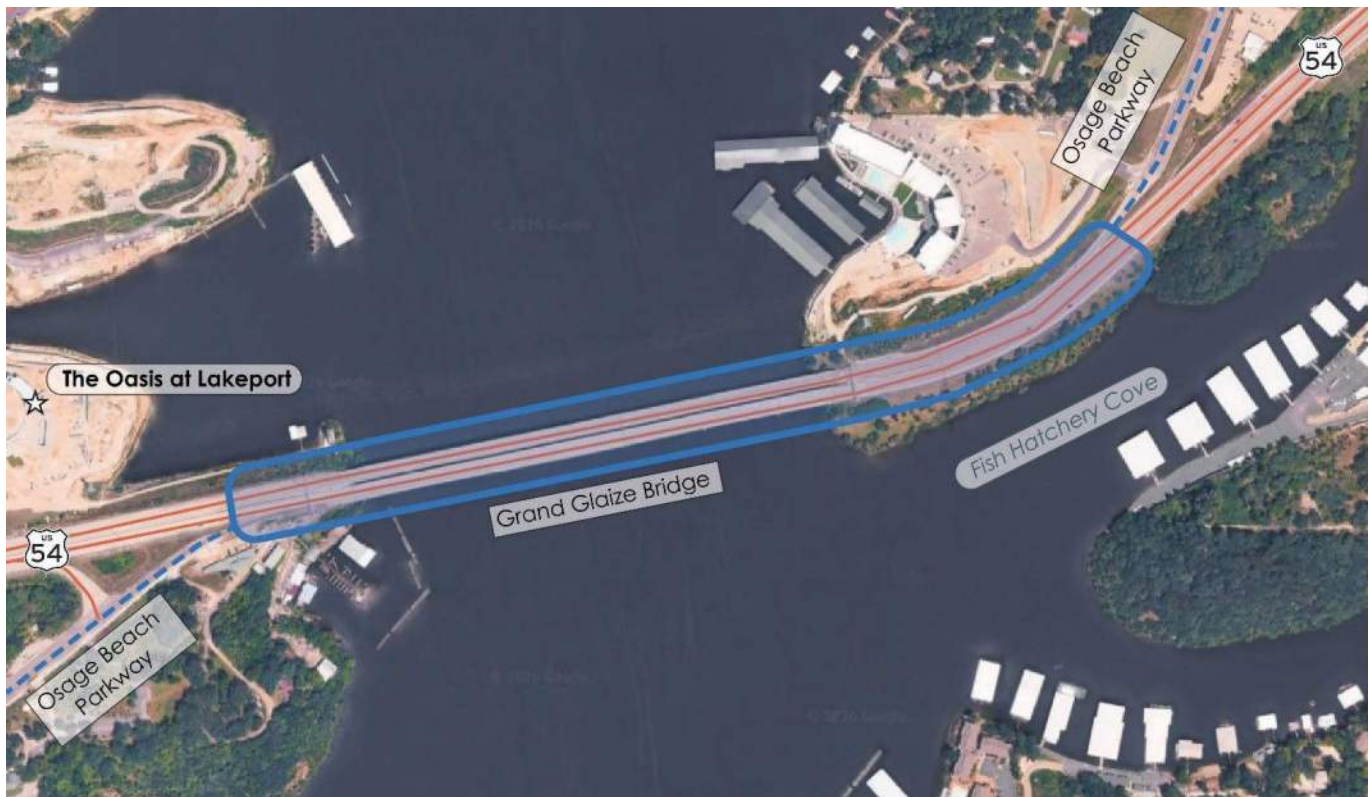
Figure 96 - Aerial image of Grand Glaize Bridge

The Grand Glaize Bridge is the two parallel girder bridge structure that connects the east and west sides of Osage Beach across the Grand Glaize Arm of the Lake of the Ozarks (). It is a six-lane bridge with three lanes and a six-foot shoulder in both directions for U.S. 54 traffic. It was originally built for U.S. 54 traffic as a part of Osage Beach Parkway, but now Osage Beach Parkway merges onto the bridge from the east and west sides. According to the U.S. Department of Transportation's National Bridge Inventory, one bridge was built in 1995 and the parallel bridge was built in 1983. The bridge received a 'fair' condition rating when it was last surveyed.

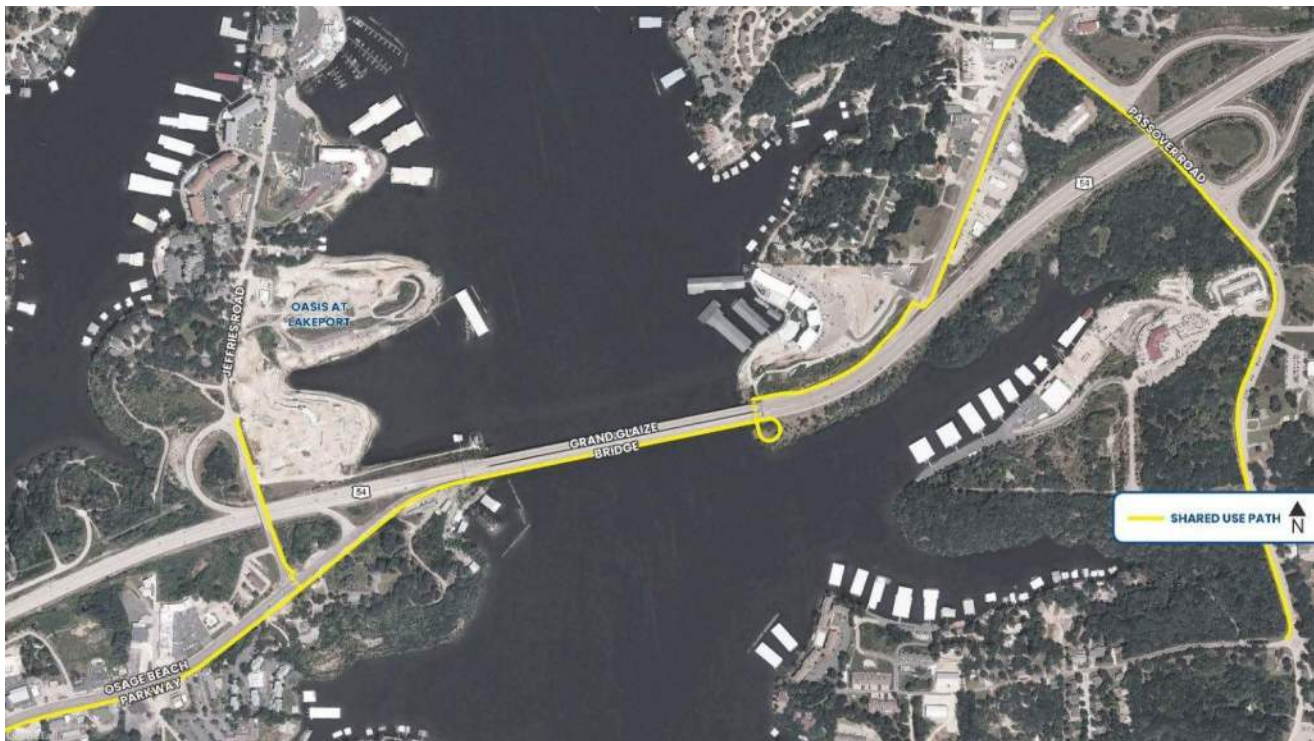
Figure 97 - Grand Glaize Bridge potential pedestrian crossing on south side of bridge.

The first concept involves closing the outside lane of the south side of the Grand Glaize Bridge to construct a concrete barrier and a shared-use path. On the east side of the bridge, the shared-use path would then connect back to east Osage Beach Parkway by going under the bridge and coming back up on the north side.

Figure 97 and Figure 98 show two potential concepts for providing a pedestrian crossing across the Grand Glaize Bridge.

Both concepts recommend extending the shared-use paths to connect west Osage Beach Parkway to Jeffries Road, and east Osage Beach Parkway to Passover Road.

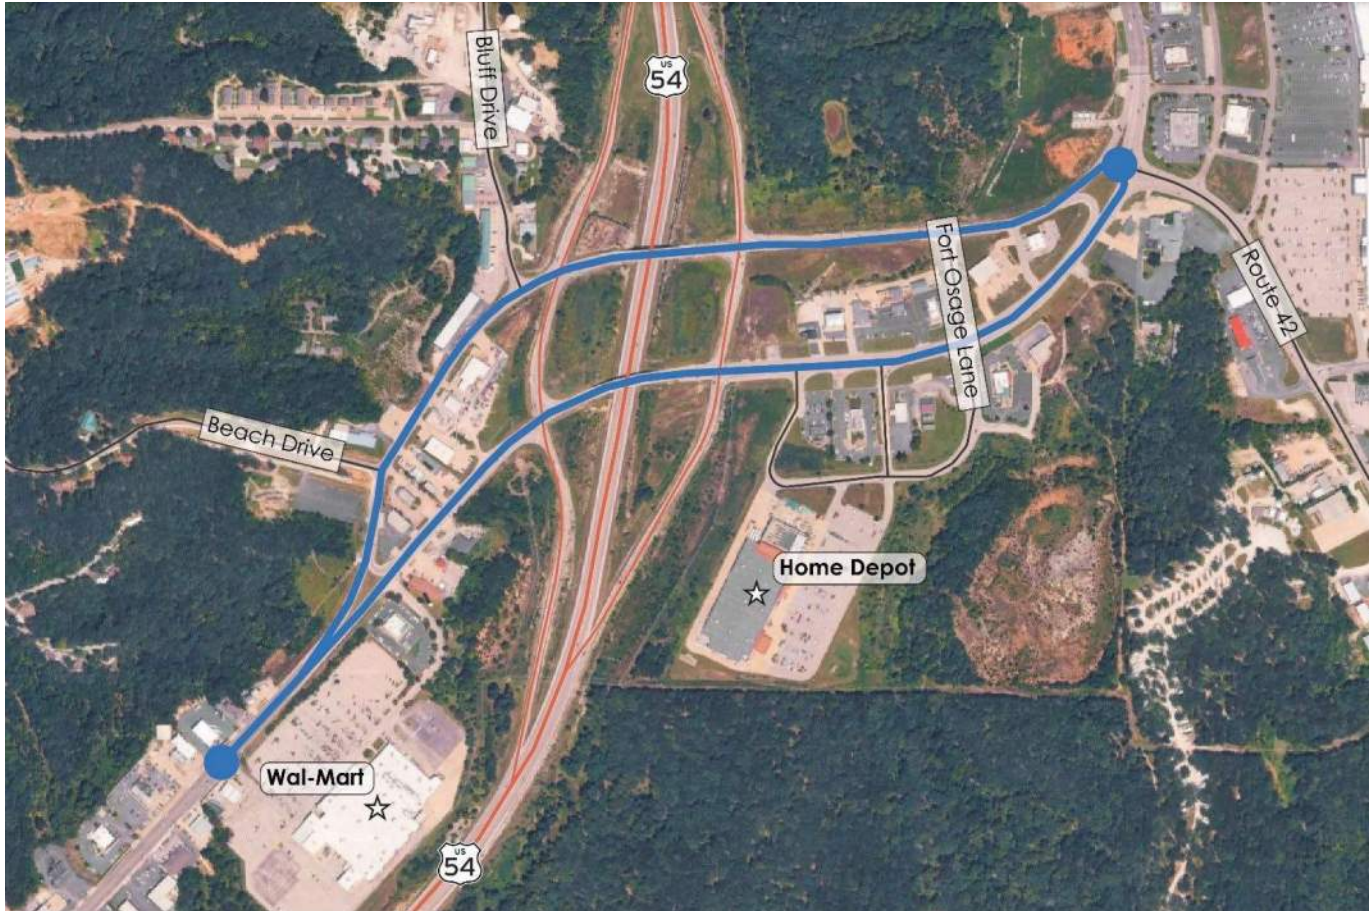
Figure 102 - Aerial image of Osage Beach Parkway Segment 4: U.S. 54 Couplet Interchange – Wal-Mart to Route 42

The Osage Beach Parkway segment from Wal-Mart to Route 42 is a couplet roadway, that splits into two separate roadways and is 1.7 miles long. Each of the two roadways are three-lane, one-way roads. This segment of Osage Beach Parkway is owned and maintained by MoDOT. Much of this area is made up of the interchange with U.S. 54, includes eight signalized intersections, and two unsignalized intersections. The majority of segment 4 connects to commercial land uses including Wal-Mart, Home Depot, and the Prewitt's Point Shopping Center.

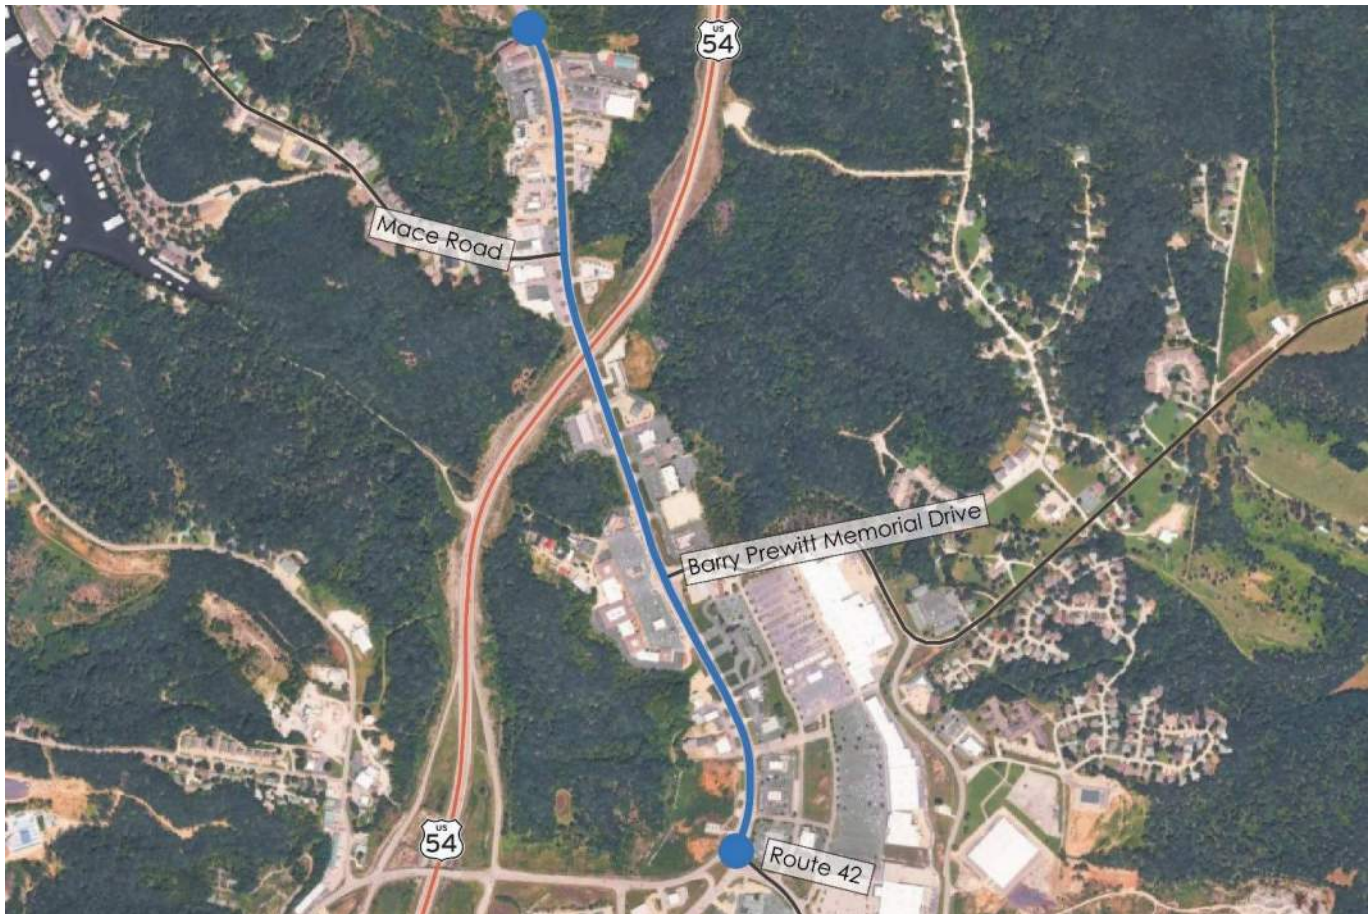
Figure 107 - Aerial image of Osage Beach Parkway Segment 5: Route 42 to Osage Beach City Limits

The Osage Beach Parkway segment from Route 42 to Osage Beach City Limits is a five-lane road with a center turn lane and is 1.1 miles long. This segment is mostly surrounded by commercial land uses including Target, Hy-Vee, Stone Crest Mall, and Bell Plaza. There are two unsignalized intersections and two signalized intersections. Mace Road and Barry Prewitt Memorial Drive connect residential areas to Osage Beach Parkway. Route 42 provides access to the School of Osage. Just south of Mace Road, there is a bridge supporting Osage Beach Parkway over U.S. 54.

There are 47 driveways along this segment of Osage Beach Parkway, mostly to commercial uses. There are about 42 driveways per mile and 4.05 driveways per 500 feet.

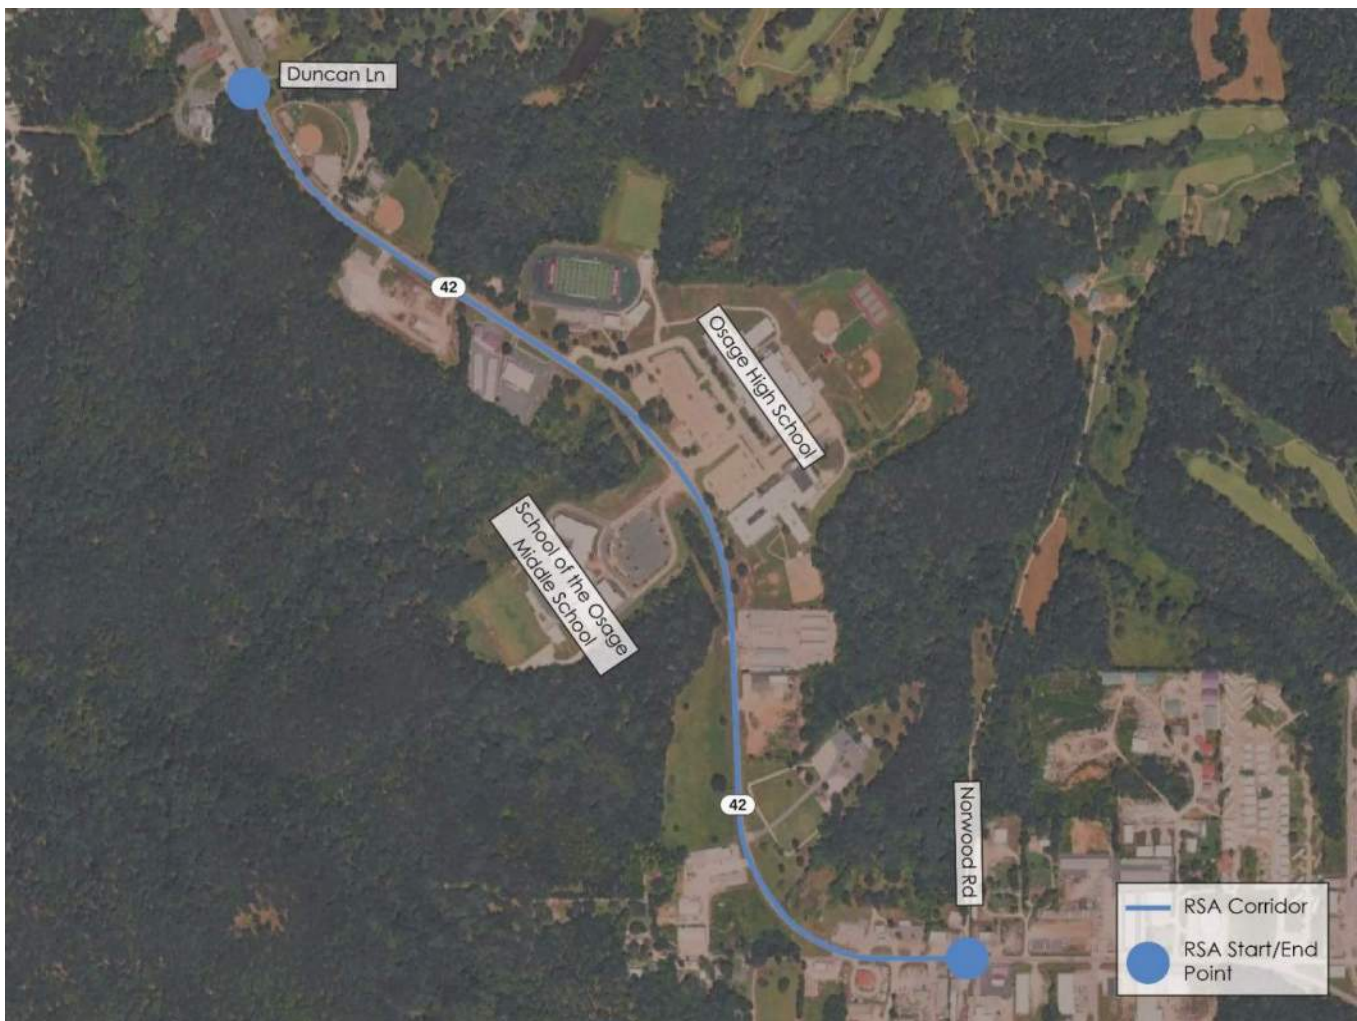
Figure 108 - School of the Osage RSA Project Area

The project area for this RSA starts at Duncan Ln and Route 42 north of the school campus and ends at the city limits at 414 Route 42 and Norwood Road (Figure 108). Overall recommendations include engineering, education and encouragement, enforcement, media, and school pick-up and drop-off solution strategies for the study area.

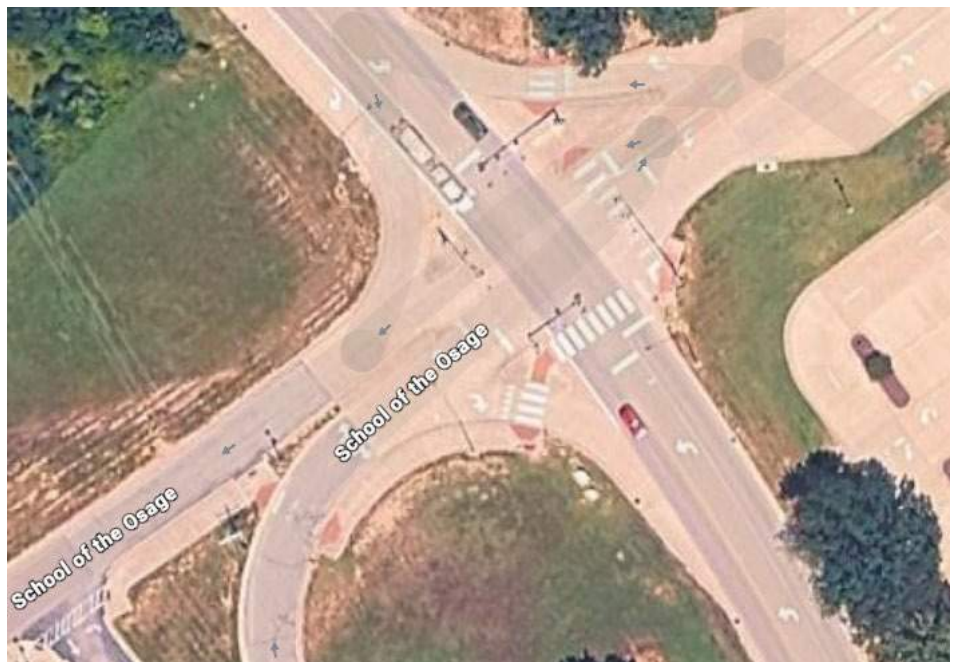
Figure 109 - Route 42 & School of the Osage Intersection

Marked crosswalks are provided across Route 42 on the south side and across School of the Osage Road on the east side (Figure 109), both equipped with push buttons and countdown timers. The east-side crosswalk connects to the parking lot on the northeast side but does not connect to pedestrian facilities on the southeast side (Figure 110). The south-side crosswalk provides access northward along the southeast side and to a short sidewalk segment that connects to an additional crosswalk across the School of the Osage exit lanes. This crosswalk leads to a sidewalk that runs through the parking lot and continues to the school, with multiple marked crosswalks provided to facilitate safe crossings through the parking areas. During the summer of 2025, minor rehabilitation work was completed at the existing intersection, including curb and sidewalk aesthetic upgrades.

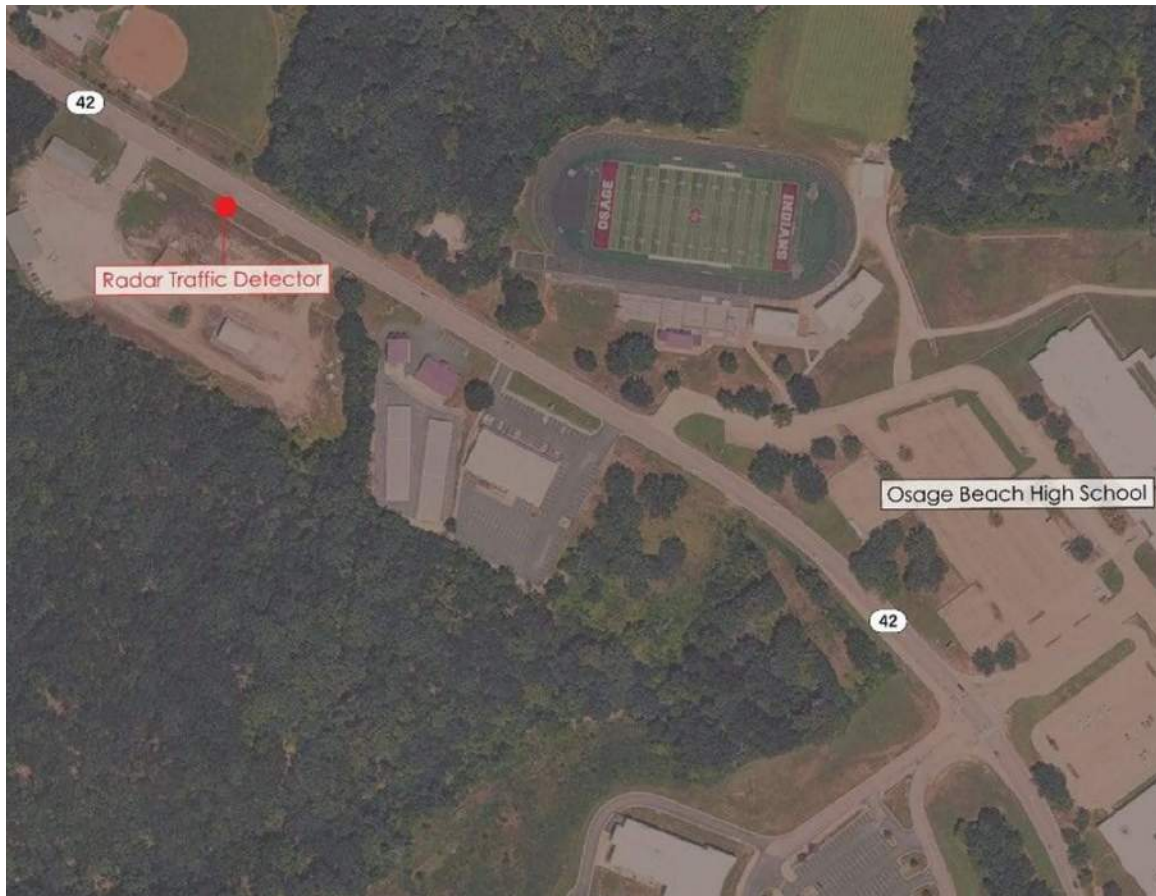
Figure 111 - Route 42 Traffic Radar Location

Traffic volumes and speeds were collected using a Black Cat II Radar along Route 42 after Duncan Ln, before Vagabond Ln on October 10, 2025 (Figure 111). In lieu of turning movement counts not collected, AADT from MoDOT was obtained to compare with the traffic radar.

There were just under 10,000 vehicles counted on the segment of Route 42 between Duncan Ln and Vagabond Ln on October 10<sup>th</sup>, 2025, about 5,700 vehicles were traveling southbound and 4,200 vehicles were traveling northbound. The AM peak time was 7am to 8am with traffic volume of 1,300 and PM peak time was 3pm to 4pm traffic volume of 1,100. For this same segment between Duncan Ln and Vagabond Ln, MoDOT shows the AADT as about 8,200, with 4,100 in the southbound direction and 4,100 in the northbound direction.

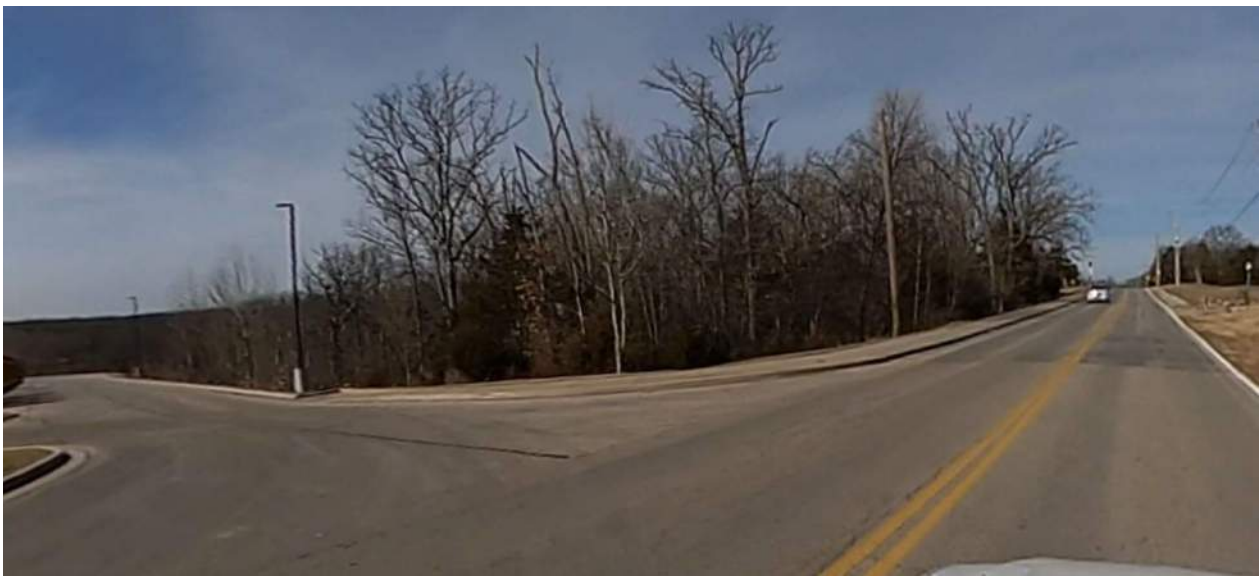
Figure 116 - Sidewalk infrastructure north of Nichols Road (02.11.2026)

Existing sidewalks are located north of the elementary school on the west side of Nichols Road and along Dude Ranch Road, located roughly 200 feet south of Cobblestone Drive (Figure 116). There is a pedestrian crossing with ADA-compliant curb ramps and a pedestrian crossing sign at Dude Ranch Road (Figure 117).

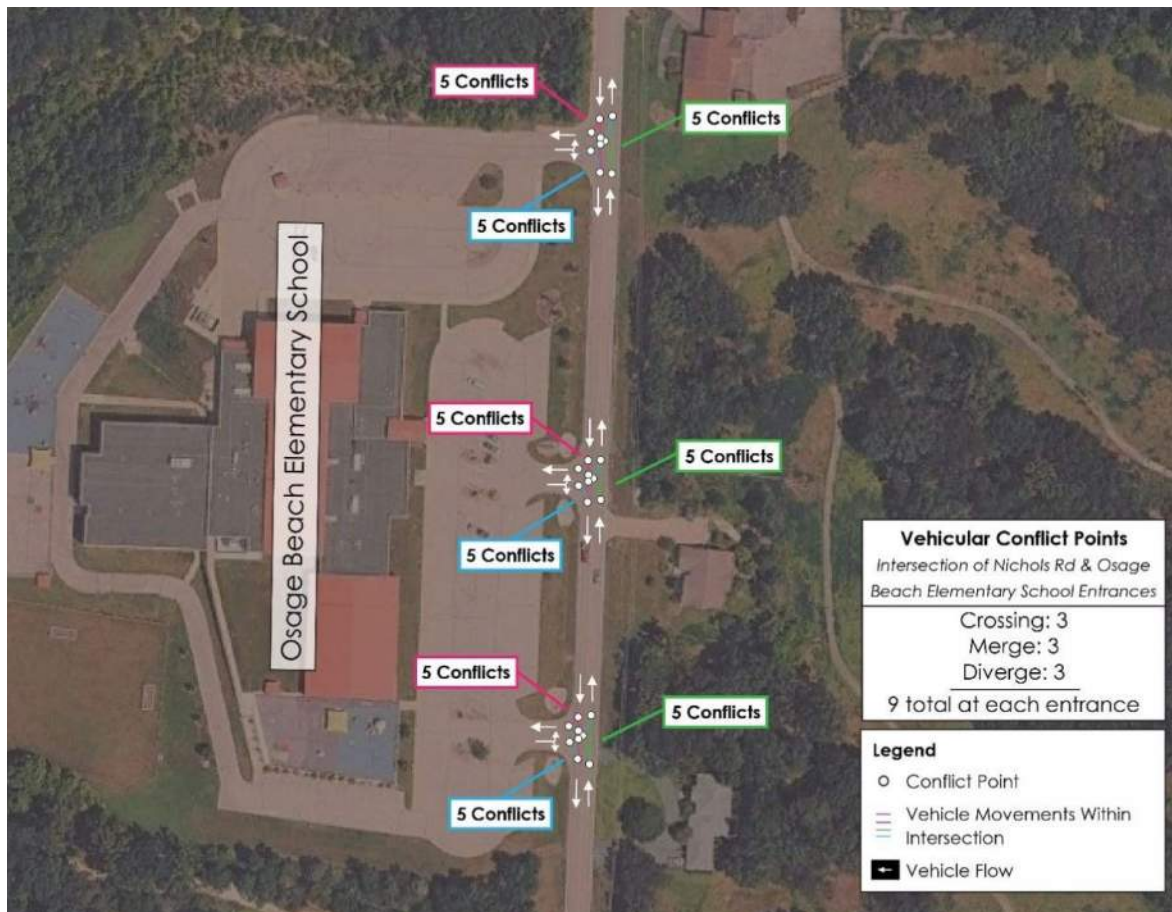
Figure 118 - Conflict Point Diagram for the Osage Beach Elementary School entrances on Nichols Road

There are 9 potential conflict points that exist at each of the three entrance access driveways of the elementary school, illustrated in Figure 118. The north entrance provides access to the north parking lot and a loading dock for deliveries. The two south entrances provide access to the main parking lot with access to the front of the school.
